TECHNICAL NOTE

No. 1235

AN INVESTIGATION OF A THERMAL ICE-PREVENTION SYSTEM FOR A  
CARGO AIRPLANE. VIII - METALLURGICAL EXAMINATION OF THE  
WING LEADING-EDGE STRUCTURE AFTER 225 HOURS OF FLIGHT  
OPERATION OF THE THERMAL SYSTEM

April 1947

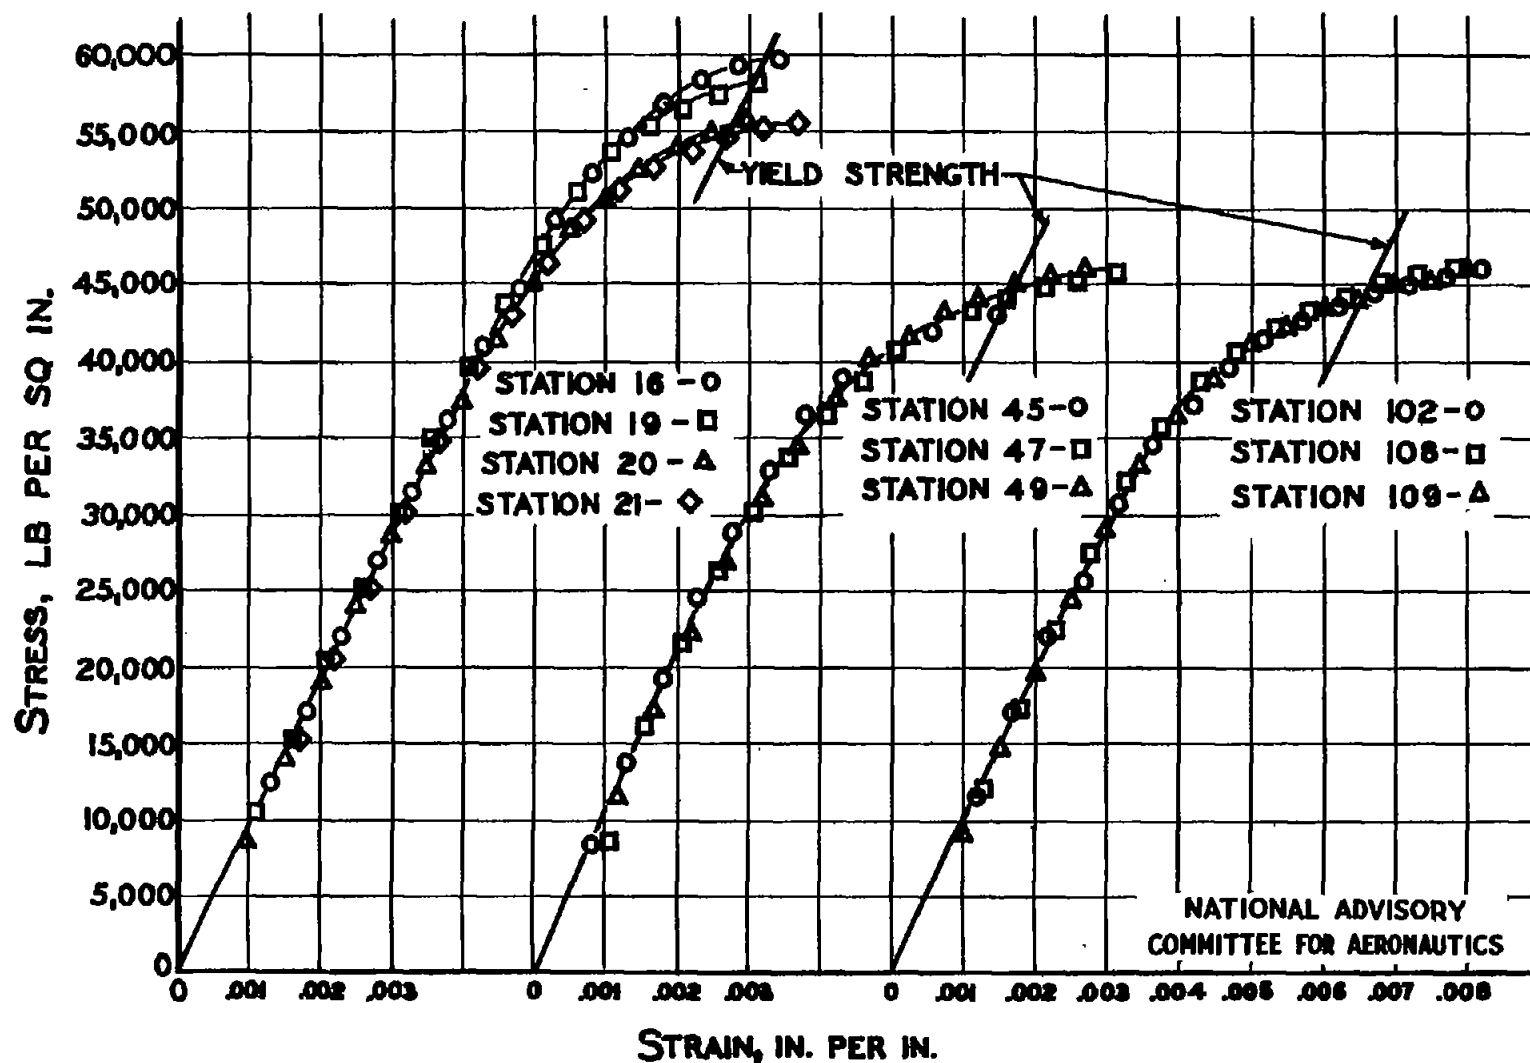
It may be noted in table I that from station 16 to 21, a distance of only 5 inches, there is a continuous decrease in yield strength and an attendant gain in elongation, approaching room-temperature values. This indicates an effective differential in temperature, even over this short distance, substantiating investigations (reference 3) on the artificial aging of Alclad 24S-T which have revealed that in a critical temperature range of from 300° F to 375° F small differences in temperature may cause quite noticeable changes in yield strength. The values obtained for the ultimate tensile strength and yield strength for the specimens from stations 45, 47, 49, 102, 108, and 109 do not indicate any marked temperature-aging effect as they compare closely with the figures given in reference 15. The stress-strain curve for each specimen is shown in figure 12. This figure shows clearly the

increased ultimate and yield strengths of the specimens from stations 16 to 21 resulting from artificial aging. The yield at 0.2-percent offset is indicated by the short intercept line at the knee of each curve. Essentially, the modulus of elasticity is the same for all curves, which is normal for room-temperature tensile tests of this material.

FIGURE 12- STRESS-STRAIN CURVES FOR ALCLAD 24S-T ALUMINUM ALLOY TEST SPECIMENS TAKEN FROM THE BAFFLE PLATE OF A THERMAL ICE-PREVENTION SYSTEM INSTALLED IN A C-46 AIRPLANE WING.
