# RESEARCH MEMORANDUM

CYCLIC ENGINE TEST OF CAST VITALLIUM

TURBINE BUCKETS - II

By J. Elmo Farmer, George C. Deutsch  
and Paul F. Sikora

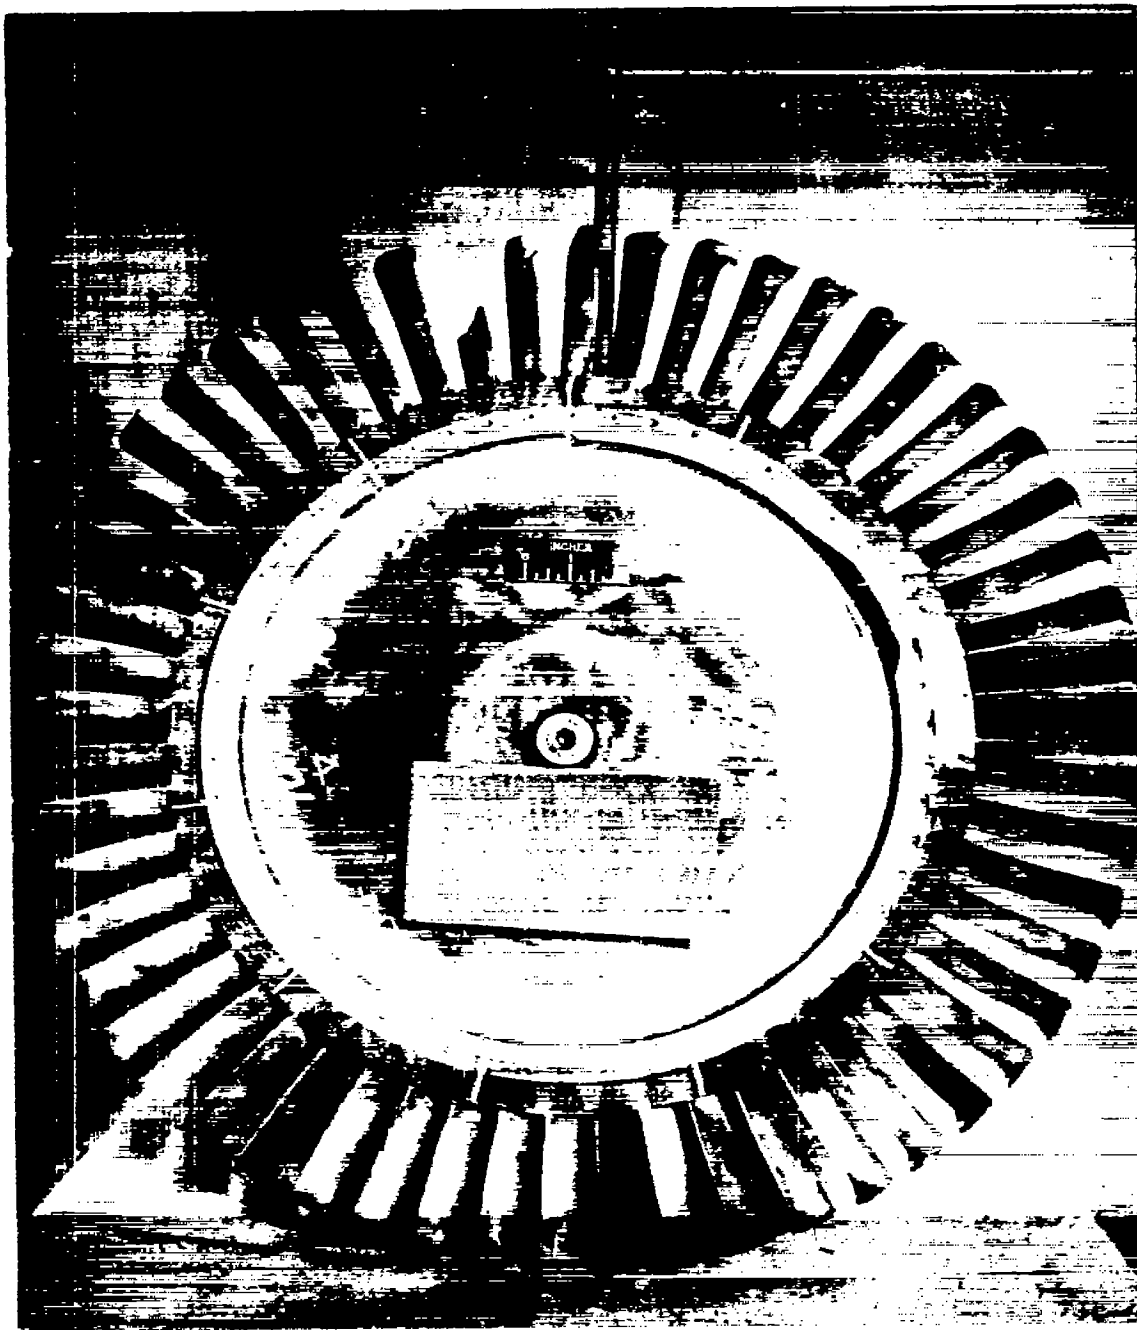
NACA  
C-17718  
1-27-47

Wheel 1. - The first and second bucket failures, in cycle 22 at 7 hours and 20 minutes and in cycle 25 at 8 hours and 12 minutes, respectively, are described in reference 1. The third bucket, 1-53, broke in cycle 26 at a total running time of 8 hours and 34 minutes (fig. 2).

Figure 2. - Wheel 1 after third bucket failure (bucket 1-53) during cycle 26 at total running time of 8 hours and 34 minutes.

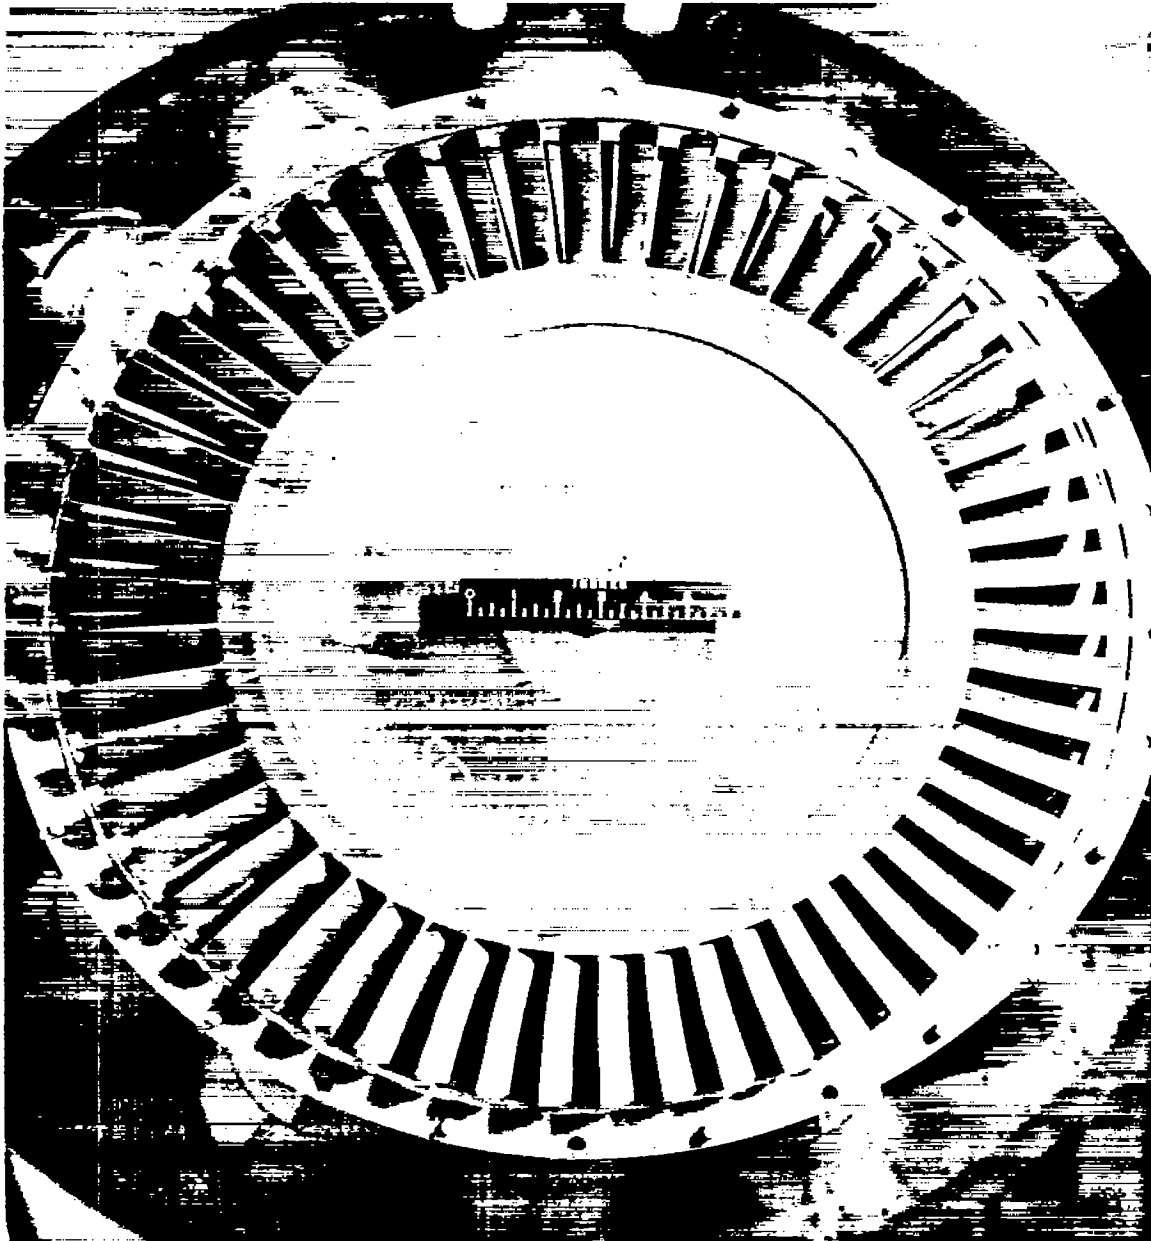
NACA  
C-16025  
10-15-46

Wheel 2. - The first bucket failure (bucket 2-18) occurred in cycle 29 at 9 hours and 28 minutes (reference 1). The second bucket, 2-48, broke in cycle 106 at a total running time of 35 hours and 10 minutes (fig. 3).

Figure 3. - Wheel 2 after second bucket failure (bucket 2-48) during cycle 106 at total running time of 35 hours and 10 minutes.

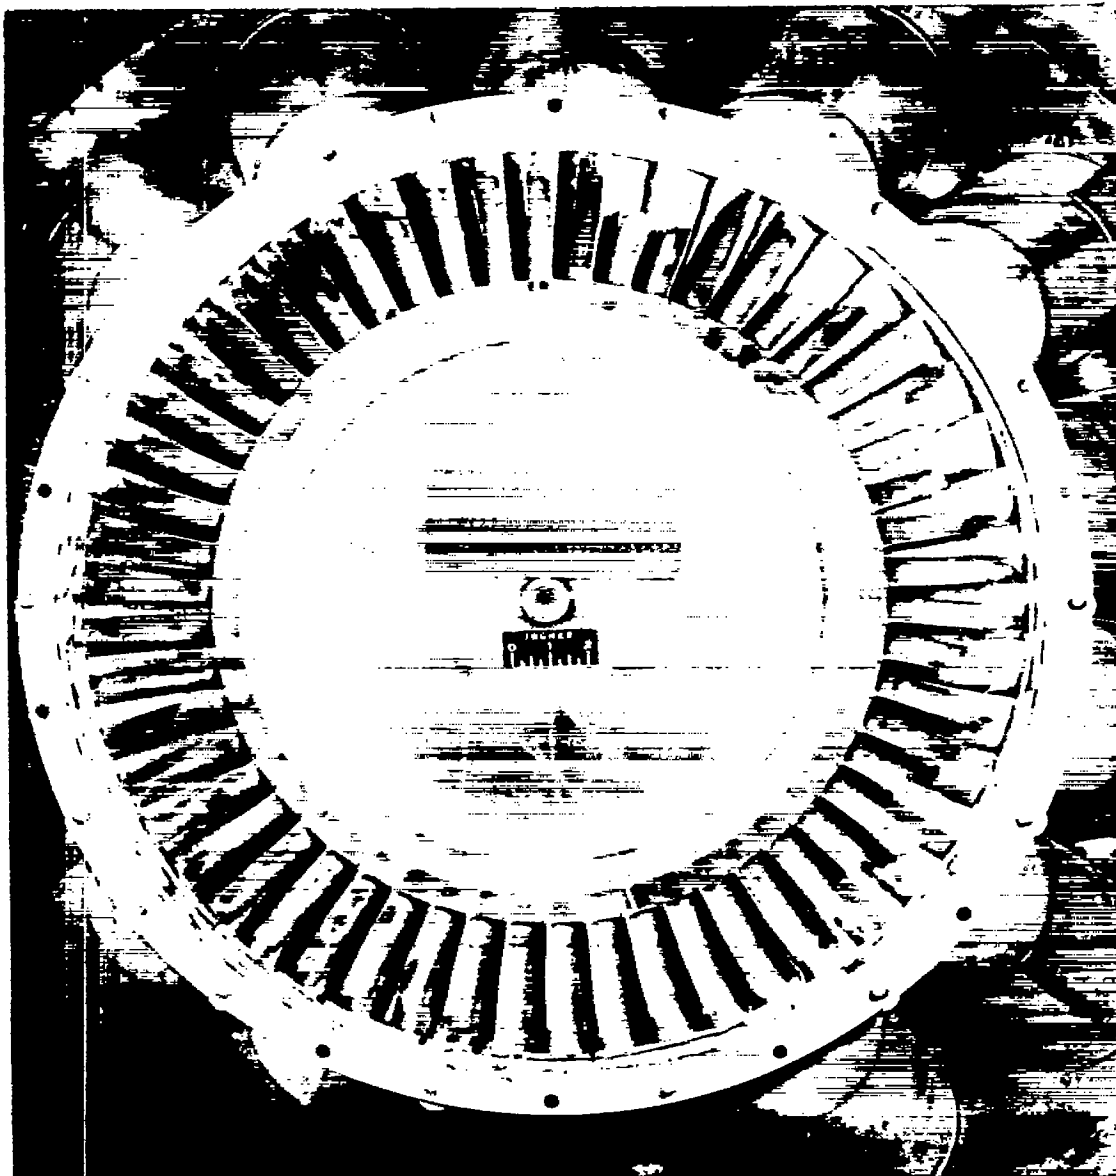
NACA  
c-17520  
1-10-47

Wheel 3. - Buckets 3-16 and 3-43 were removed for examination after cycle 229 at 76 hours and 20 minutes total running time. Two new buckets were installed, the wheel balanced and the running continued. Upon inspection after cycle 260 (86 hr, 40 min, total running time), bucket 3-34 was found to be cracked on the convex surface. This bucket was replaced, the wheel balanced, and the running continued. In cycle 268 (89 hr, 17 min), a failure occurred that broke eight buckets and so damaged the others that running could not be continued with this wheel (fig. 4). Four of the eight broken buckets (3-33, 3-36, 3-45, and 3-49) were removed for examination.

Figure 4. - Wheel 3 after second bucket failure occurred during cycle 268 at total running time of 89 hours and 17 minutes damaging eight buckets.

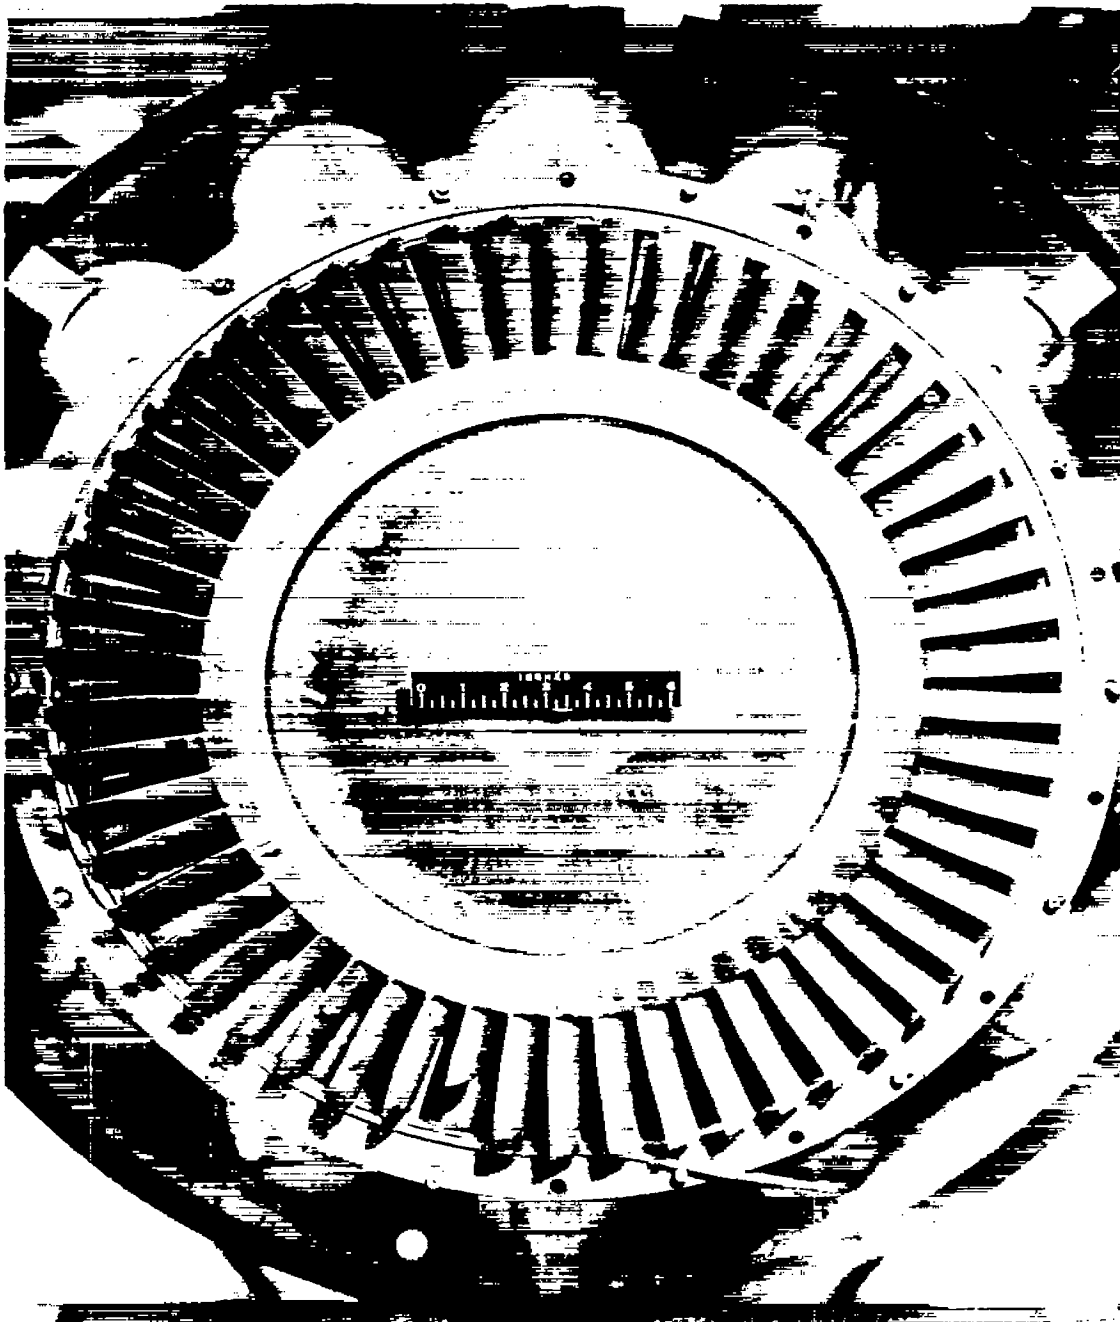
NACA  
C-16024  
10-15-46

Wheel 4. - The first bucket, 4-28, failed in cycle 156 at a total running time of 51 hours and 57 minutes (fig. 5). The broken bucket and two unbroken ones, 4-1 and 4-29, were removed from the wheel for examination. Three new buckets were installed, the wheel balanced, and the running continued. In cycle 188 (62 hr, 37 min, total

Figure 5. - Wheel 4 after first bucket failure (bucket 4-28) during cycle 156 at total running time of 51 hours and 57 minutes.

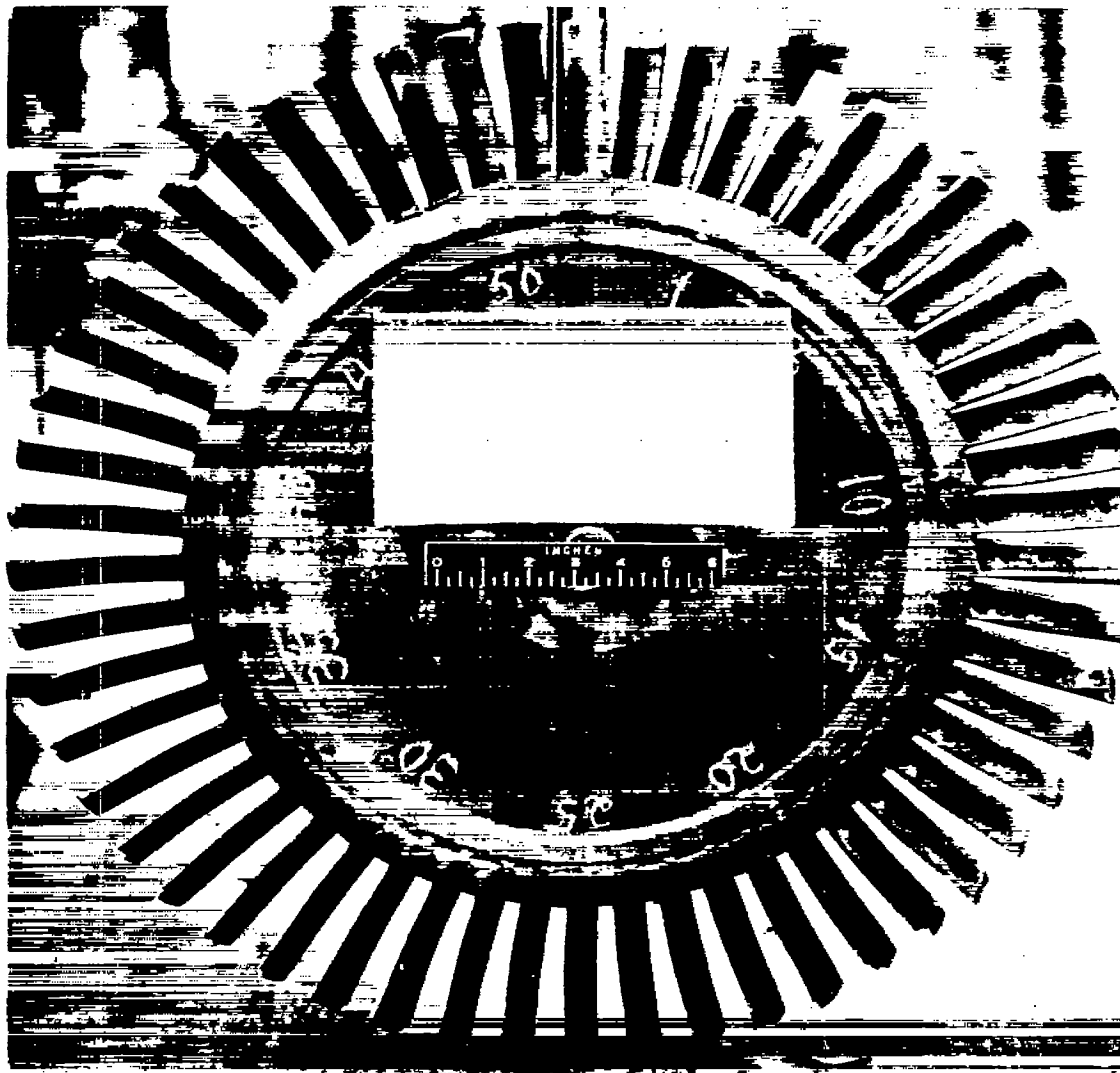
NACA  
c-17340  
12-9-46

running time), bucket 4-1A broke. This bucket (fig. 6) was one installed after the first failure and had been operated for 32 cycles (10 hr, 40 min). The bucket was replaced, the wheel balanced, and the running continued. The third bucket, 4-39, broke during cycle 190 at a total running time of 63 hours and 16 minutes (fig. 7).

Figure 6. - Wheel 4 after second bucket failure (bucket 4-1A) during cycle 188 at total running time of 62 hours and 37 minutes. This bucket was installed after first bucket failure and was run 32 cycles (10 hr, 40 min).

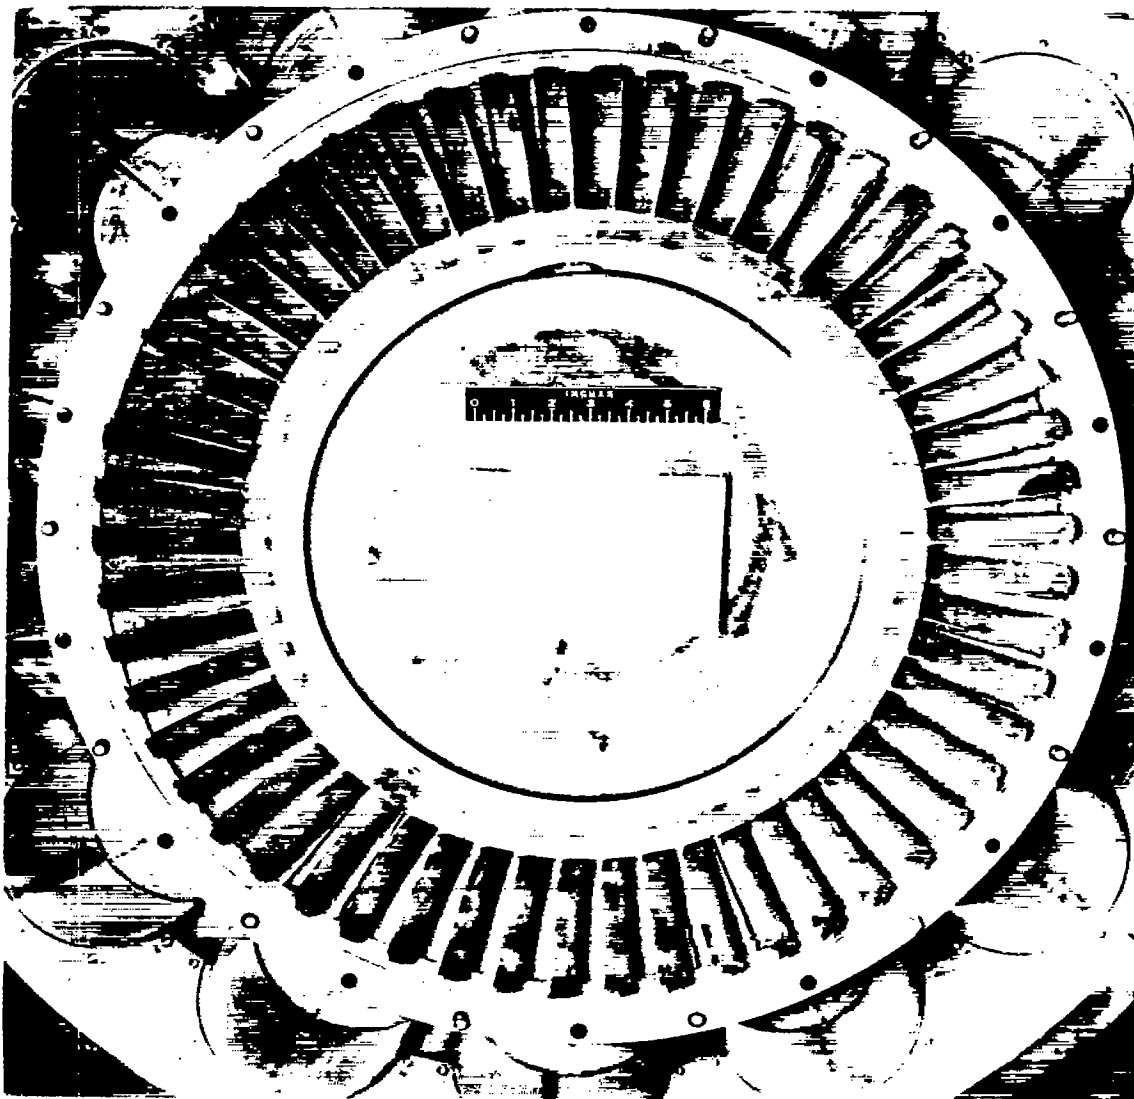
NACA  
c-17616  
1-16-47

Figure 7. - Wheel 4 after third bucket failure (bucket 4-39) during cycle 190 at total running time of 63 hours and 16 minutes.

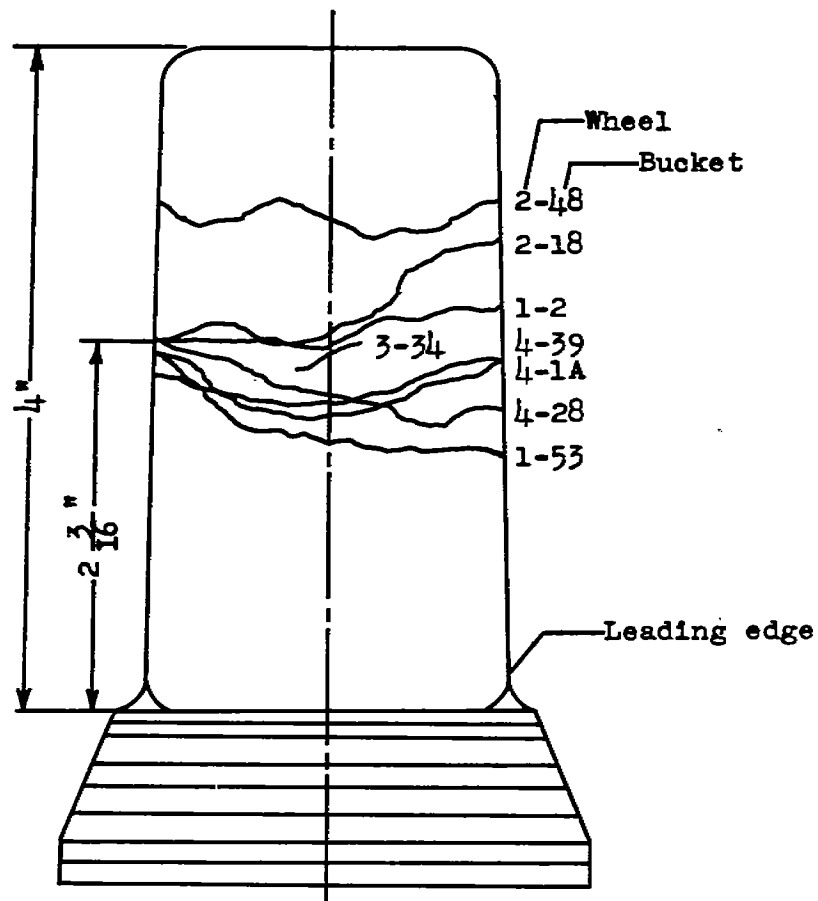
(a) Failures caused by fatigue.

Figure 9. - Composite profile of failures of cast Vitallium turbine buckets.

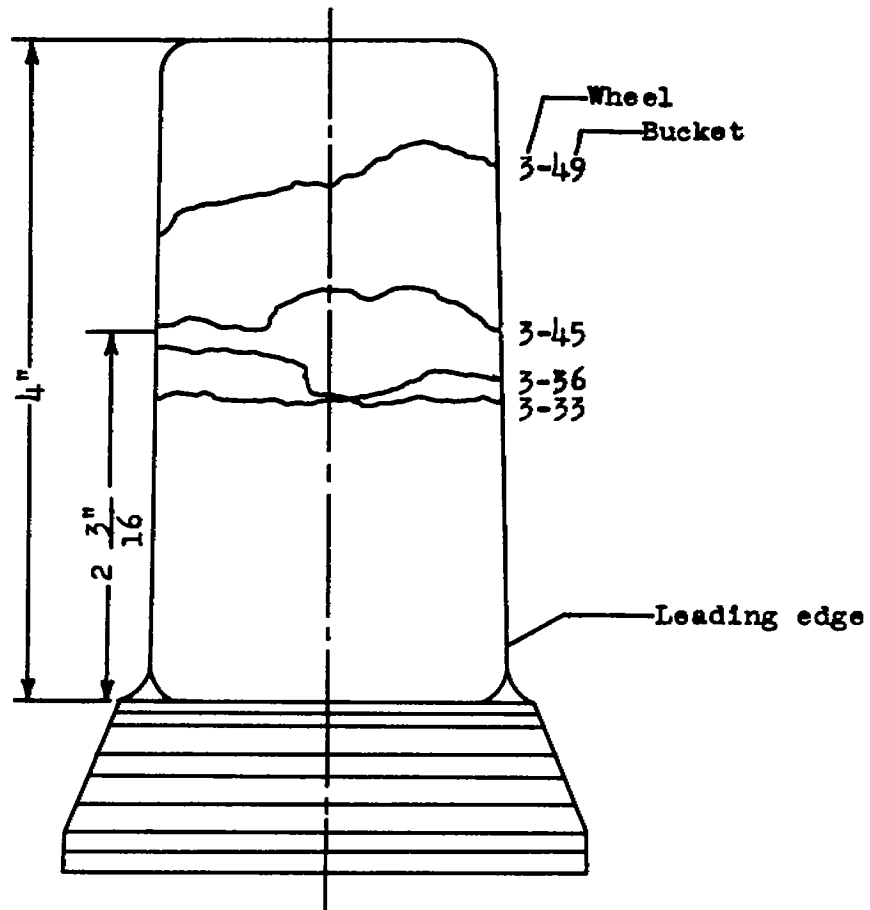
5. The fractured faces of four buckets representative of the secondary type of failure (fig. 8(b)) exhibited an appearance, uniform across the entire bucket, that was similar both in color and in texture to the fibrous zone previously described. This type of failure was also transcrystalline and had a random distribution along the blade length (fig. 9(b)). These failures probably occurred upon impact with segments of other broken buckets.

(b) Failures probably caused by impact.

Figure 9. - Concluded. Composite profile of failures of cast Vitallium turbine buckets.
