NATURAL ICING OF AN AXIAL-FLOW TURBOJET ENGINE
IN FLIGHT FOR A SINGLE ICING CONDITION

NACA RM No. E8F01a

RESEARCH MEMORANDUM

By Loren W. Acker

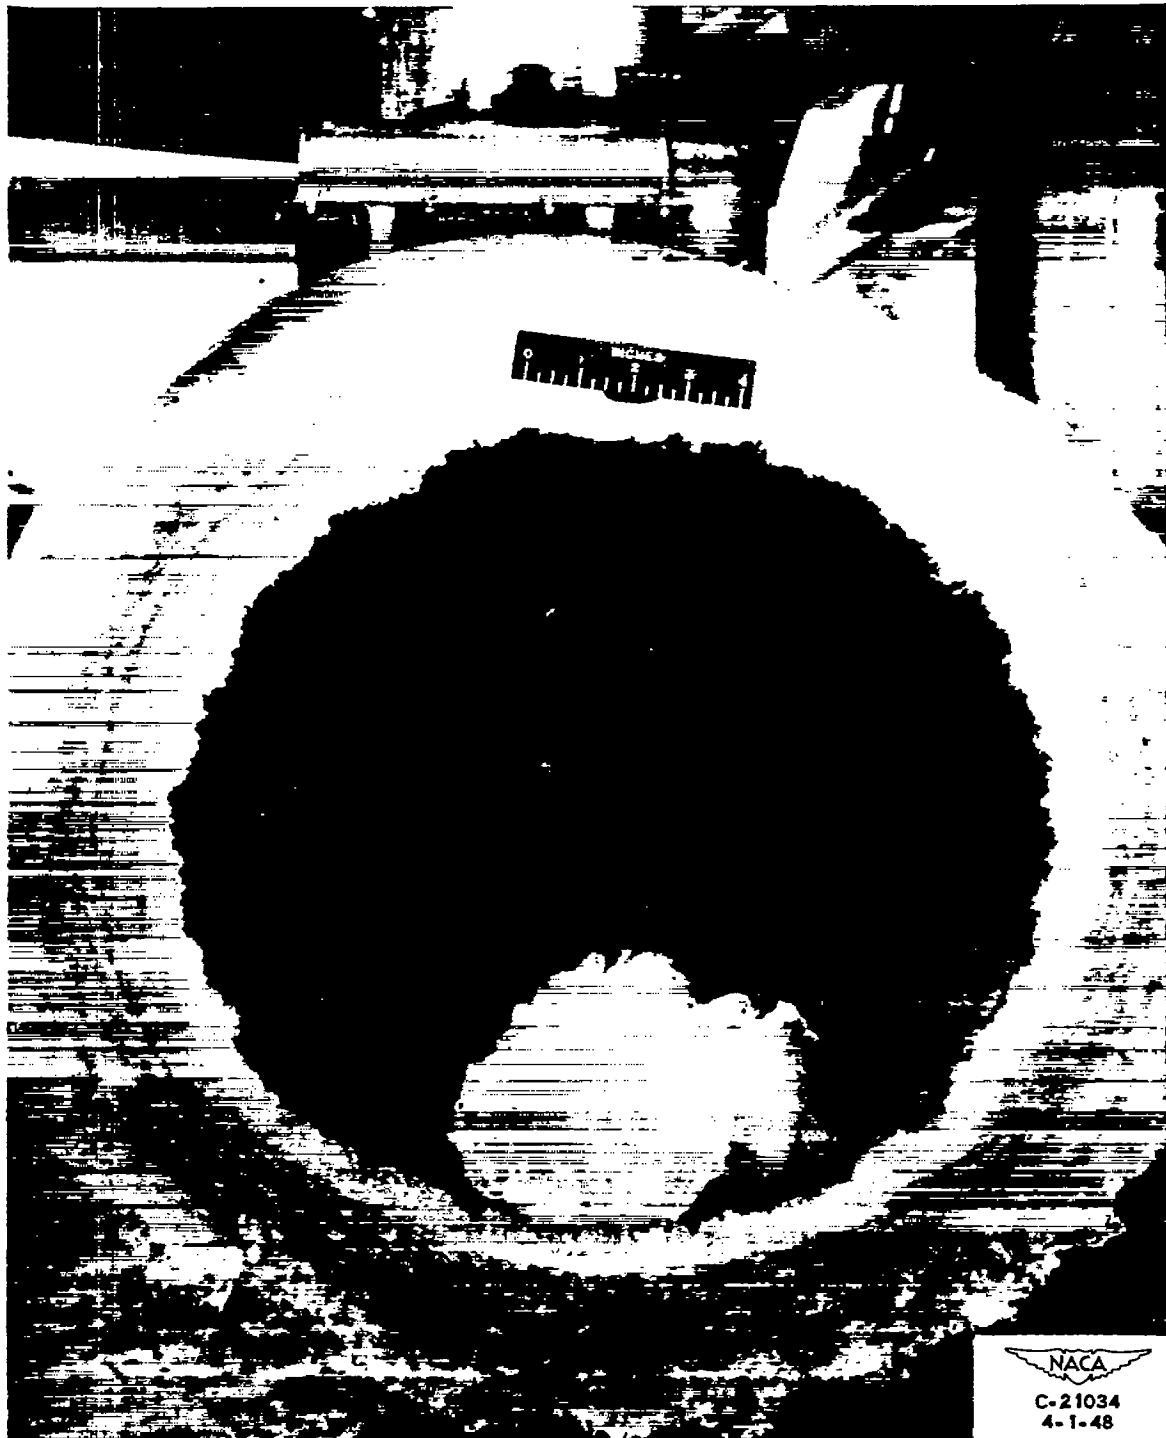
(b) Front view.

The ice formation obtained on the jet-engine cowling inlet is shown in figure 3. The degree of ice accumulation on the engine inlet is indicated by figures 4(a) and 4(b), which are side and front views, respectively, of the engine inlet photographed after landing. Very little ice, if any, collected on the engine-inlet guide vanes. The ice shown at the bottom of the inlet guide vanes is believed to consist of pieces broken from the ice formation on the starter housing or the support struts. A time history of the data taken in the icing condition is shown in figure 5. Engine jet thrust, fuel flow, and tail-pipe temperature are shown in figure 5(a); average droplet size, free-air temperature, and liquid-water content are shown in figure 5(b). Engine and icing data were taken upon entering the icing cloud and periodically during the encounter with the icing condition, which lasted for approximately 1 hour. The engine speed was maintained at 11,000 rpm. A sudden drop in engine thrust as the airplane entered the icing cloud is believed to be a result of ice collection on the cowl lip, which disrupted the air flow and destroyed the pressure recovery at the compressor inlet.

Figure 4. - Concluded. Ice formation on engine cowling after icing flight.

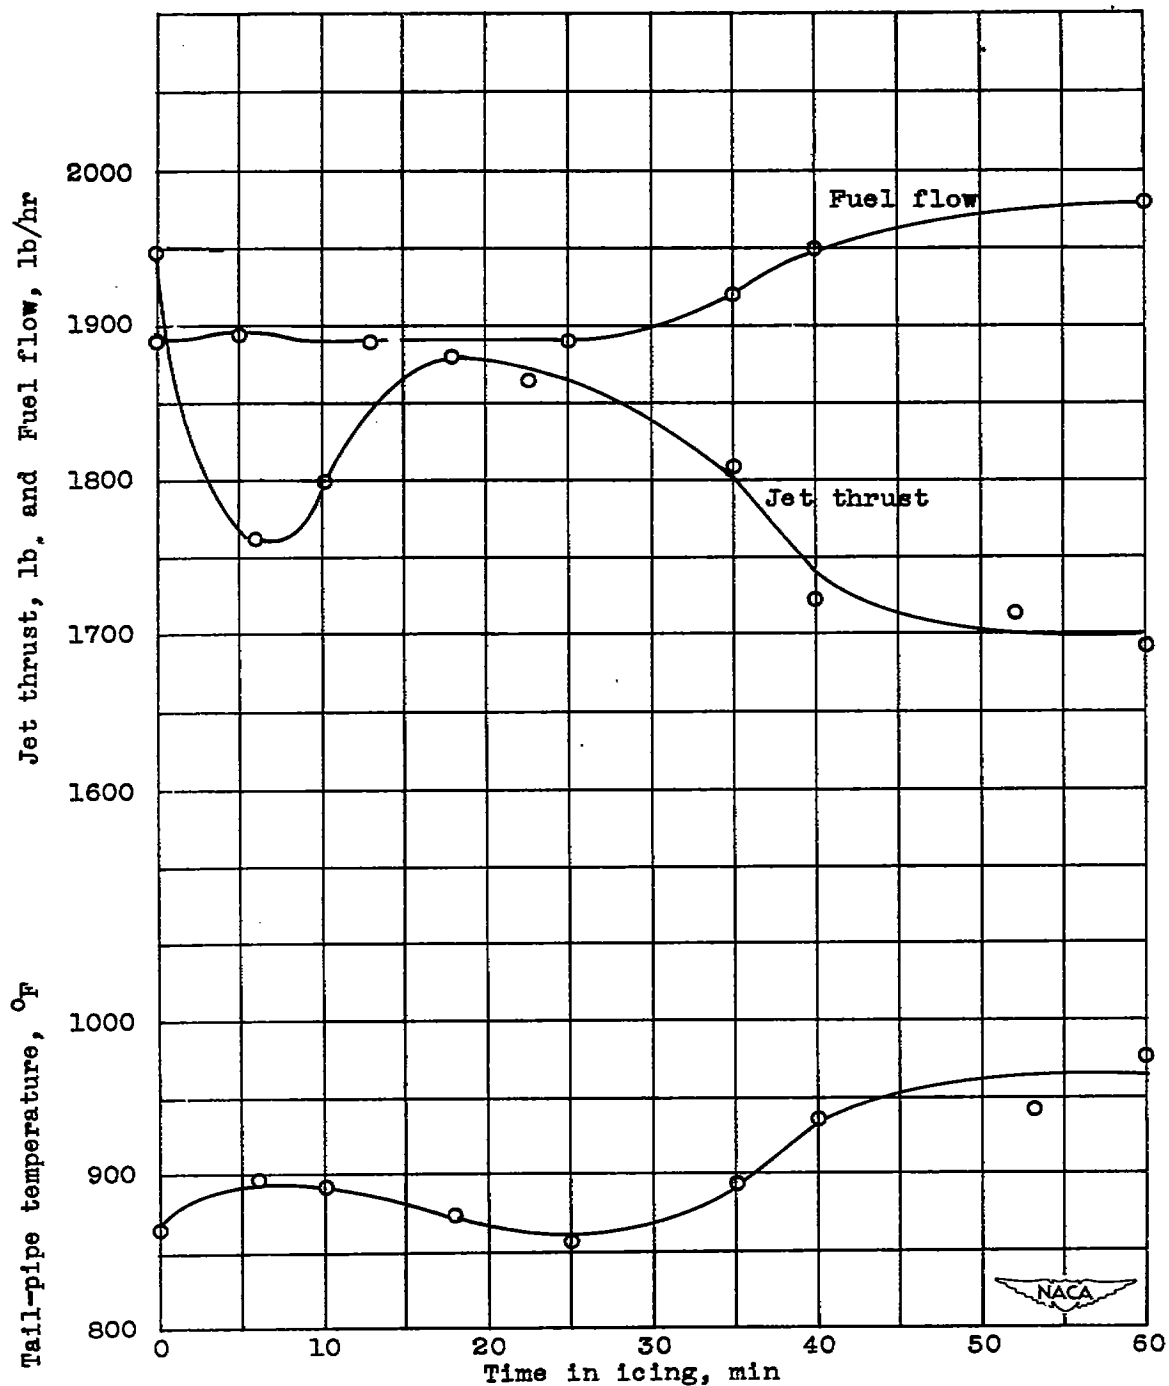
(a) Engine performance data.

At the end of 60 minutes, the thrust, the tail-pipe temperature, and the fuel flow had stabilized (fig. 5(a)). During the icing encounter, the thrust decreased from 1950 to 1700 pounds, the tail-pipe temperature increased from 865° to 965° F, and the fuel flow increased from 1890 to 1980 pounds per hour. During the time in the icing condition, the free-air temperature varied from 25° to 31° F, the average droplet size varied from 5.4 to 12.1 microns, and the liquid-water content varied from 0.077 to 0.490 gram per cubic meter (fig. 5(b)).

Figure 5. - Time history of data taken in icing condition.

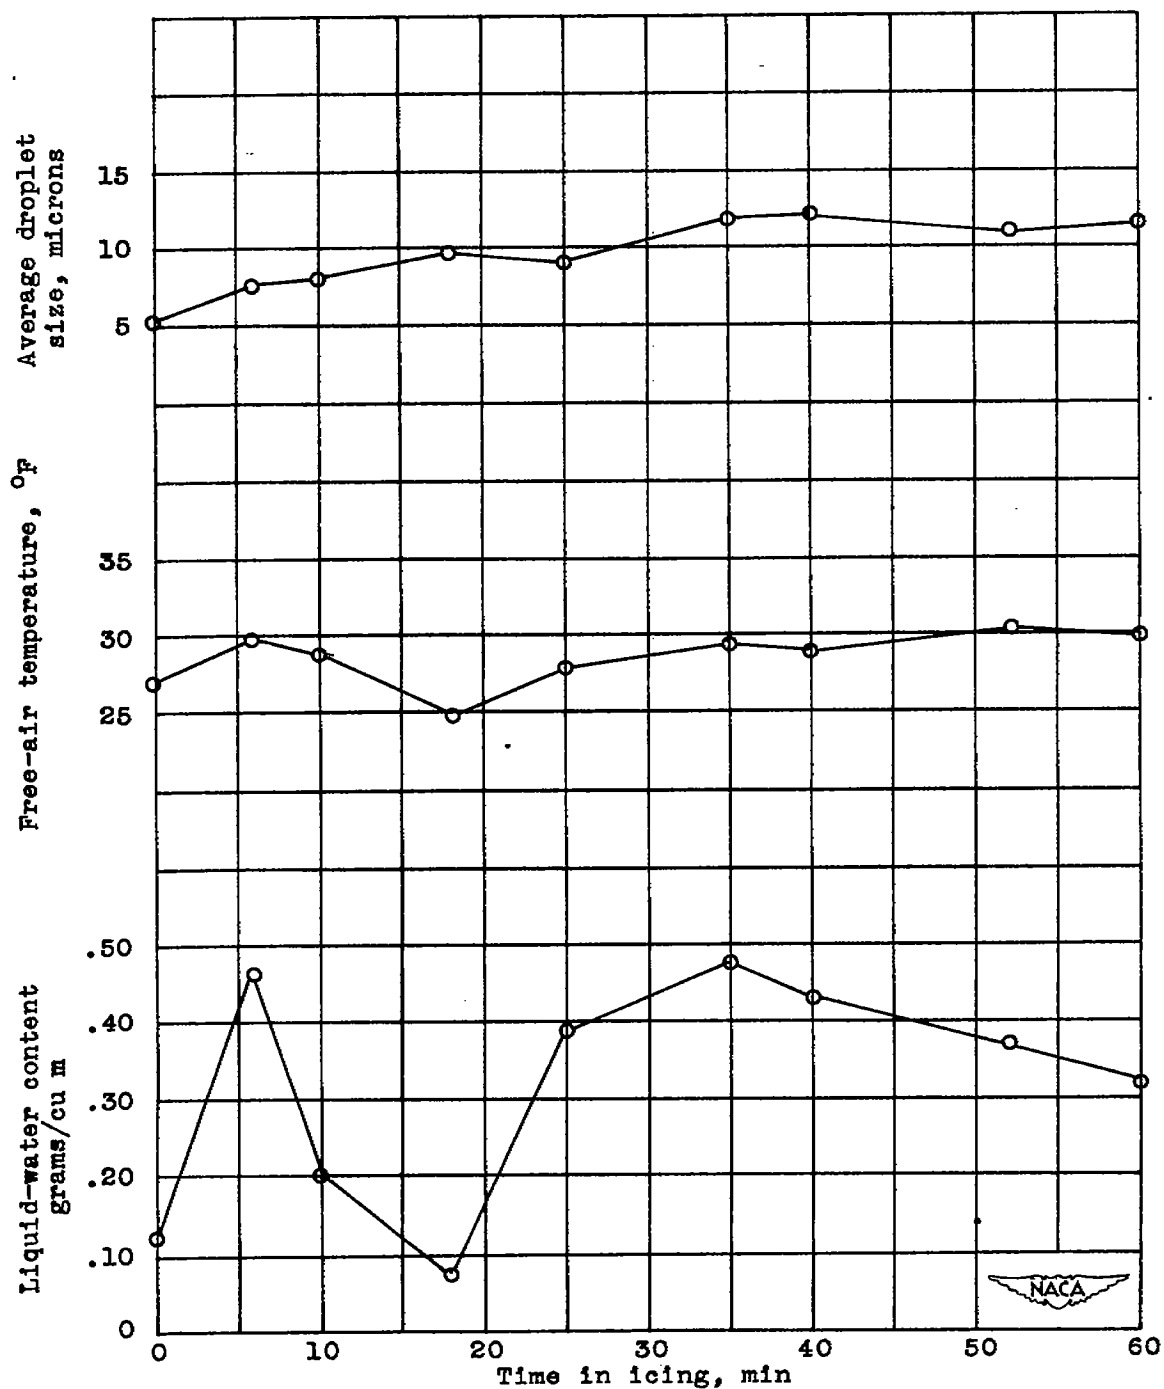
(b) Meteorological data.

After 18 minutes in the icing condition, the engine returned to nearly normal operation. Because of the very low liquid-water content at that time (0.077 gram per cubic meter) and high free-air temperature (25° F), the ice accumulation on the engine inlet melted and ran back along the cowling (fig. 5(b)).

After 35 minutes, the liquid-water content rapidly rose to 0.49 gram per cubic meter (fig. 5(b)). The fuel flow then increased to maintain the engine speed, which resulted in a corresponding increase in tail-pipe temperature. At this point the thrust rapidly decreased.

After 35 minutes, the liquid-water content gradually decreased from 0.49 to 0.32 gram per cubic meter at the end of the run (fig. 5(b)). The additional ice accumulation on the engine resulted in a gradual increase in fuel flow and tail-pipe temperature and a gradual decrease in jet thrust.

Figure 5. - Concluded. Time history of data taken in icing condition.
