# RESEARCH MEMORANDUM

IDENTIFICATION OF FOREIGN OBJECTS DAMAGING  
COMPRESSOR BLADES IN TURBOJET ENGINES

By A. E. Spakowski and J. Graab

WASHINGTON  
January 7, 1957

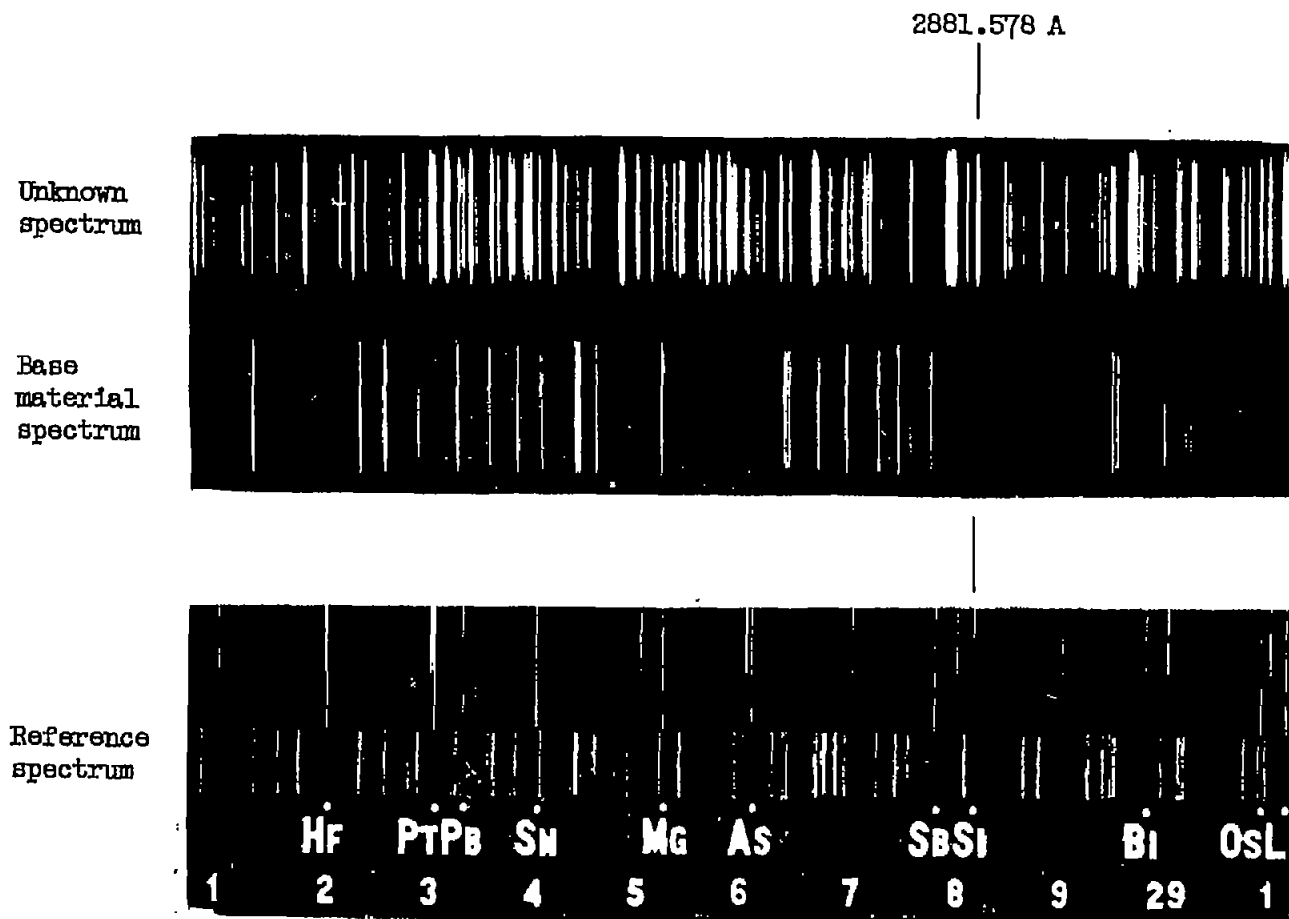
C-42775

During the course of this study compressor blades became available from two engines that had suffered damage due to the ingestion of foreign objects. These engines were received new and were run entirely in jet, static test stands. The results of the analysis of the damaged compressor blades from these two engines (labeled A and B) are shown in table IV. The compressor of engine A had been severely damaged, and damaged areas where copper and aluminum metal were clearly visible could be easily observed. In testing the spectroscopic method, however, only those areas where minor damage occurred were used. In actual practice every available means would be used to aid in the identification of the foreign material. The compressor of engine A has aluminum blades in the first stages and 403 stainless-steel blades in the remaining stages. A number of damaged areas on each type blade was analyzed; the results in table IV show that the principal element in each foreign material was found. It was known beforehand that engine B was damaged by a titanium carbide cermet with nickel as the binding agent. Upon analysis large quantities of titanium and nickel were found with trace amounts of aluminum and magnesium. The origin of the aluminum and magnesium is unknown.

(a) Identification of silicon.

Figure 1. - Emission spectrum of a foreign-object-damaged compressor blade from engine A.
