MINISTRY OF TECHNOLOGY

AERONAUTICAL RESEARCH COUNCIL

Civil Aircraft Airworthiness
Data-Recording Programme.
Special Events Relating
to Handling and Control
(January 1963 to February 1966)

CAADRP Special Events Working Party

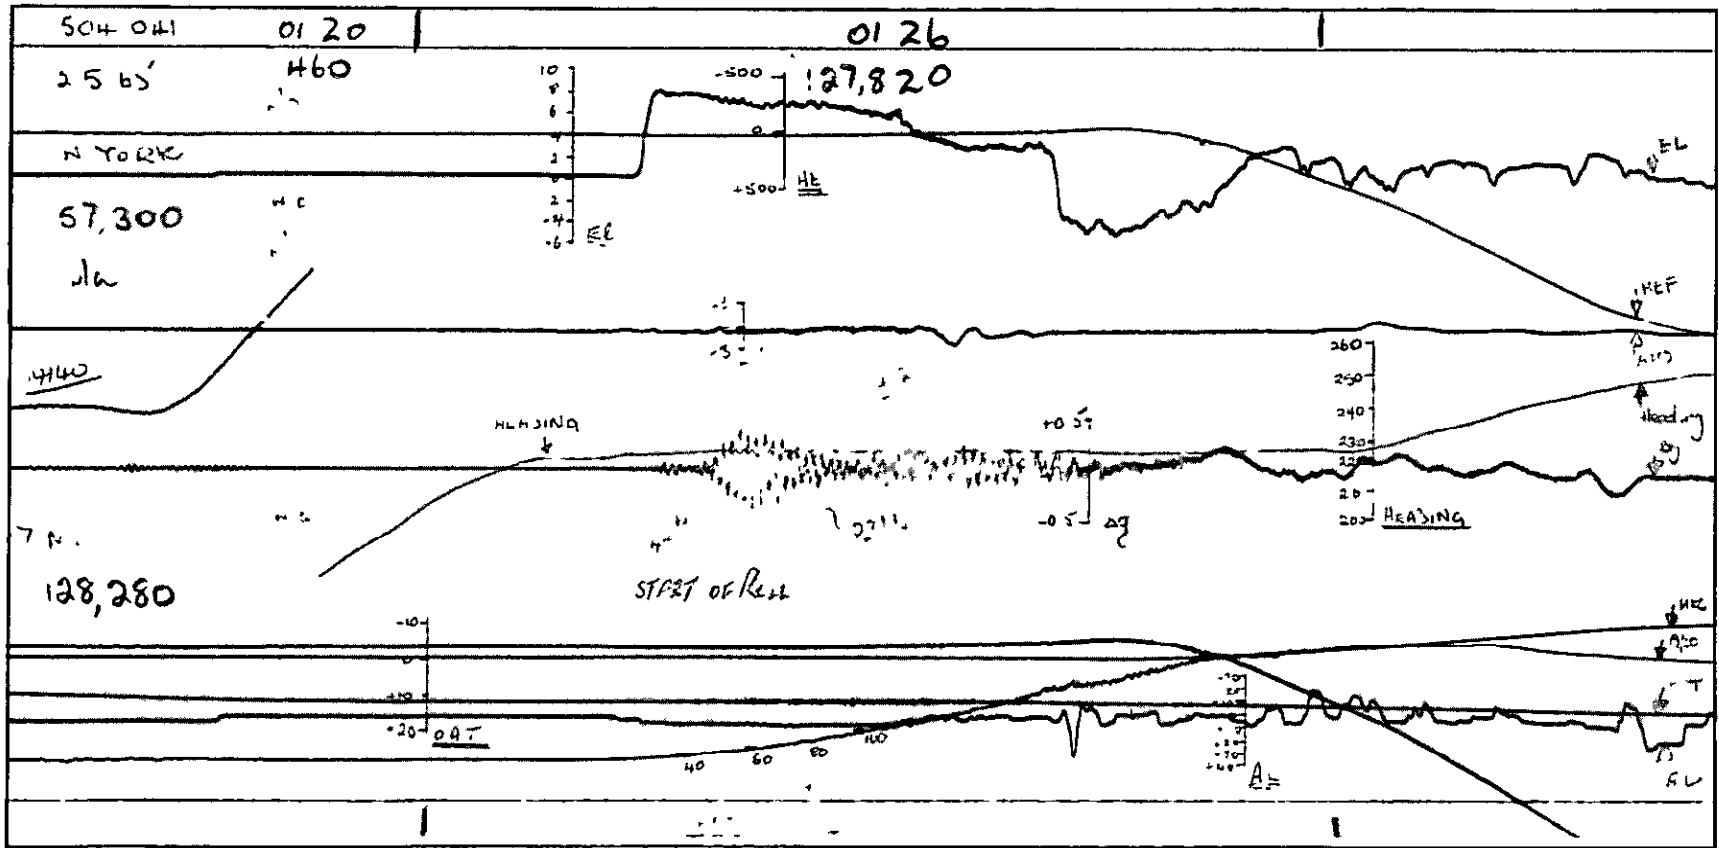
Fig.A2(a) Event in flight 14140

The examples presented in Figs.A.2a, b, c, illustrate the build-up and decay of large amplitude oscillations in normal acceleration at the aircraft cg during take-offs at high all-up-weights from runways 22 and 31L at New York. The amplitude and frequency for the above flights are 0.4 g at 1 cps, 0.5 g at 1.4 cps, and 0.3 g at 1.6 cps. Similar oscillations of up to 0.25 g amplitude are not uncommon.

Runways 22 and 31L at J.F.K., New York are of concrete with numerous small discontinuities and several intersections.

However from these records it is apparent that in normal operations on particular runways some aircraft can experience normal acceleration oscillations which could be associated with unacceptable levels of flight deck vibration. Although this has not as yet produced control difficulties it is considered that the situation merits close attention. Recent work by Handel-Hall⁹ has identified this problem with excitation of the undercarriage heaving mode.

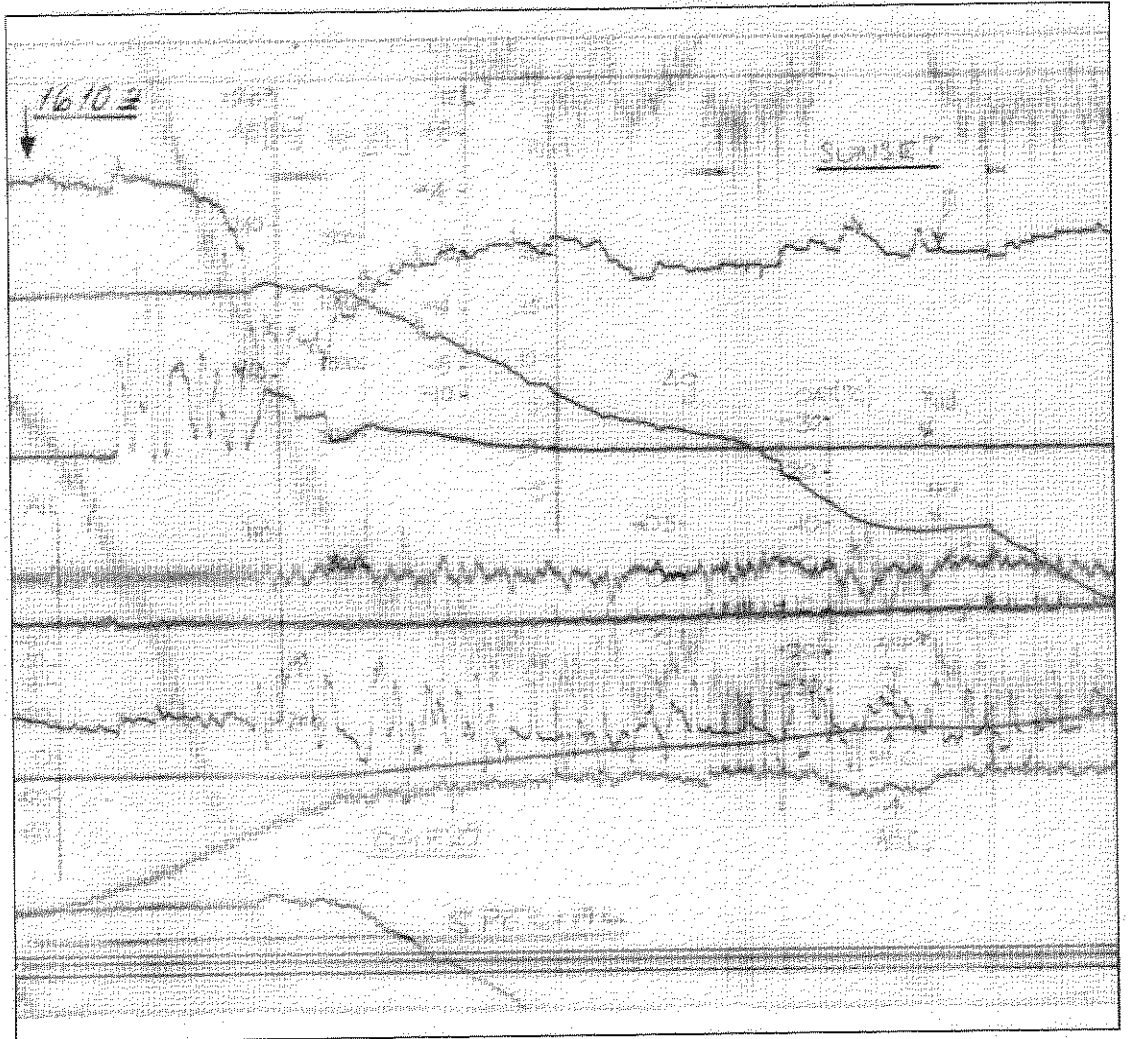
Fig.A3 Event in flight 04827

Large, but not maximum, left rudder movements were applied throughout the take-off run. Climb-out appears to have been delayed. (See Fig.A.3.)

It was subsequently determined that one of the stick shaker signal transducers was unserviceable and that the take-off took place in winds gusting from 23 kt to 31 kt at 80° to the runway.

The control usage in the take-off is consistent with the procedure to be adopted in a high cross-wind. The maximum allowable cross-wind on take-off is 30 kt. The delay in climb-out may have been caused by the shaker warning.

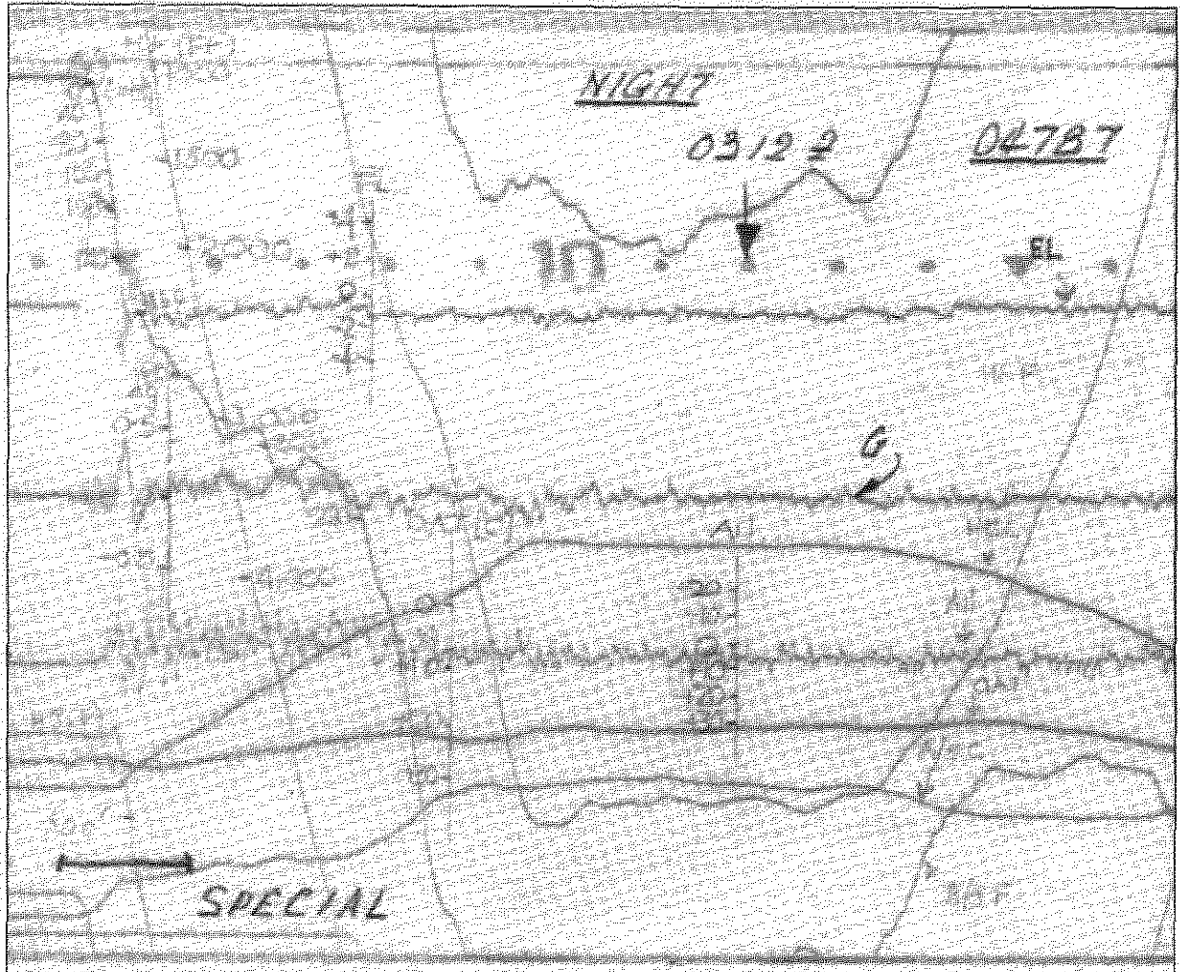
Fig.A4(a) Event in flight 04787

A normal acceleration increment of +0.5 g was pulled immediately after lift-off, during a light weight take-off (see Fig.A.4a).

It can be seen from Fig.A.4b that normal acceleration increments greater than +0.3 g are exceptional for this type but from Fig.A.4c, there is a tendency to pull rather more g at light weights. The elevator control used is by no means large in this case, and because the airspeed has reached 158 kt, the margin of normal acceleration between that applied and that necessary to produce stall buffet is in excess of 0.8 g.

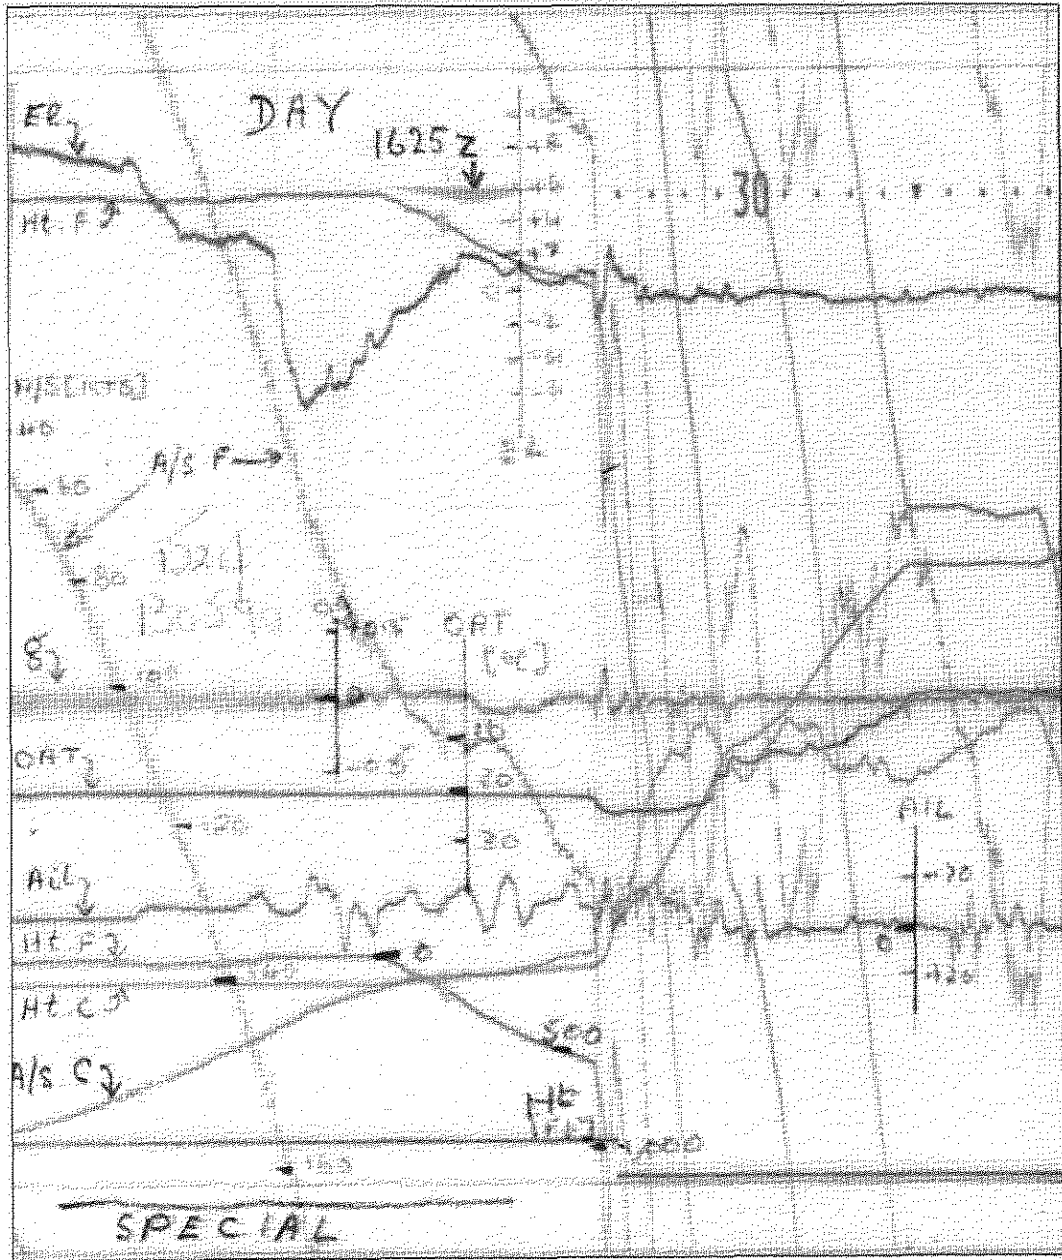
Fig.A5 Event in flight 01830

The fine height trace indicates that the aircraft did not start to climb until 15 seconds after unstick. (See Fig.A.5.)

From examination of the change in position error on the altimeter trace the aircraft appears to have rotated without deliberate action on the part of the pilot at 146 knots ias. Unstick appears to have occurred 9 seconds later at a speed of 166 knots ias. Normal rotation and unstick speeds for the weight would be 152 knots and 162 knots ias respectively. Therefore the fine height trace indicates that the aircraft stayed very close to the ground for a period of 8 seconds before the climb was commenced.

The question of faulty instrumentation has been considered, but the smooth variation of the height trace after the start of climb is thought to render this explanation unlikely. The noise on this trace some 8 seconds after the start of climb is due to retraction of the undercarriage.

Delayed climb-out procedures are rare, particularly from inland airports. However, as the take-off was made in good visibility over flat terrain the delayed climb does not in this instance, give rise to concern.

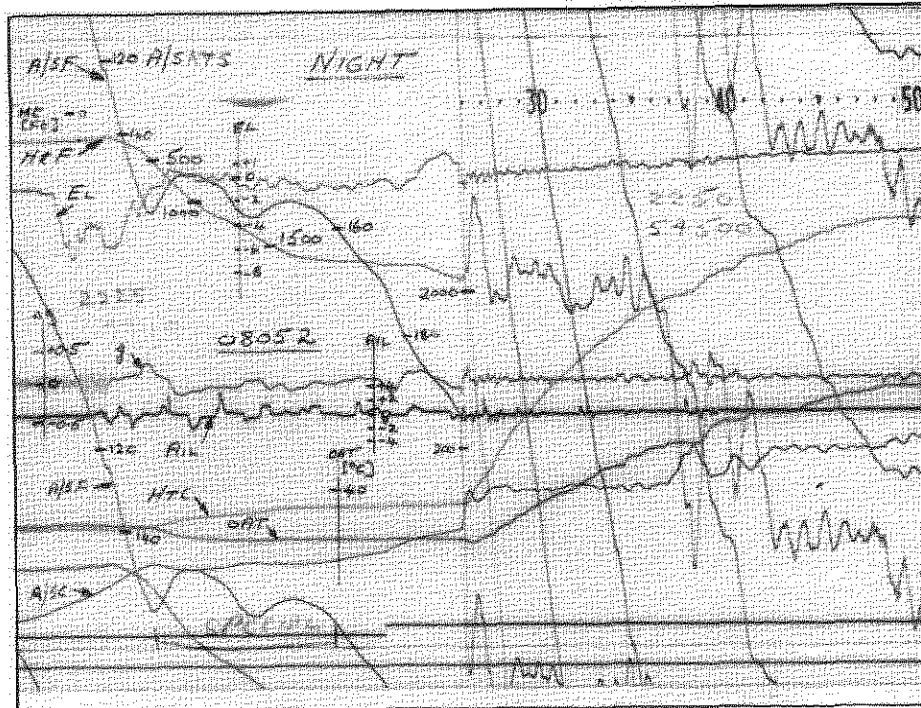
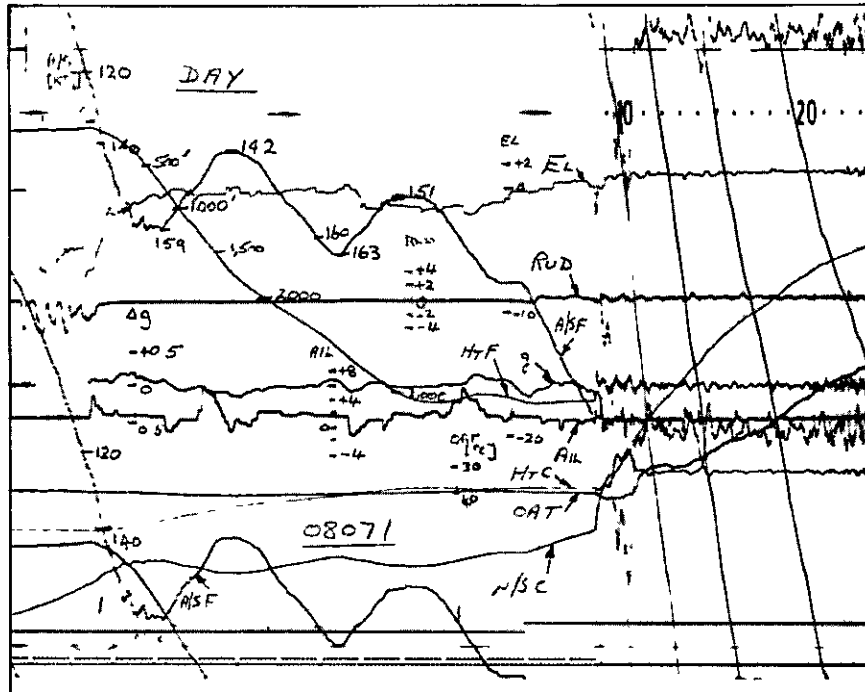
During each take-off, the indicated airspeed was allowed to fall back after attaining climb-out speed and thereafter fluctuated with about 10 knots amplitude and period of about $\frac{1}{2}$ minute until 2000 ft altitude was reached. A similar fluctuation occurred near the top of the climb with a period of 2 minutes. The first event is at night and it is probable that both events occurred during instrument flight conditions. (See Figs.A.6a, b, c.)

Maximum and minimum speed limitations were not contravened during these oscillations. This type of oscillation in airspeed and height is known to occur when insufficient attention is given to the artificial horizon and reliance is placed on the altitude, airspeed and vertical speed indications.

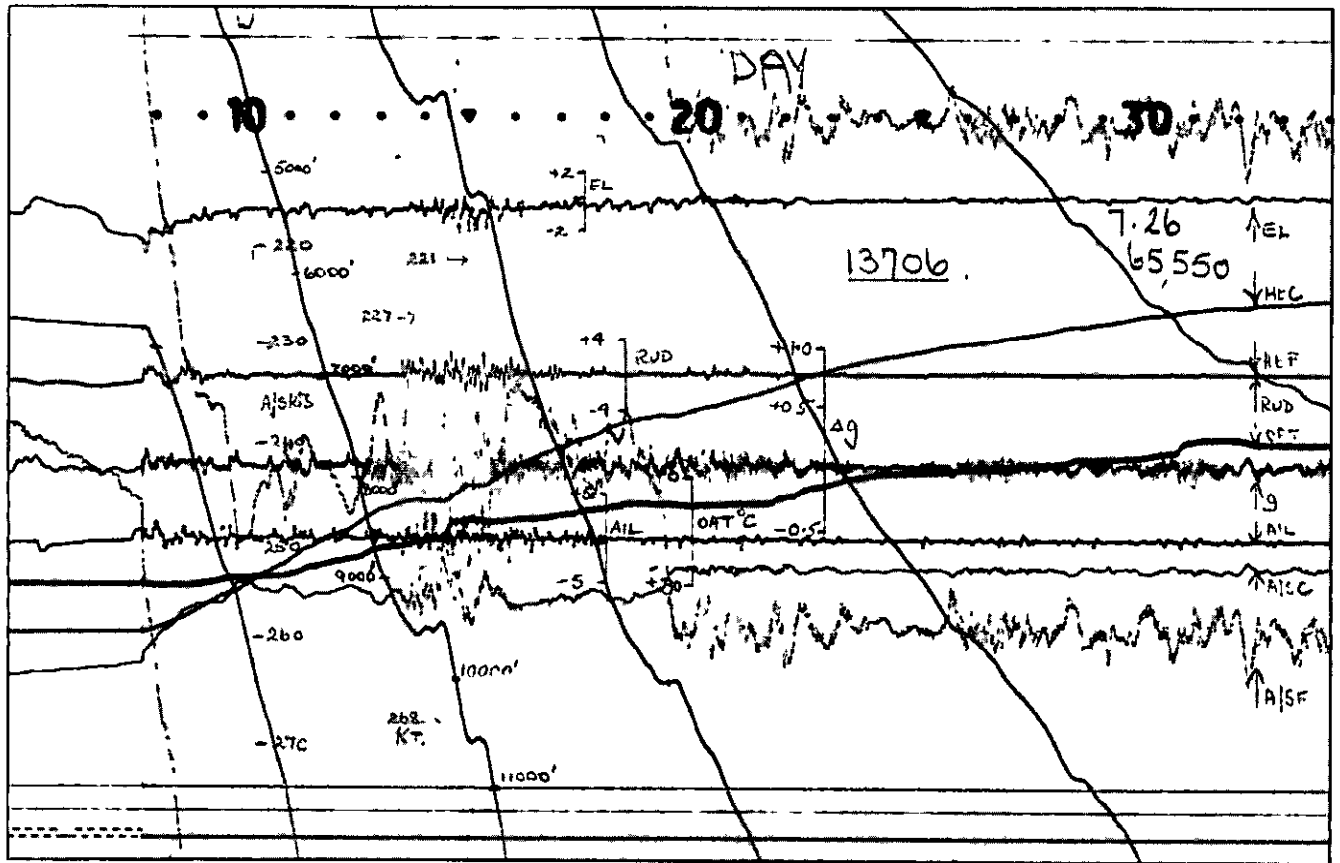
Fig.A7 Event in flight 13706

Severe turbulence was encountered between 9000 ft and 12000 ft during the climb out of Calcutta.

Considerable control surface movement was evident and airspeed excursions of up to 25 knots were recorded. (See Fig.A.7.)

This example has been included to illustrate a storm penetration during climb. Control applications in the few minutes preceding the Event are compatible with slight changes in course possibly associated with the use of storm-warning radar.

The considerable control movements during the period in which the turbulence was encountered indicate that the pilot was having some difficulty and that he may have contributed significantly to the changes recorded in airspeed and height.

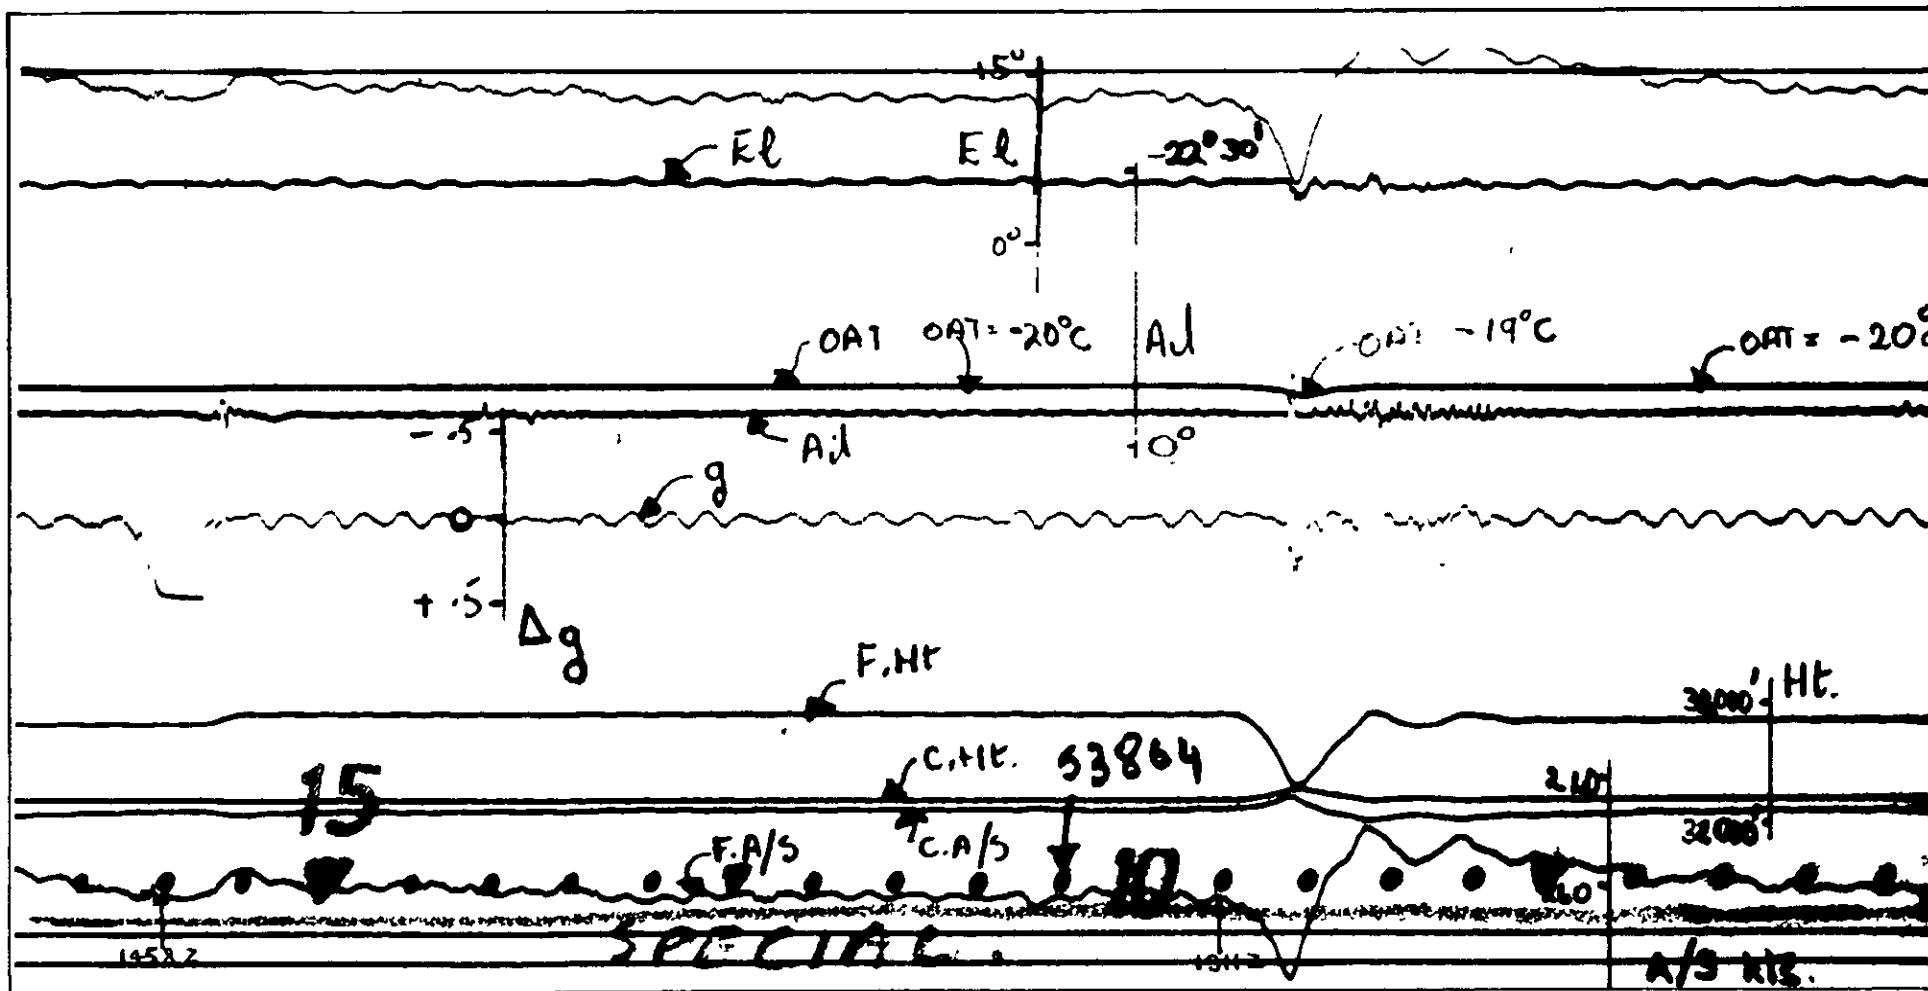
Fig.A8(a) Event in flight 00349

The pilot recalled that after the Mach Warning Horn had sounded in cruise the aircraft was found to have entered a dive as the result of the autopilot disengaging without the knowledge of the crew. The autopilot disengagement was found to be due to a malfunction of No.2 inverter. No.1 inverter, which had been unreliable on previous sectors, had malfunctioned earlier in the flight, and some of its load (including the autopilot) had been transferred to No.2 inverter. The flight recorder was left on No.1 inverter.

The unusual behaviour of the accelerometer trace at 1458Z was probably due to the malfunction of No.1 inverter. The accelerometer is an ac instrument (the only ac instrument in the recorder): in the event of failure of its power supply the indicator mirror is slowly deflected to a standby position by means of a weak spring in the indicator. The accelerometer was functioning normally after 1459Z.

Examination of the elevator and aileron traces suggests that the autopilot disengaged at approximately 1511Z, leaving the aircraft slightly out of trim laterally and nose down. The aircraft slowly went into a dive and the crew were finally alerted by the Mach Warning Horn. Recovery was made by application of aileron followed by elevator suggesting that the aircraft had entered a spiral dive. Approximately one minute elapsed between autopilot disengagement and the initiation of recovery action. During the incident the airspeed increased by some 20 knots, the aircraft lost about 1500 ft in height and a maximum normal acceleration increment of 0.3 g was experienced. The operational limit for this aircraft is 1.5 g increment.

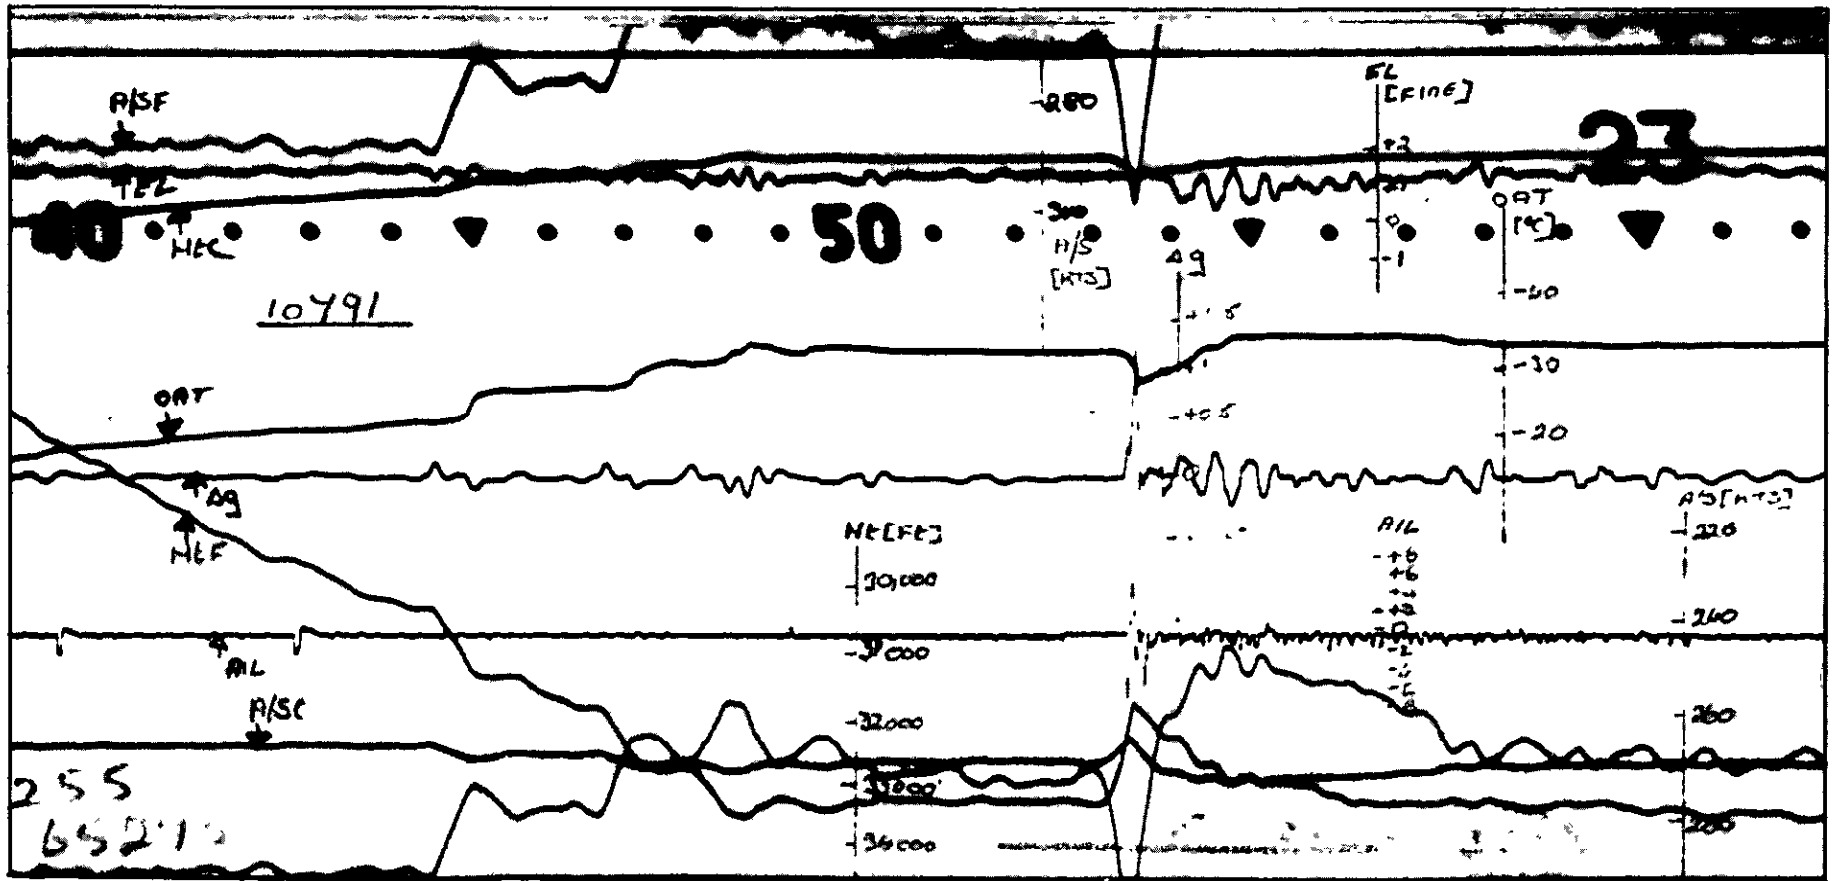
Fig.A8(b) Event in flight 10791

In this instance the aircraft was left markedly out of trim laterally and slightly nose-up as evidence by the initial small loss in airspeed at time 2253Z. The aircraft then smoothly entered a spiral dive with height and airspeed changing more rapidly than in the first Event. Again the crew were alerted by the Mach Warning Horn and recovery was initiated by the use of ailerons and airbrakes. The automatic Mach trim device also appears to have operated since no elevator movement is apparent. Approximately one minute elapsed between the apparent time of disengagement and the initiation of recovery action. During this incident the airspeed increased by some 30 knots, the aircraft lost about 1500 ft in height and a maximum normal acceleration increment of 1.2 g was experienced. The operational limit for this aircraft is 1.5 g increment.

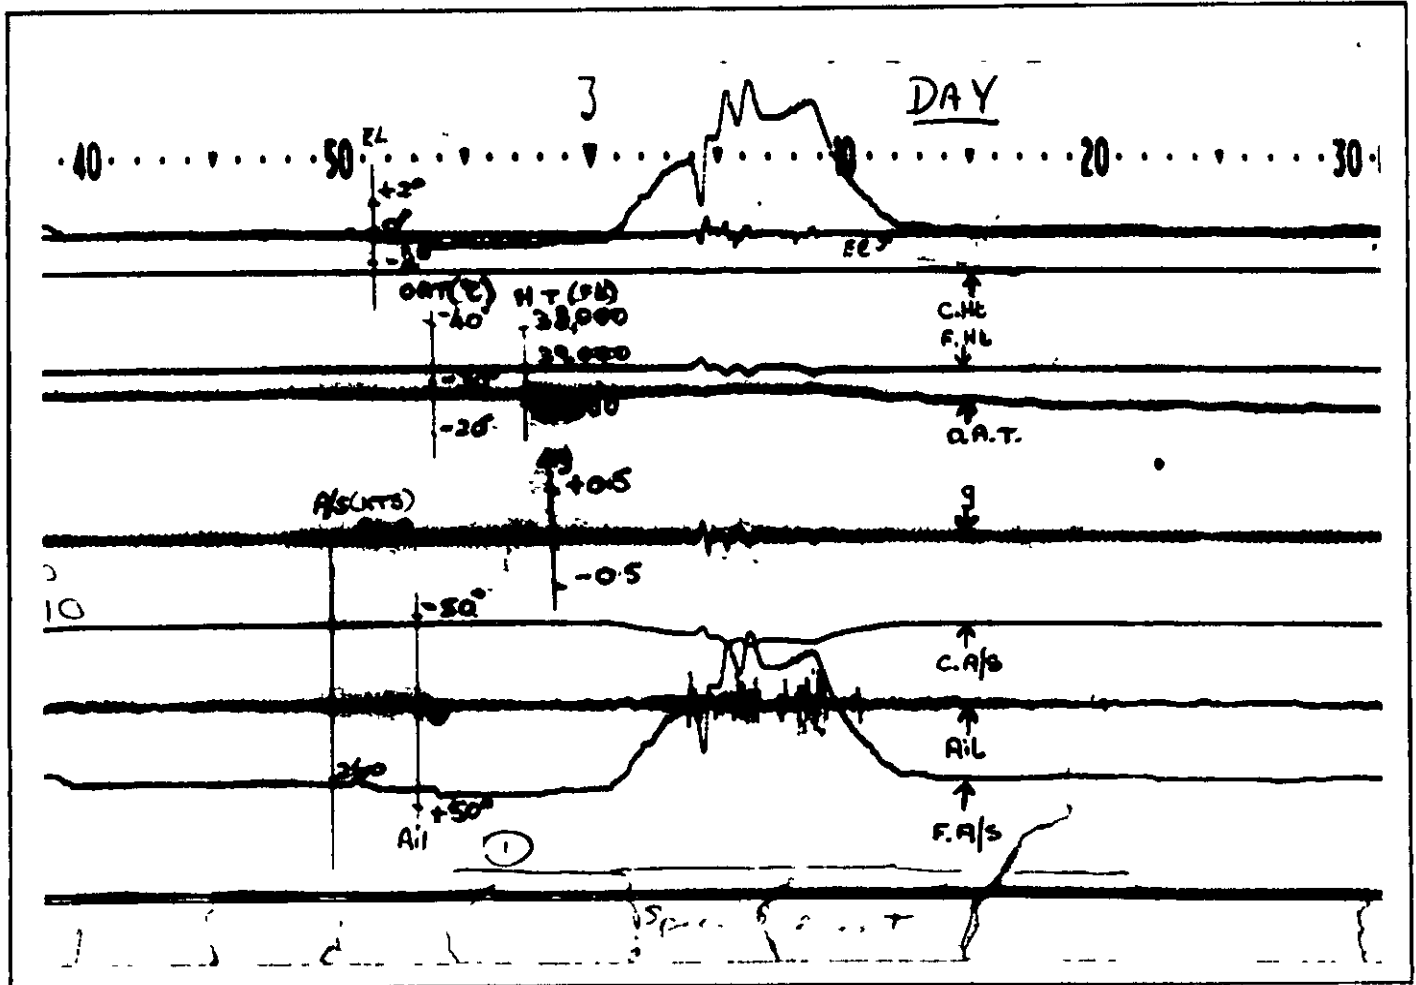
Fig.A9 Event in flight 02857

"This aircraft whilst flying at 39000 ft, Mach 0.80 started to dutch roll persistently. The only way it would be made to fly steadily was by increasing speed to 0.82 Mach. Conditions covering the period mentioned were as follows:-

The record indicates airspeeds of 260 kt, 247 kt and 260 kt, before, during and after the event, corresponding to Mach numbers of 0.83, 0.80, 0.83 respectively which suggests that the pilot was unaware that he had previously been cruising at the speed at which he finally stabilized. Normal long range cruise is at Mach numbers of 0.79-0.81 and the maximum permissible Mach number in turbulence is 0.80.

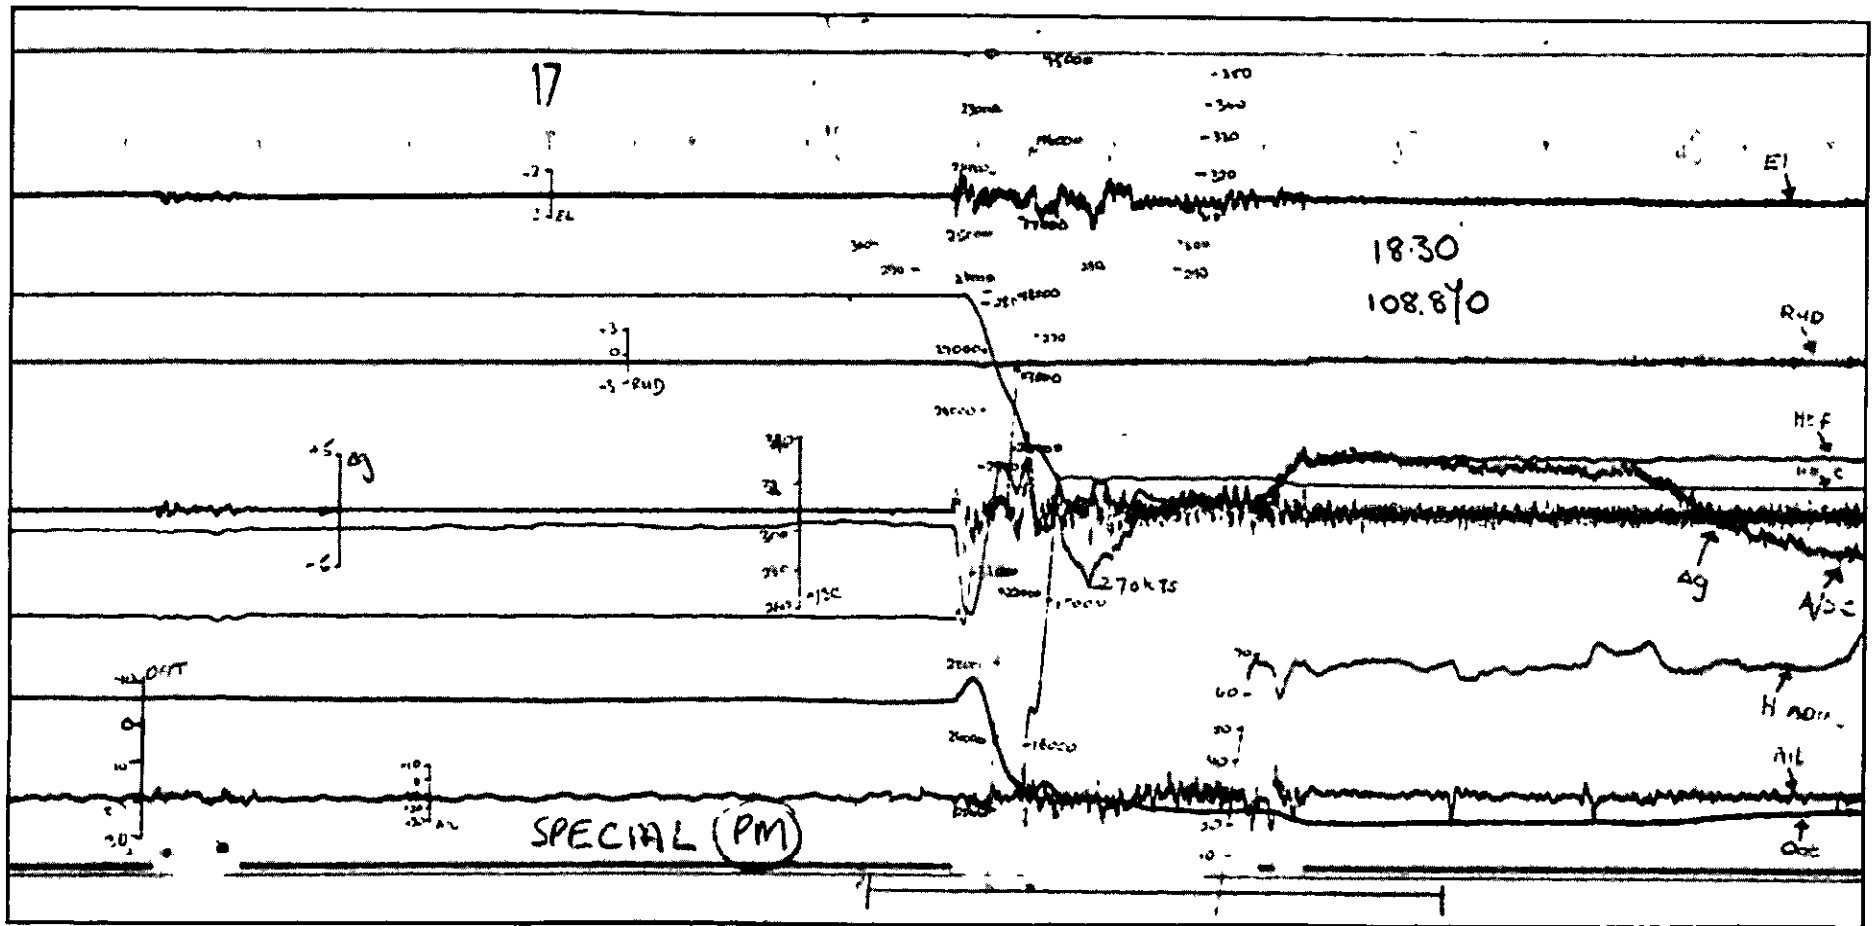
Fig.A10 Event in flight 15000

During cruise at 32000 ft a pressurisation system failure was experienced and an emergency descent was made to 14000 ft. (See Fig.A.10.)

Emergency descent to 14000 ft when L.P. duct rose and cabin started to pressurise, but any attempt to turn-off a bleed resulted in an uncontrolled climb of the cabin which indicated a high leak rate from the L.P. duct. Both before and after the incident both controllers (auto and manual) functioned normally."

The recommended descent procedure was followed very closely. Airspeed was reduced and a turn initiated before commencing the descent from 32000 to 14000 ft. This was accomplished in $3\frac{1}{2}$ minutes without significant exceedance of either the Mach number or airspeed limitations of $M = 0.83$ and 320 knots respectively.

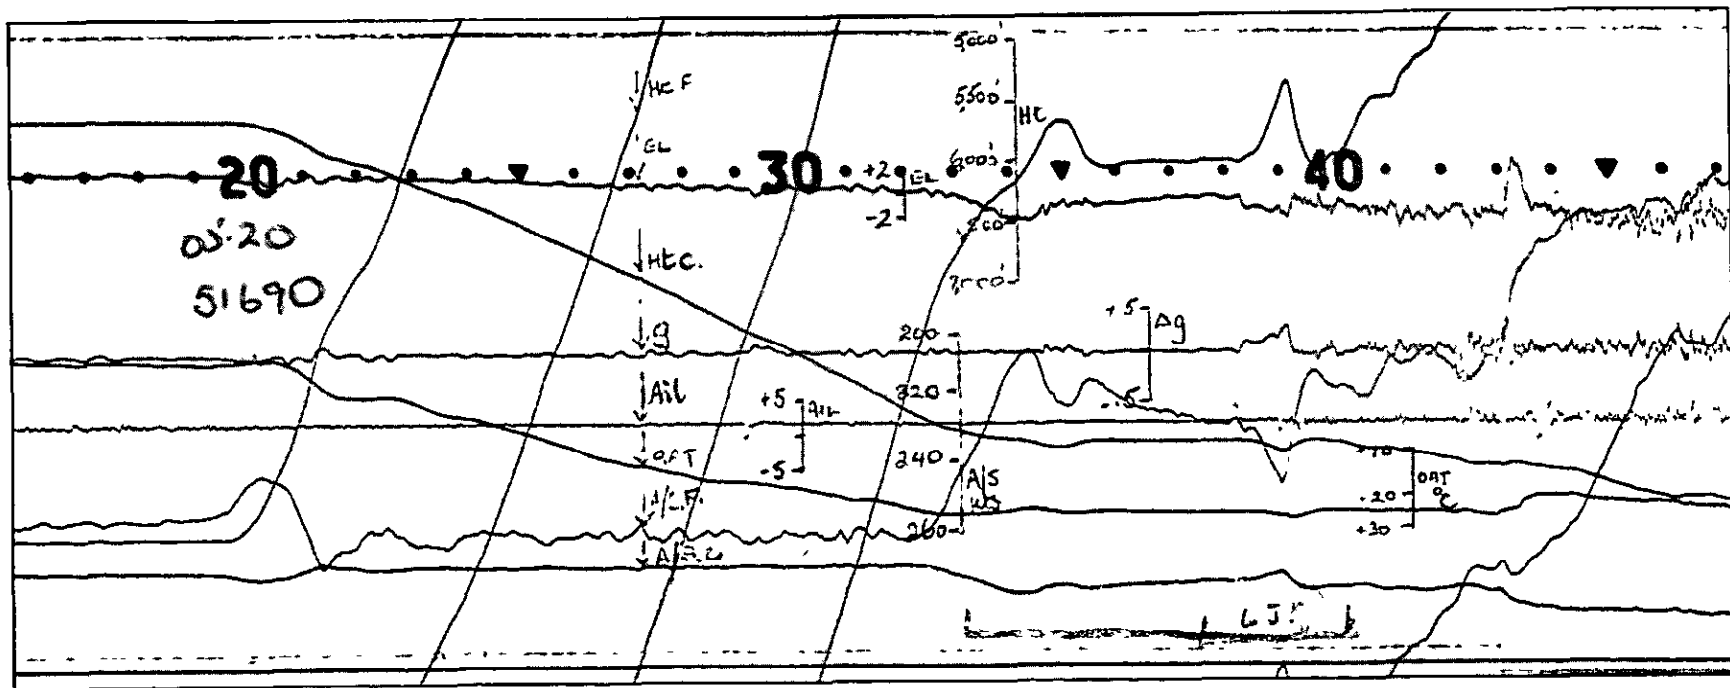
Fig.A11 Event in flight 15273

The aircraft entered both turns at an altitude of 6000 ft, but failed to maintain height and lost 350 ft in the first and 700 ft in the second turn; during this period the airspeed varied between 210 and 250 kt. Although such imprecise airspeed control is not exceptional, altitude holds are normally maintained to within 100 ft or so.

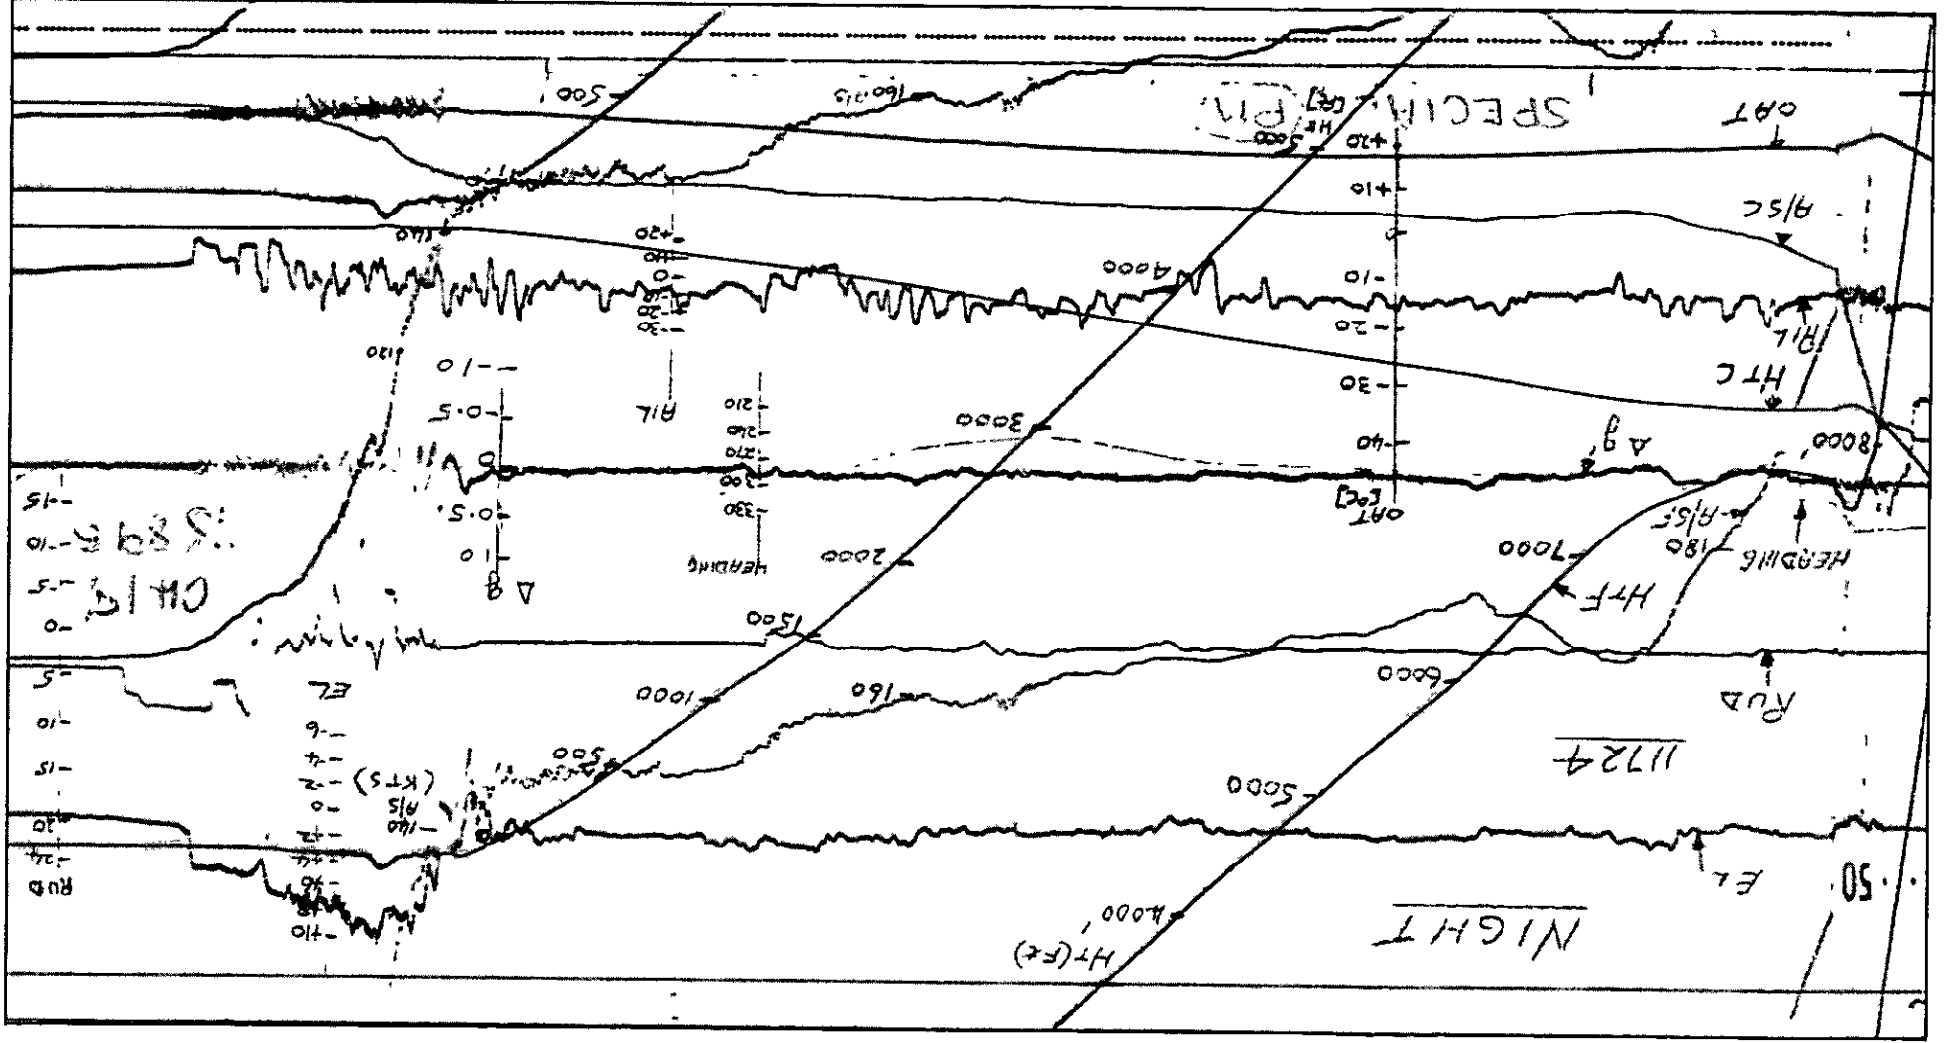
Fig. A12 Event in flight 11724

This is included as an example of high rate of descent during approach. More normal final approach descent velocities for this aircraft type are near 750 ft per minute. The threshold speed was high but within the recommended band of 139 to 147 kt.

On the glide path from 6000 ft to 1000 ft the estimated average ground speed was 170 kt and rate of descent 2700 ft/min; this gives a glide path angle of 9° compared with the normal 3° . From 1000 ft to the ground (150 kt, 2000 ft/min) the angle reduced to $7\frac{1}{2}^\circ$. Information was not available to enable wind speed to be taken into account but this would almost certainly have increased the estimated approach angle by a small amount.

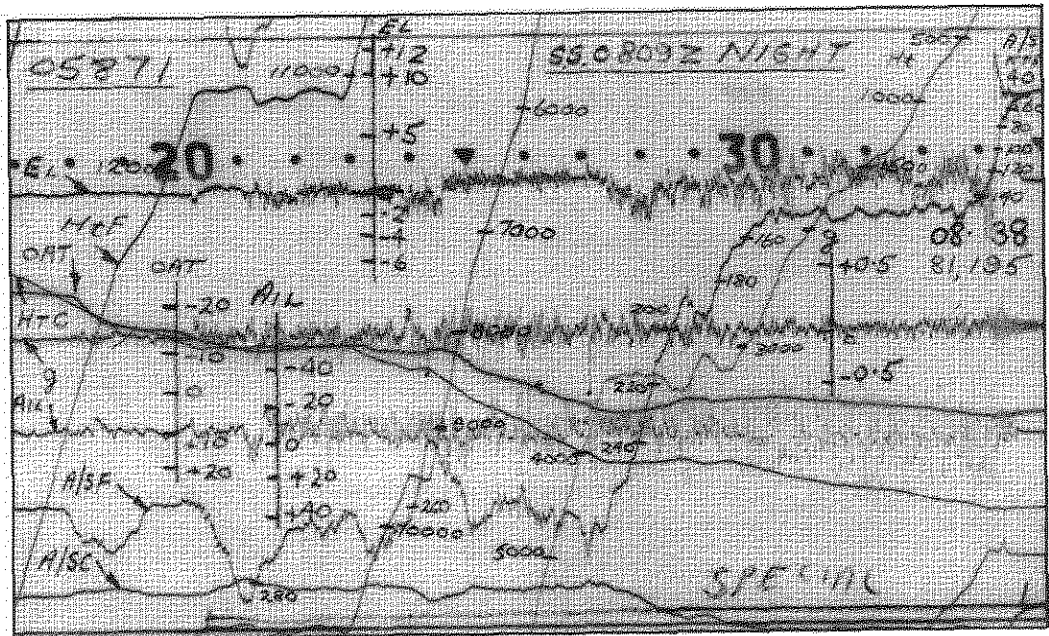
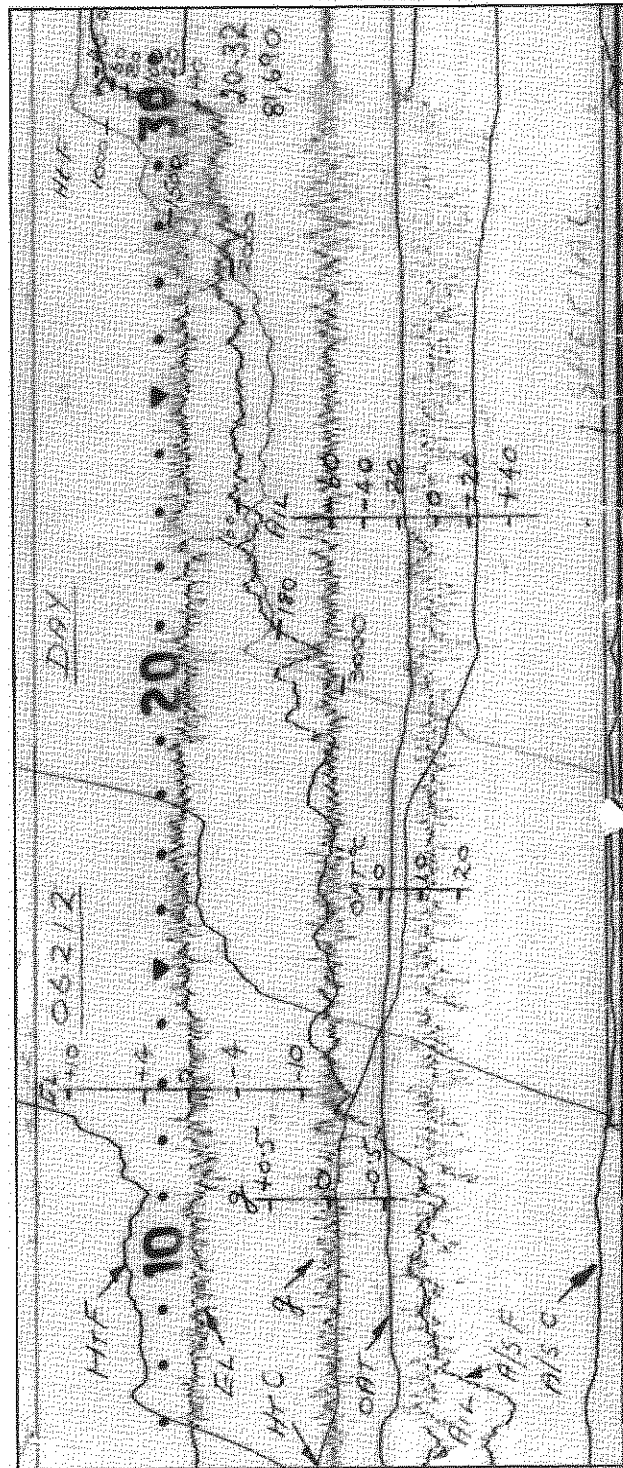
The approaches were made in turbulent conditions, but the recorded normal acceleration increments appear to be almost entirely due to manoeuvres; the pilot inputs to the aileron and, to a lesser extent, to the elevator, indicate over-control. A common feature of both landings appears to be the irregular descent rate, which suggests that unaided visual approach procedures were employed.
