MINISTRY OF TECHNOLOGY

AERONAUTICAL RESEARCH COUNCIL

Civil Aircraft Airworthiness
Data-Recording Programme.
Special Events Relating
to Handling and Control
(January 1963 to February 1966)

CAADRP Special Events Working Party

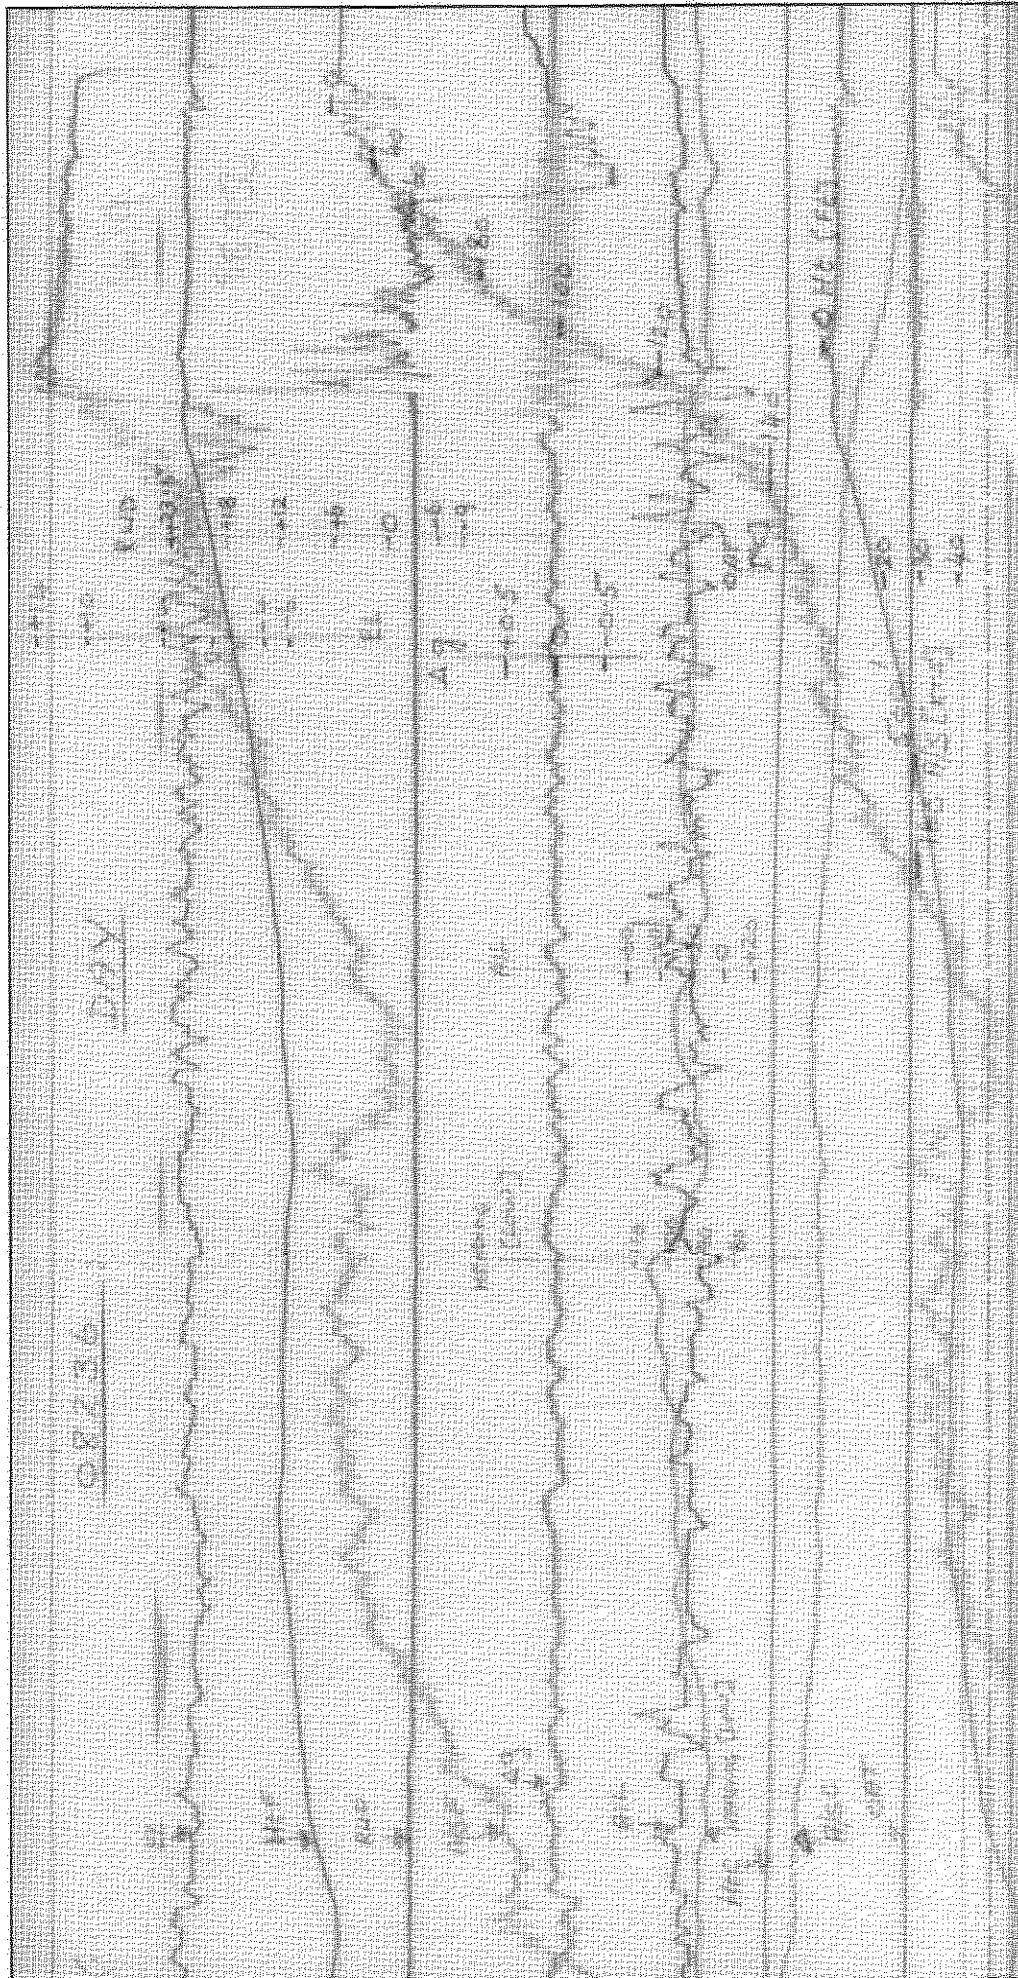
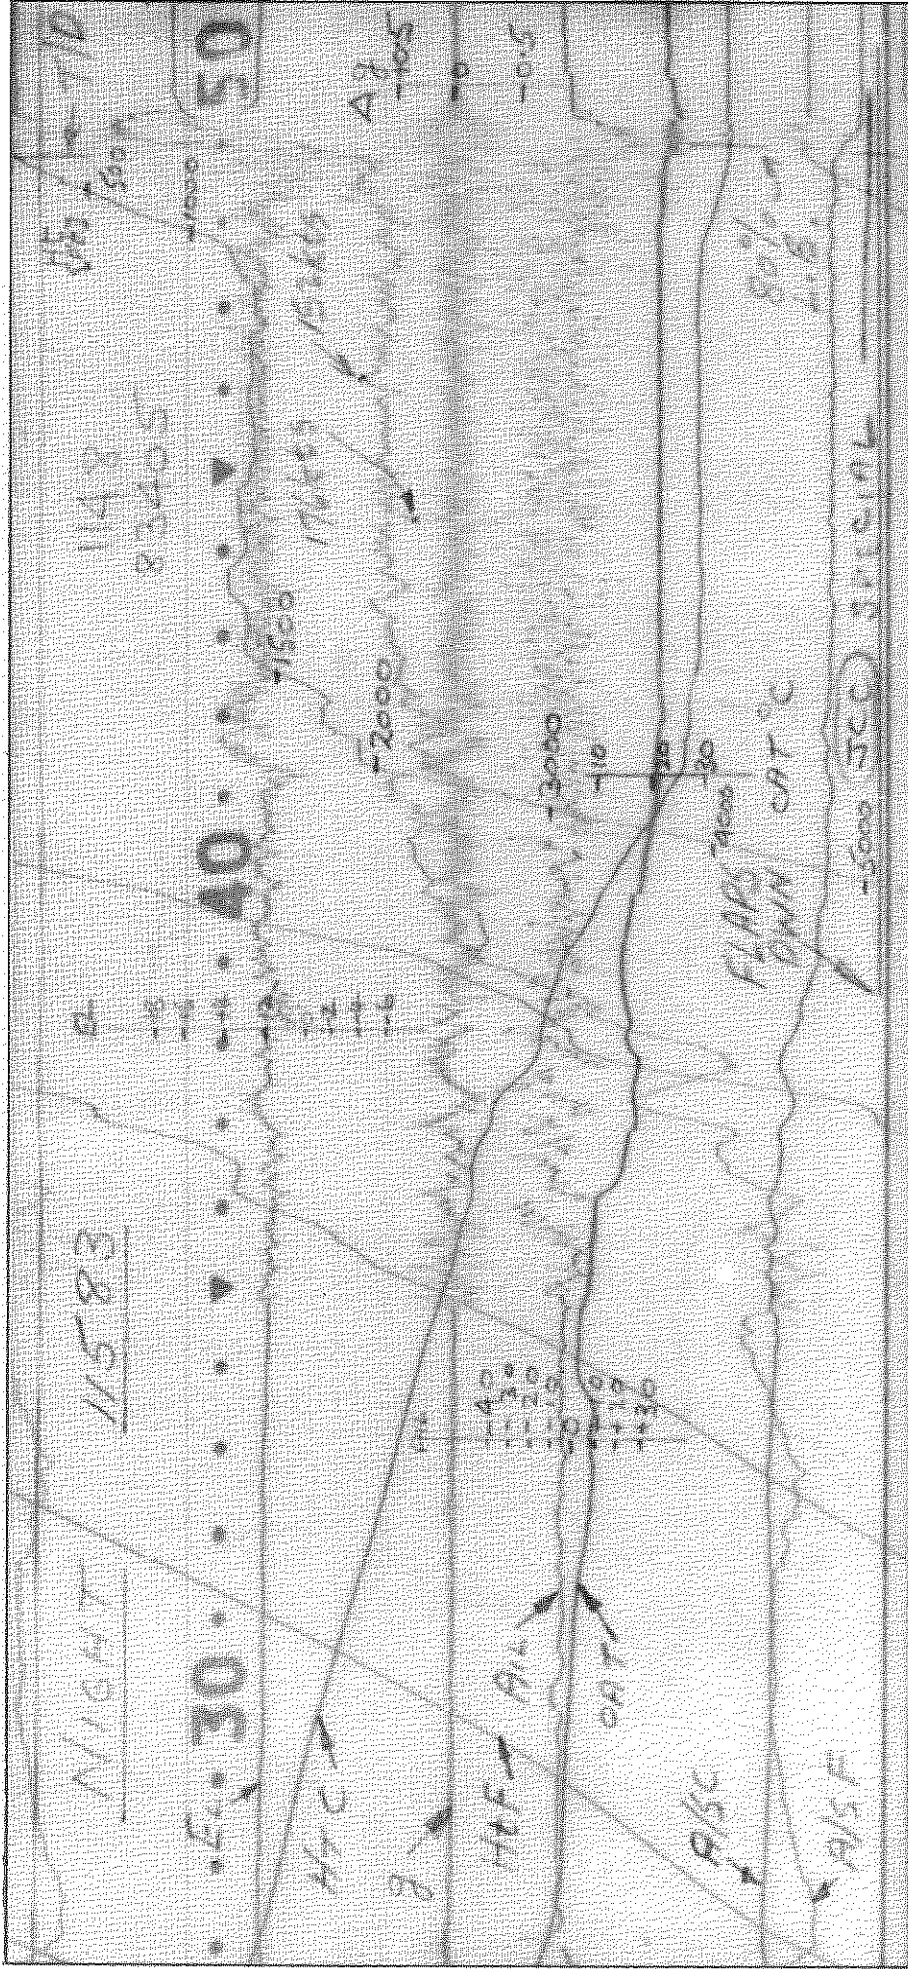
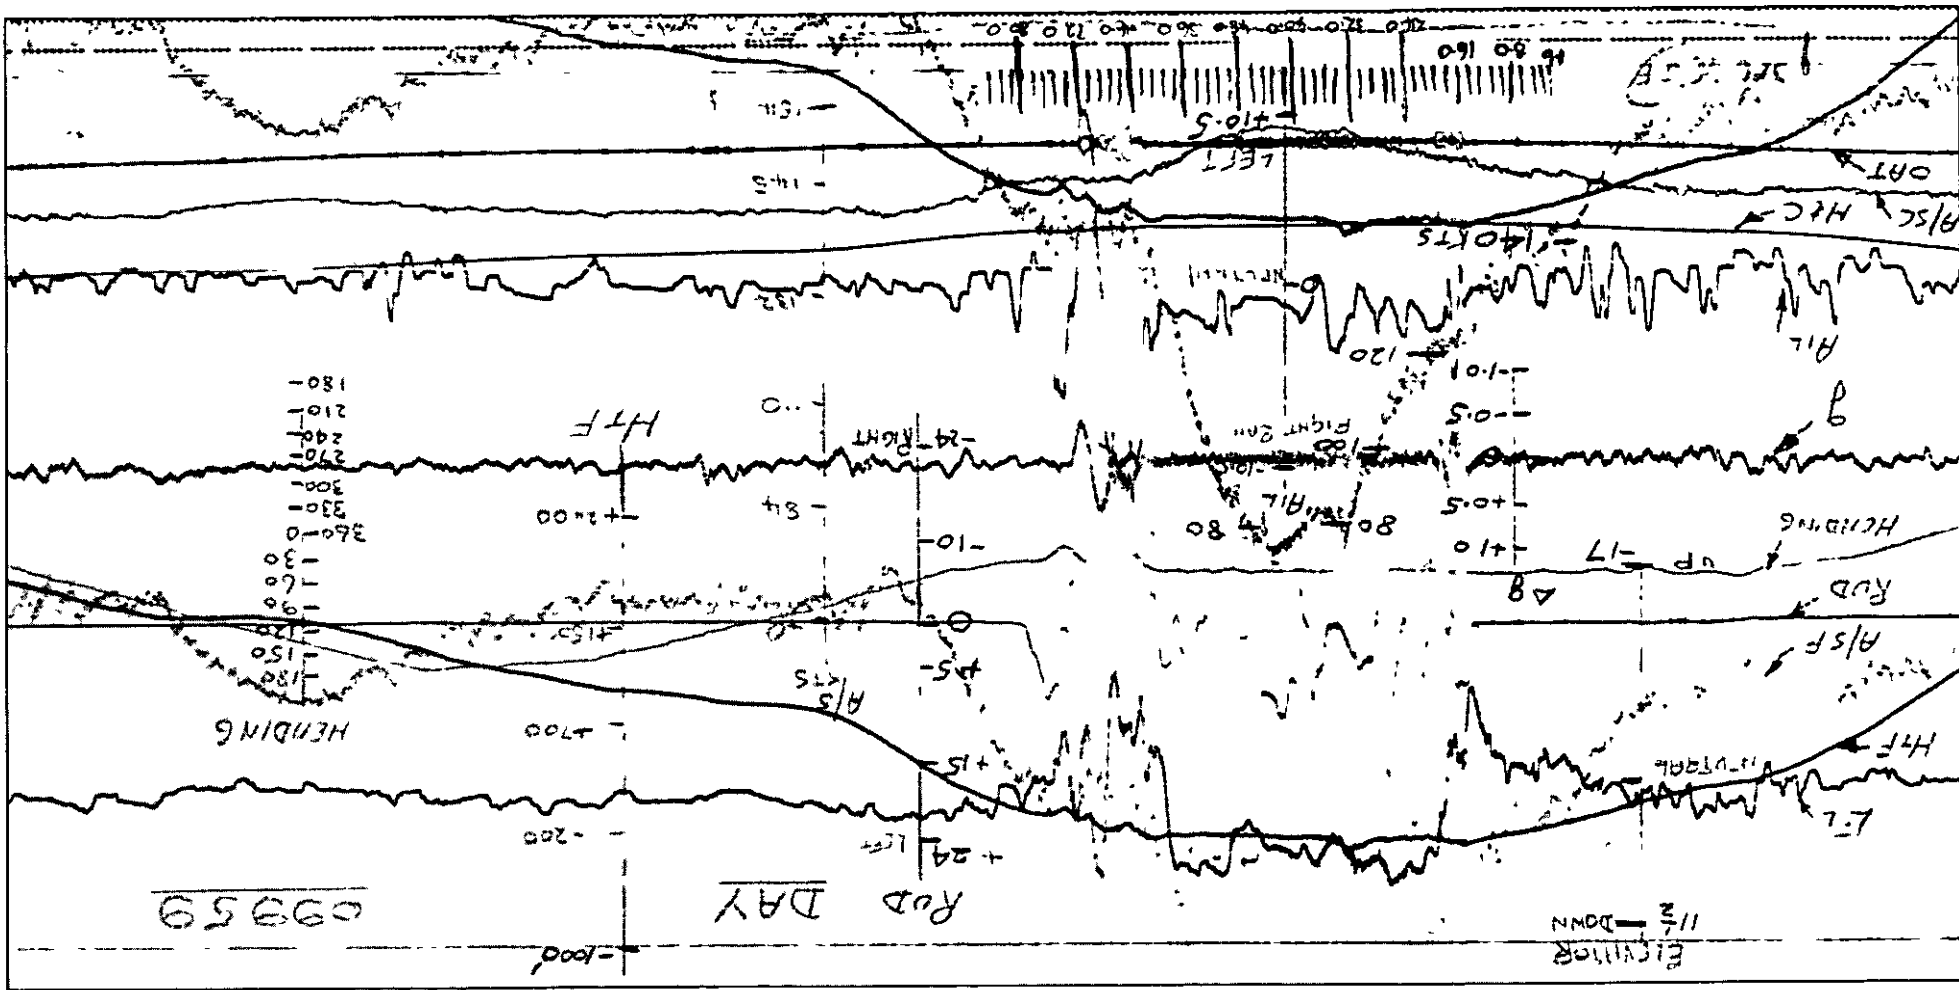
On aircraft of the same type, two operational landings were made in which an engine pod or engine pods touched the ground. Approach and threshold techniques were recorded as normal in each case. In the landing at Hong Kong some turbulence was present but there was none in the Barbados landing. The third record is from a training flight where two pods touched the ground during a touch-and-go with a simulated engine failure. (See Figs.A.14a, b, c.)

During the Barbados and Stansted incidents, steady crosswinds of 14 kt and 18 kt respectively were reported at 55° and 60° from starboard. The Hong Kong incident also occurred in crosswind conditions and on this occasion the wind was at 50° from port at 12 kt with some evidence of gusting to 32 kt. Visibility was not critical and cloud base was 1200-1400 ft at Barbados and Hong Kong. Full lateral control movements were not employed during these landings, but were used during the Stansted take-off. Inputs to the aileron control were the same for both the Barbados and Hong Kong incidents with increasing amplitude towards touchdown.

NOTE: On the records of the Hong Kong landing, the CAADRP accelerometer was slightly underdamped, which resulted in excessive noise on the normal acceleration trace after touchdown.

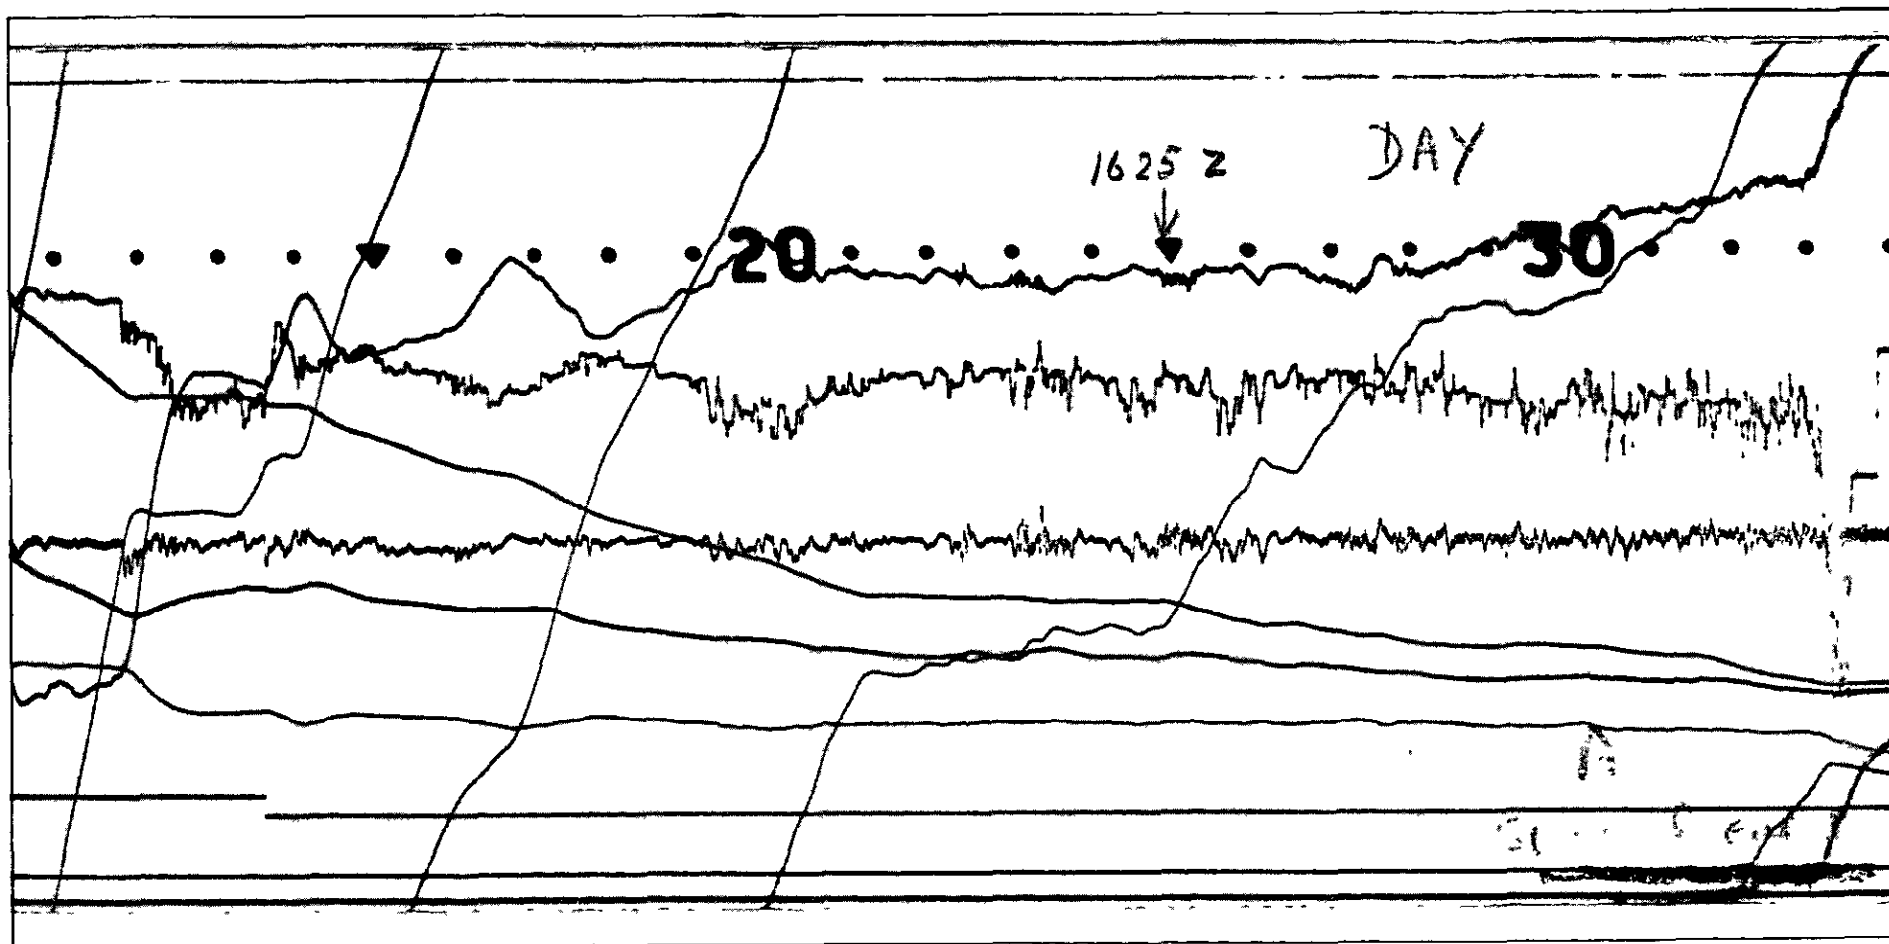
Fig.A15 Event in flight 1065

The steady and prolonged application of elevator suggests that the nosewheel was held off the runway to assist deceleration, possibly on a wet surface, at near maximum landing weight.

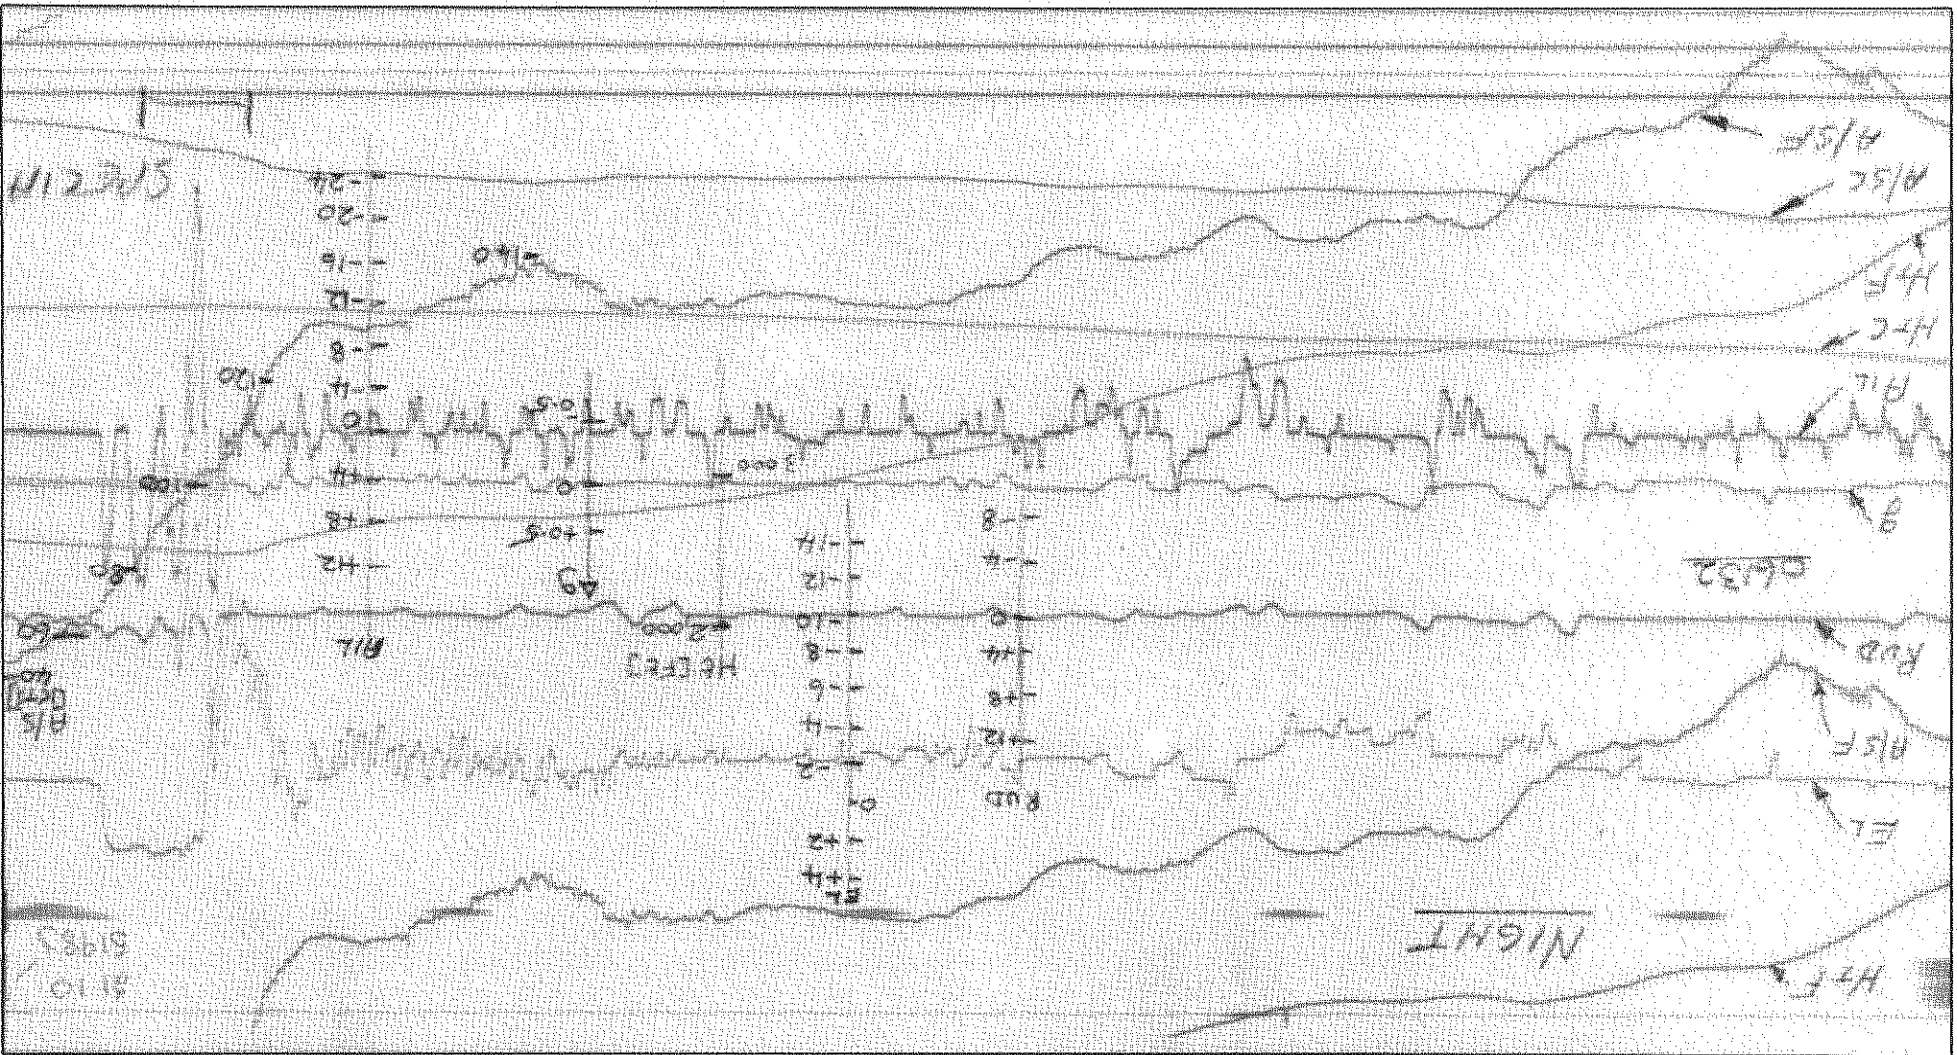
Fig. A16 Event in flight 06132

The control movements are consistent with a controlled port sideslip onto the runway centre line followed by a vigorous 'kick-off-drift' manoeuvre during which port rudder and full starboard aileron were applied.
