Civil Aircraft Airworthiness Data
Recording Programme

Uneven Runways Encountered
by Subsonic Jet Transport Aircraft
during Scheduled Airline Operations

G. B. Hutton

CAADRP Technical Report 25

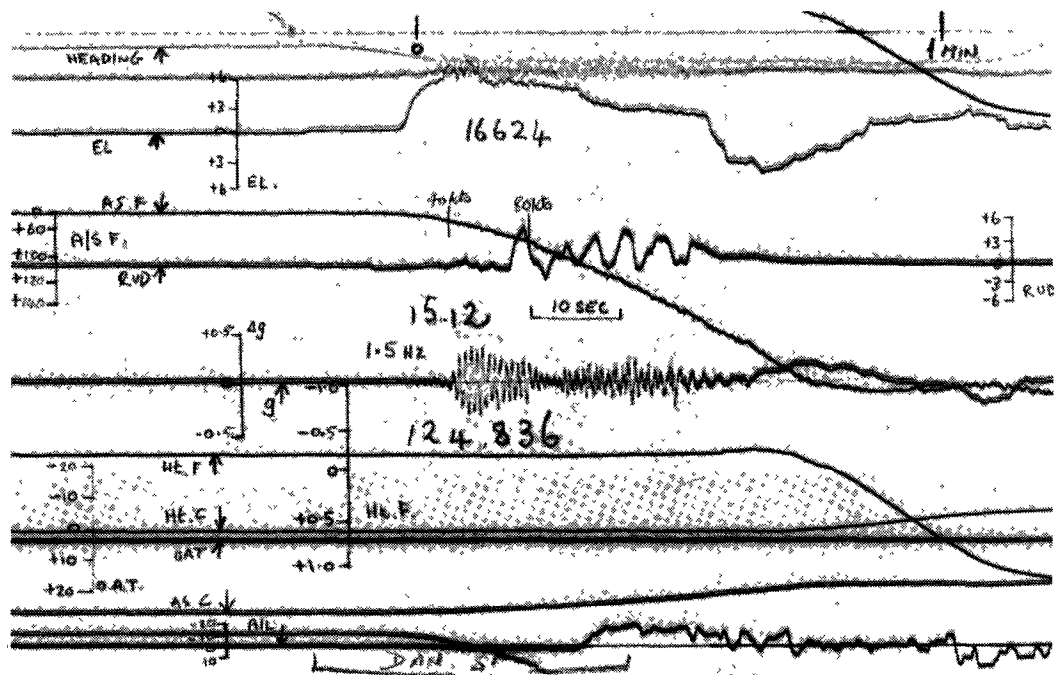
Fig.1 Take-off of aircraft Type C on Runway 22R at airport No.53

Reproduced* in Fig.1 is a portion of a flight recording taken during take-off of an aircraft Type C on runway 22R at airport number 53. This was one of three events from the same aircraft, taking off from the same runway, possessing CG acceleration oscillations virtually identical in character and maximum amplitudes ranging from $\pm 0.34 \Delta g$ (increment from 1 g datum) to $\pm 0.5 \Delta g$. The most severe is not illustrated as the recording paper speed was slower and the record clarity degraded. The three take-offs were the only ones to be performed from this runway when the Type C CAADRP aircraft was recording data and are to be found reproduced in Ref.3. In each case the patch of abnormal oscillations lasted for about 10 seconds, commencing at a low aircraft speed of about 40 kn (ias) and ceasing at about 80 kn, reaching a maximum amplitude at about 60 kn. The oscillations contained very little structural vibration, the motion being almost entirely in the heave mode at a frequency of 1.5 Hz. The wing bending natural frequency, with full fuel tanks, is not far removed from the heave frequency on this aircraft type and may cause additional stresses in

the structure. The amplitude of the oscillation built up to a peak over several cycles suggesting that a succession of runway bumps excited the heave mode of the aircraft. Hall⁴ has shown that this mode is lightly damped on a typical undercarriage when the damping coefficient of the oleo legs are chosen to optimise heavy landing performance. The frequency of 1.5 Hz at 60 kn (the speed at maximum amplitude) corresponds to a wavelength of 67 feet. Information received from the aircraft's operator stated that the runway dips and is rough where it intersects with runway 31R. The runway layout is shown in Fig.2.

The oscillation of aircraft Type C at airport number 53 (see section 2) may well have been excited by malalignment of concrete runway sections and selective tarmacdom surfacing might remove the irregularities almost entirely.

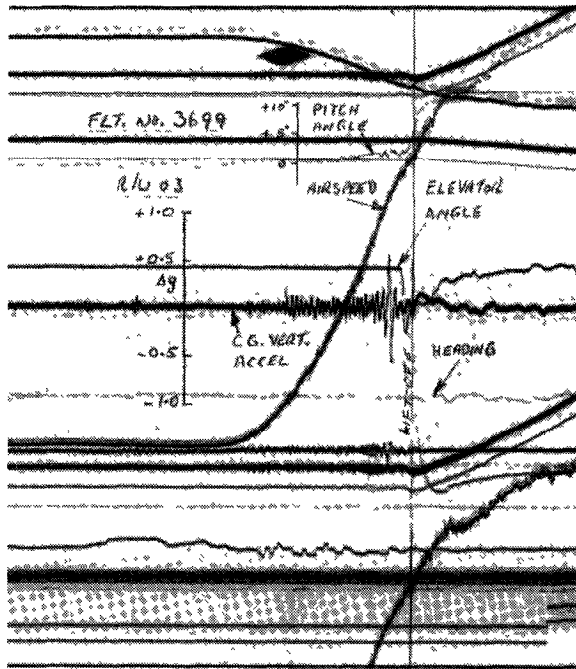
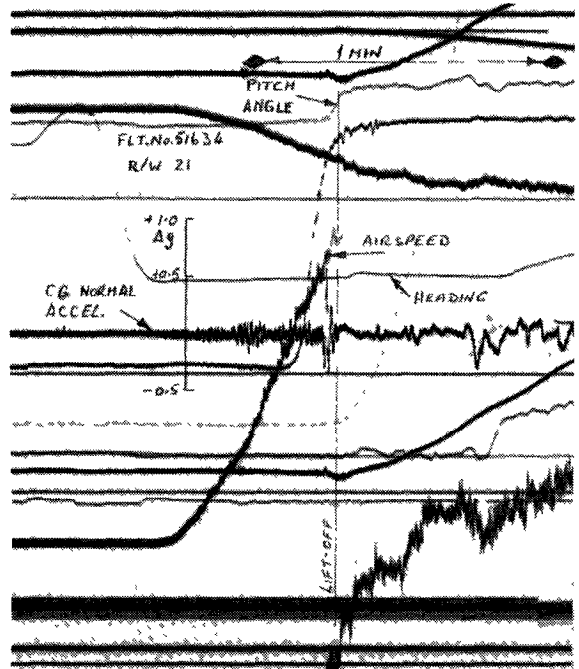
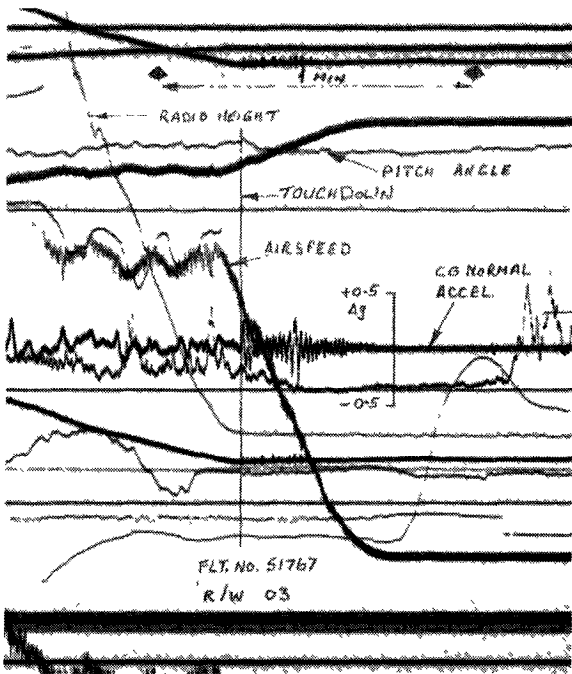
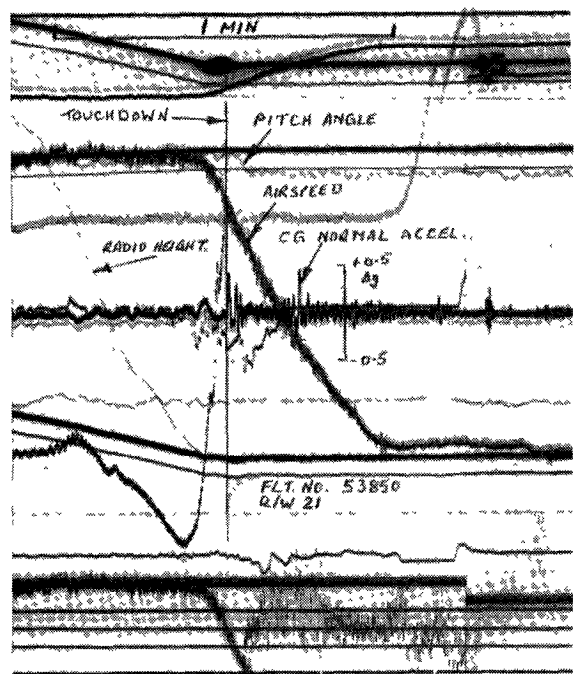
Fig.3 Flight recordings of take-offs and landings on Runway 03/21

Portions of flight recordings obtained during take-off and landing runs on runway 03/21, showing the abnormally high CG accelerations in each case, are reproduced in Fig.3. In each case the oscillation frequency was at about 1.1 Hz and the amplitude rose and decayed very rapidly, the patch lasting only about 2 seconds. The wing natural frequency of about 3 Hz on this aircraft type is far removed from the CG oscillation frequency recorded and this first structural response mode therefore does not enhance the importance of the event. All amplitude values quoted are the extreme values recorded, i.e. response at all frequencies contribute to the peak reading up to the limit of the accelerometer system at about 17 Hz but recorder trace resolution prevents identification of frequencies above 4 Hz. The response curve of the accelerometer system is shown in Fig.4.

The large amplitude accelerations were due to a dip in the runway surface in the vicinity of the intersection with taxiway number 3. The airport's runway layout is shown in Fig.5. The approximate position of the dip can be

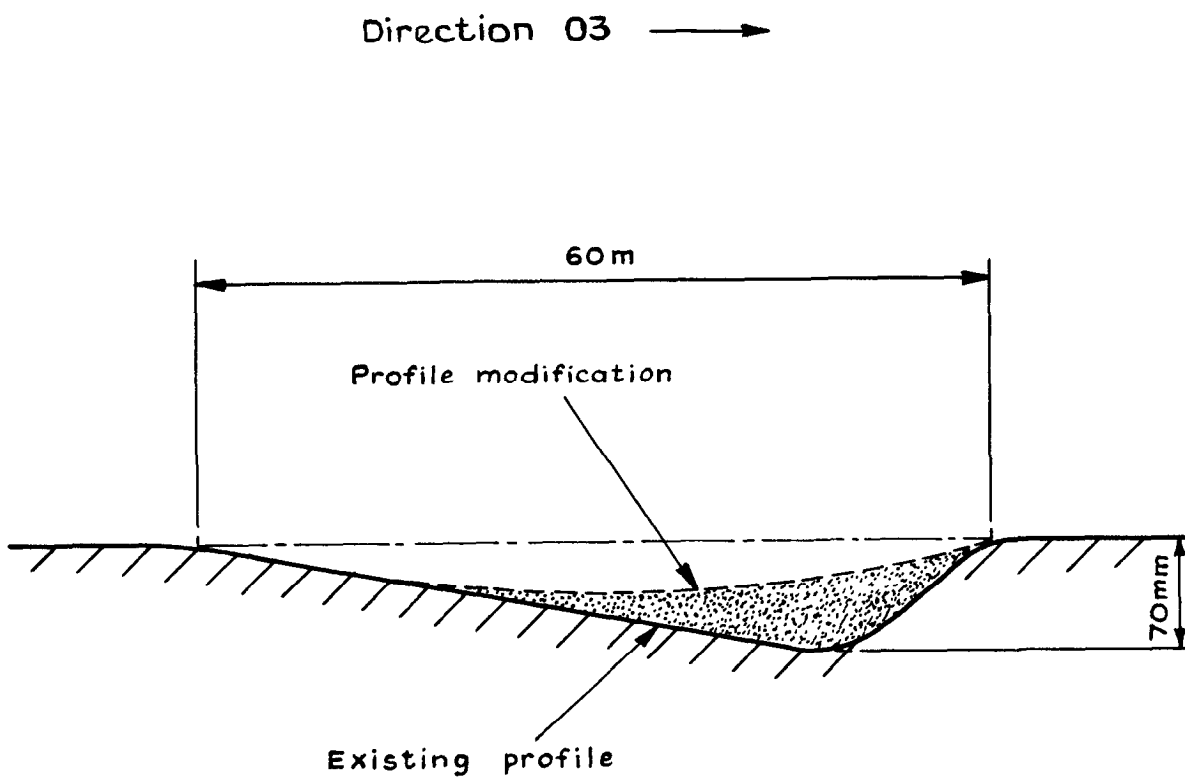
Fig.6 Possible profile of irregularity in runway 03/21 at airport 63 and suggested improvement

confirmed from a recording of a take-off run along direction 03 by integration of the airspeed from the start of roll to the time of the CG acceleration oscillations, assuming the aircraft starts at a point close to the threshold. Subjective witness reports suggest that the longitudinal profile of the dip is shaped as shown in Fig.6.

The irregularity in runway 03/21 at airport number 63 is thought to be of the form shown in Fig.6. Total elimination of such irregularities is not necessary to produce acceptable improvements, modification of the profile to alter suitably the wavelength, amplitude and/or shape being sufficient to achieve a considerable reduction in aircraft response. The profile in Fig.6 is shown modified in such a manner and, based on the roughly estimated dimensions shown, it is found that about 0.5×10^6 kg of material would be sufficient to effect this improvement.

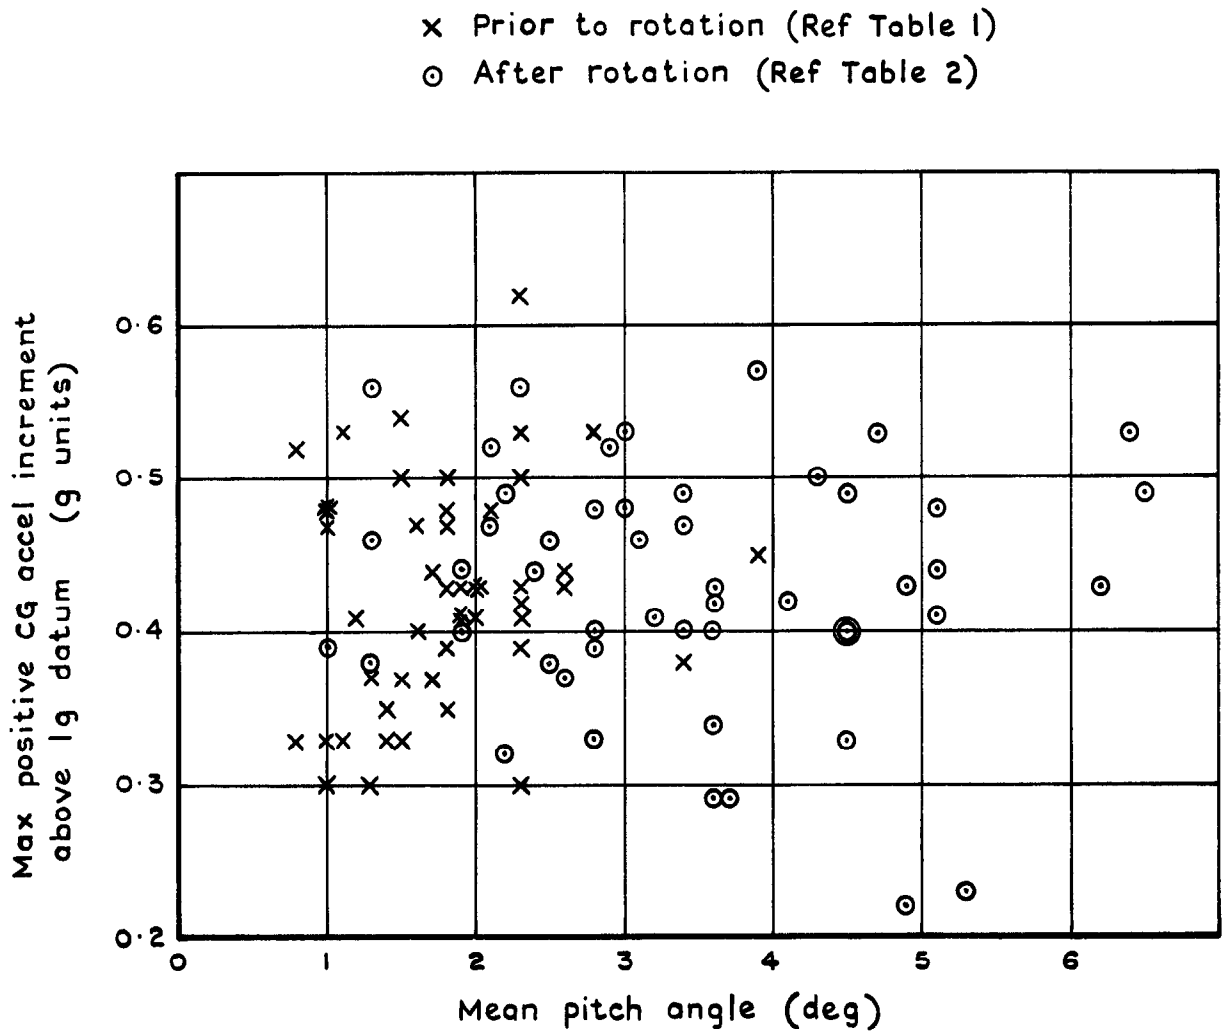
Fig.7 Aircraft type E at airport No 63
Relationship between mean pitch angle and maximum positive CG
acceleration increment on encountering the runway unevenness

Plotted in Fig.7 for each group of 50 take-offs is the maximum positive CG acceleration increment *versus* the pitch angle. No correlation is present, indicating that the severity at the CG was not a function of pitch angle.

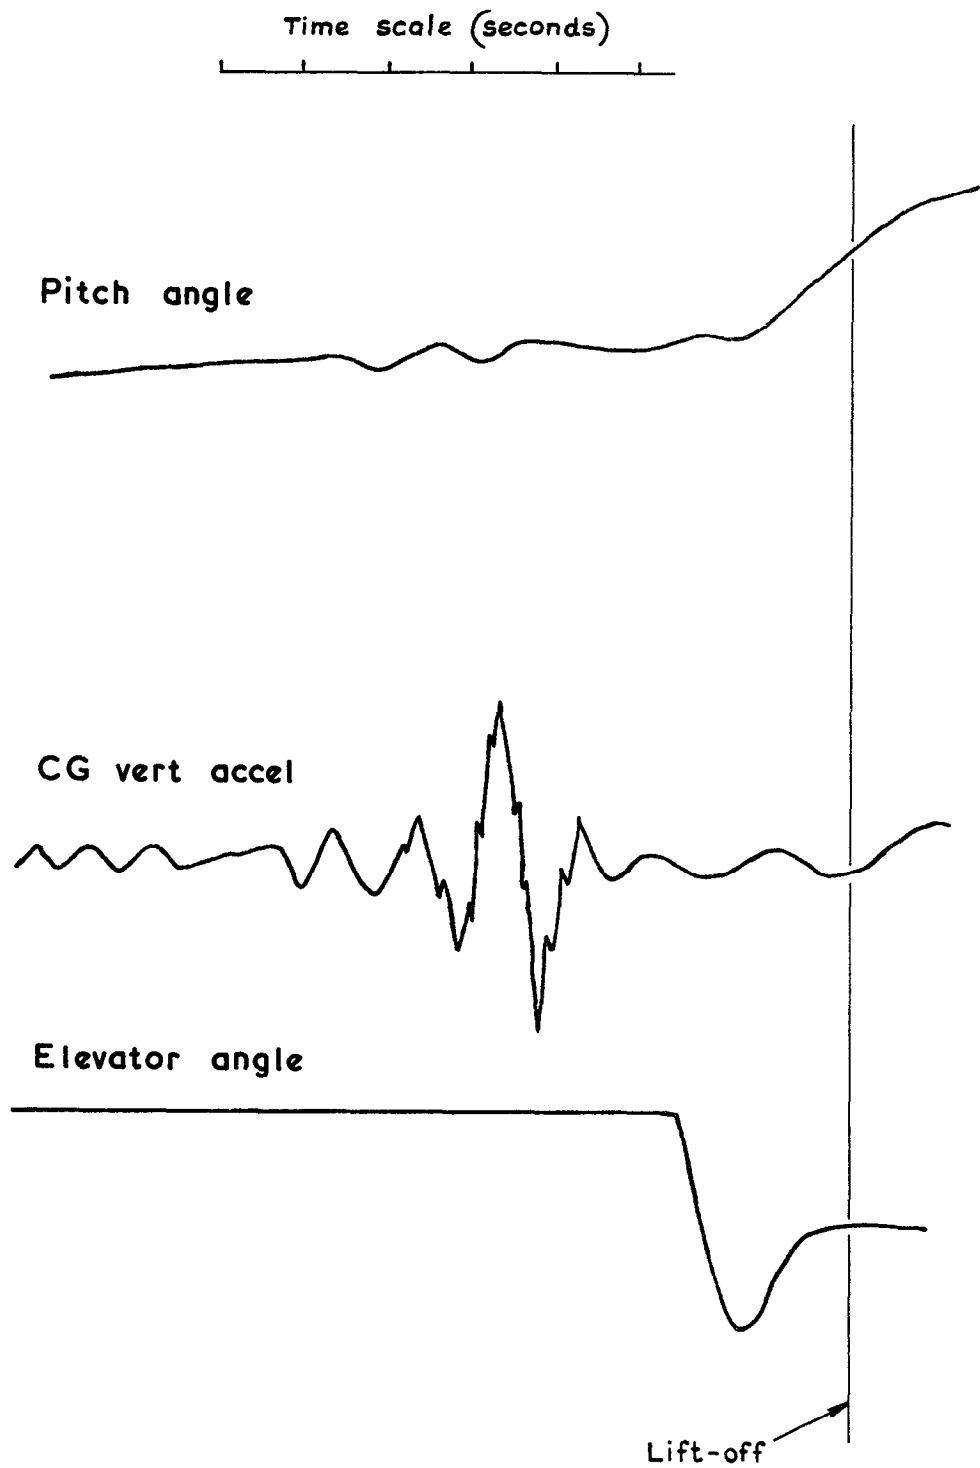
Fig.8 Take off run of aircraft type E from runway O3/21 at airport 63 on flight No 536 99 (see also Fig.3)

In some cases a small degree of pitching motion at about 1 Hz was apparent at the time of the high amplitude CG oscillation. This was shown to be a factor in increasing the motion at the cockpit, and hence the crew's discomfort. The 100 take-offs in Tables 1 and 2 were studied in respect of pitching amplitude and frequency and the phase difference in relation to the CG vertical motion. Where pitching variations of 0.5° or more were measured Tables 1 and 2 also show the peak-to-peak fluctuation and frequency. Twenty-one take-offs in the sample could not be assessed in this respect as the recording paper speed was too low to provide sufficient separation between adjacent oscillation peaks. In 54 of the remaining 79 take-offs there were no fluctuations in pitch greater than 0.5° , and oscillations with peak-to-peak fluctuations greater than 0.5° were measured on nine take-offs. As would be expected all of these nine were found in the first group of the sample, no pitch fluctuations greater than 0.5° being found when rotation had commenced. The phase differences between the pitch and CG heave motions were difficult to measure but appeared to be about 90° , i.e. the maximum peak acceleration at the cockpit due to the pitching motion usually occurred about $\frac{1}{4}$ second before the maximum peak CG acceleration. The largest pitch oscillation of 1.5° peak-to-peak was measured on flight number 53699 (see Table 1). The recording is reproduced on an expanded time scale in Fig.8. In this particular case the vertical acceleration at the cockpit was modified by the pitching oscillation as shown in the Appendix assuming simple harmonic motion and was estimated to be $0.85 \Delta g$ maximum for a maximum CG acceleration of $0.52 \Delta g$ (an increase of 0.33 g or 63%) assuming a phase difference of 90° .

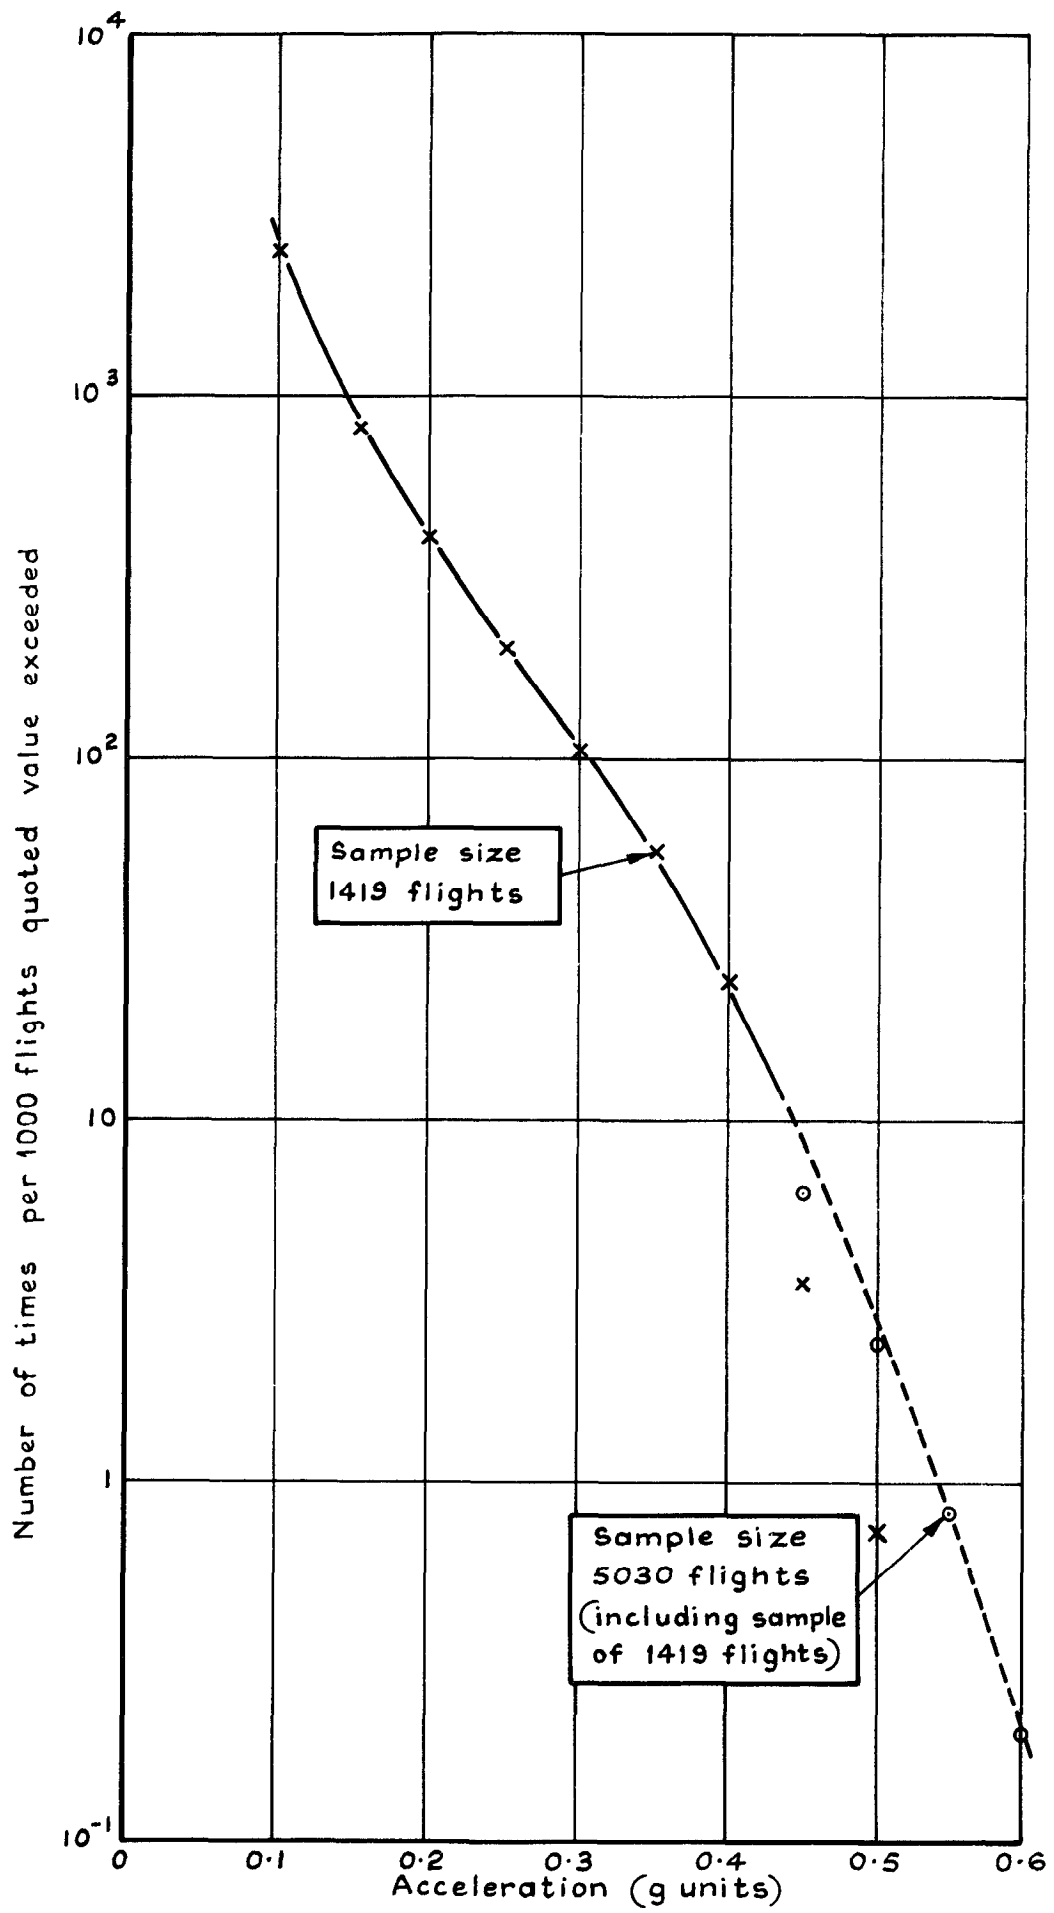
Fig.9 Positive peak CG acceleration during take-off Aircraft type E

In order to assess the effect of aircraft fatigue it was necessary to determine the distribution of peak acceleration exceedances during the overall flying time of the aircraft. Each take-off during one complete year on one aeroplane was studied. From the start of each take-off run until lift-off positive normal CG acceleration peaks exceeding various levels from a minimum threshold of $0.10 \Delta g$ were counted. Distinction between the nosewheel being on or off the ground was ignored owing to the difficulty of identifying the start of rotation in some cases. In the majority of take-offs the duration of rotation was up to 3 seconds (about one-tenth of the take-off run), during which time peak vertical accelerations were generally no larger than in the preceding length of the run. The contribution to the fatigue load distribution (see below) during this time was therefore small.

To improve the accuracy of the distribution of accelerations (Fig.9) above $0.45 \Delta g$ the sample size was increased by 3611 to 5030 by including data from Tables 1 and 2. The author is confident that no contributions were made to the distribution above this level by any runway other than 03/21. Each of the two samples were from different aircraft (both Type E) but the proportion of take-offs from runway 03/21 were approximately the same for each at 5.9% and 6.5%.
