Saunders-Roe Princess Flying Boat

G-Alun Engineering Appraisal

M. A. E. E. Report No. F/187
(Saunders-Roe Report No. FT/15/0/24, Part 31

June 1955

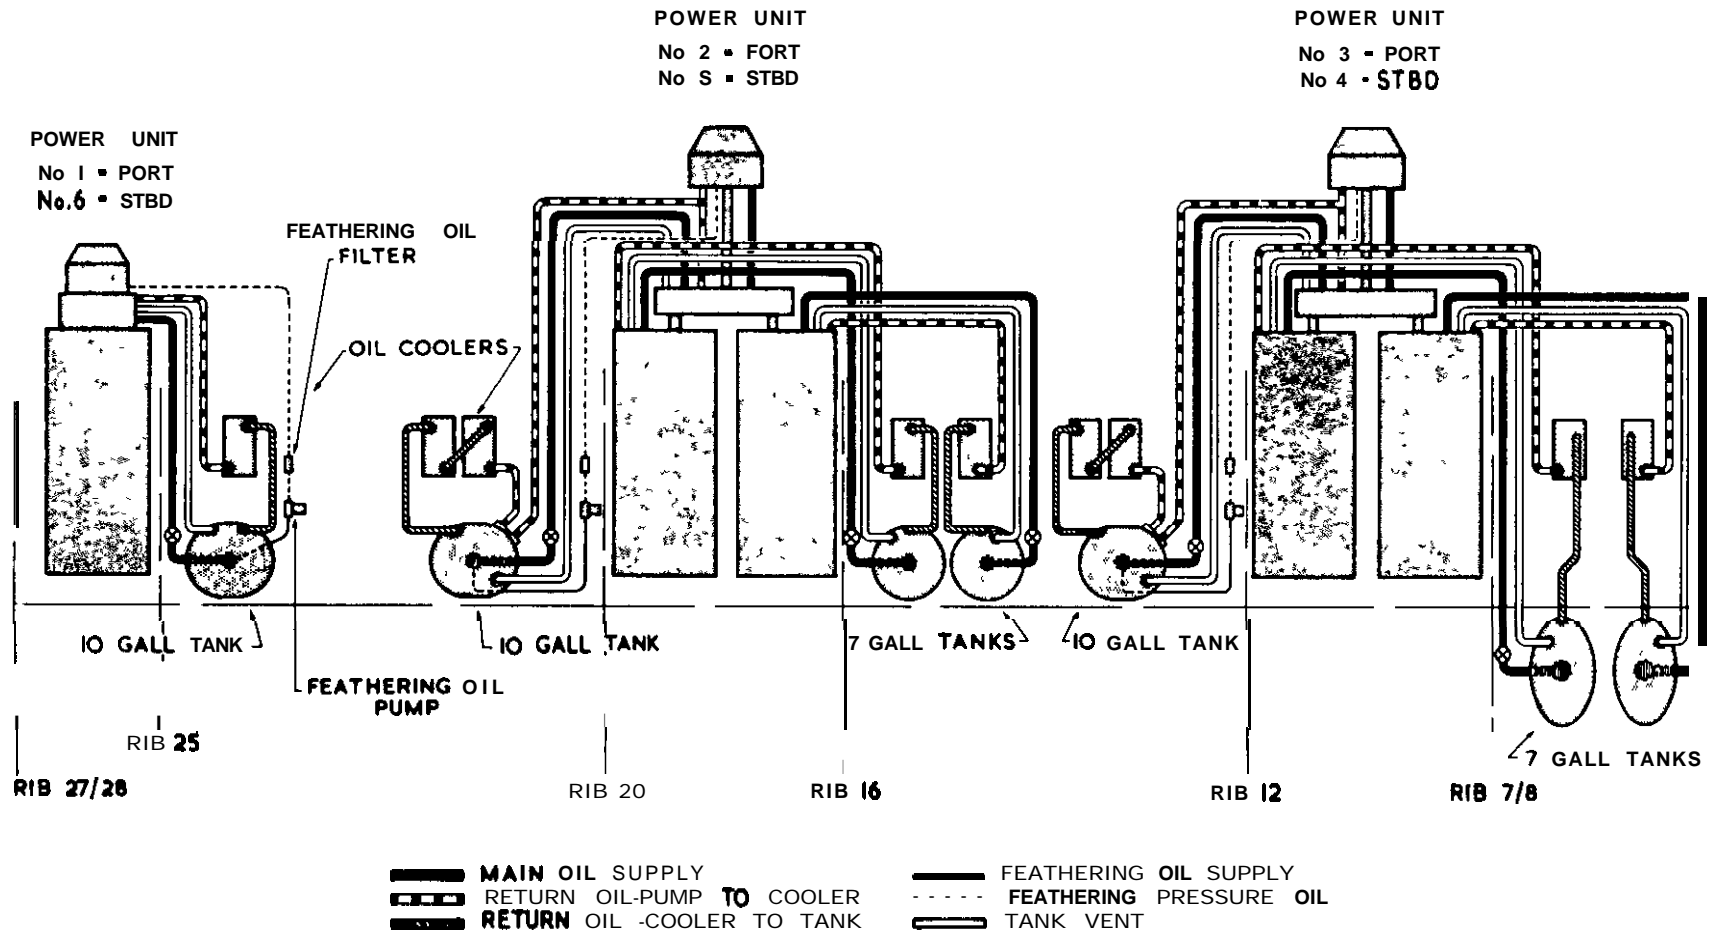
FIG. 5

Each coupled power unit had its own oil system and also a separate transmission oil system. A single unit installation had one common system for both engine and transmission. The layout of the oil systems for two coupled and one single engine is shown schematically in Figure 5 and a full description may be found in Section 4, Chapter 3 of Reference 4.

The four coupled engine transmission systems and the combined single engine systems were satisfactory. The oil systems for the coupled units were not satisfactory. Even under temperate summer conditions it was not possible to warm the oil up to a desirable operating temperature, or to maintain it at a figure above the minimum limit in flight. This over-cooking was mainly due to the low oil circulating rate through the engine, and was aggravated to some extent by air leaks around the cooler shutters. Temporary sealing was fitted to the shutters, and part of the cooler matrix blanked off; this enabled flying to continue, but was only a temporary arrangement.

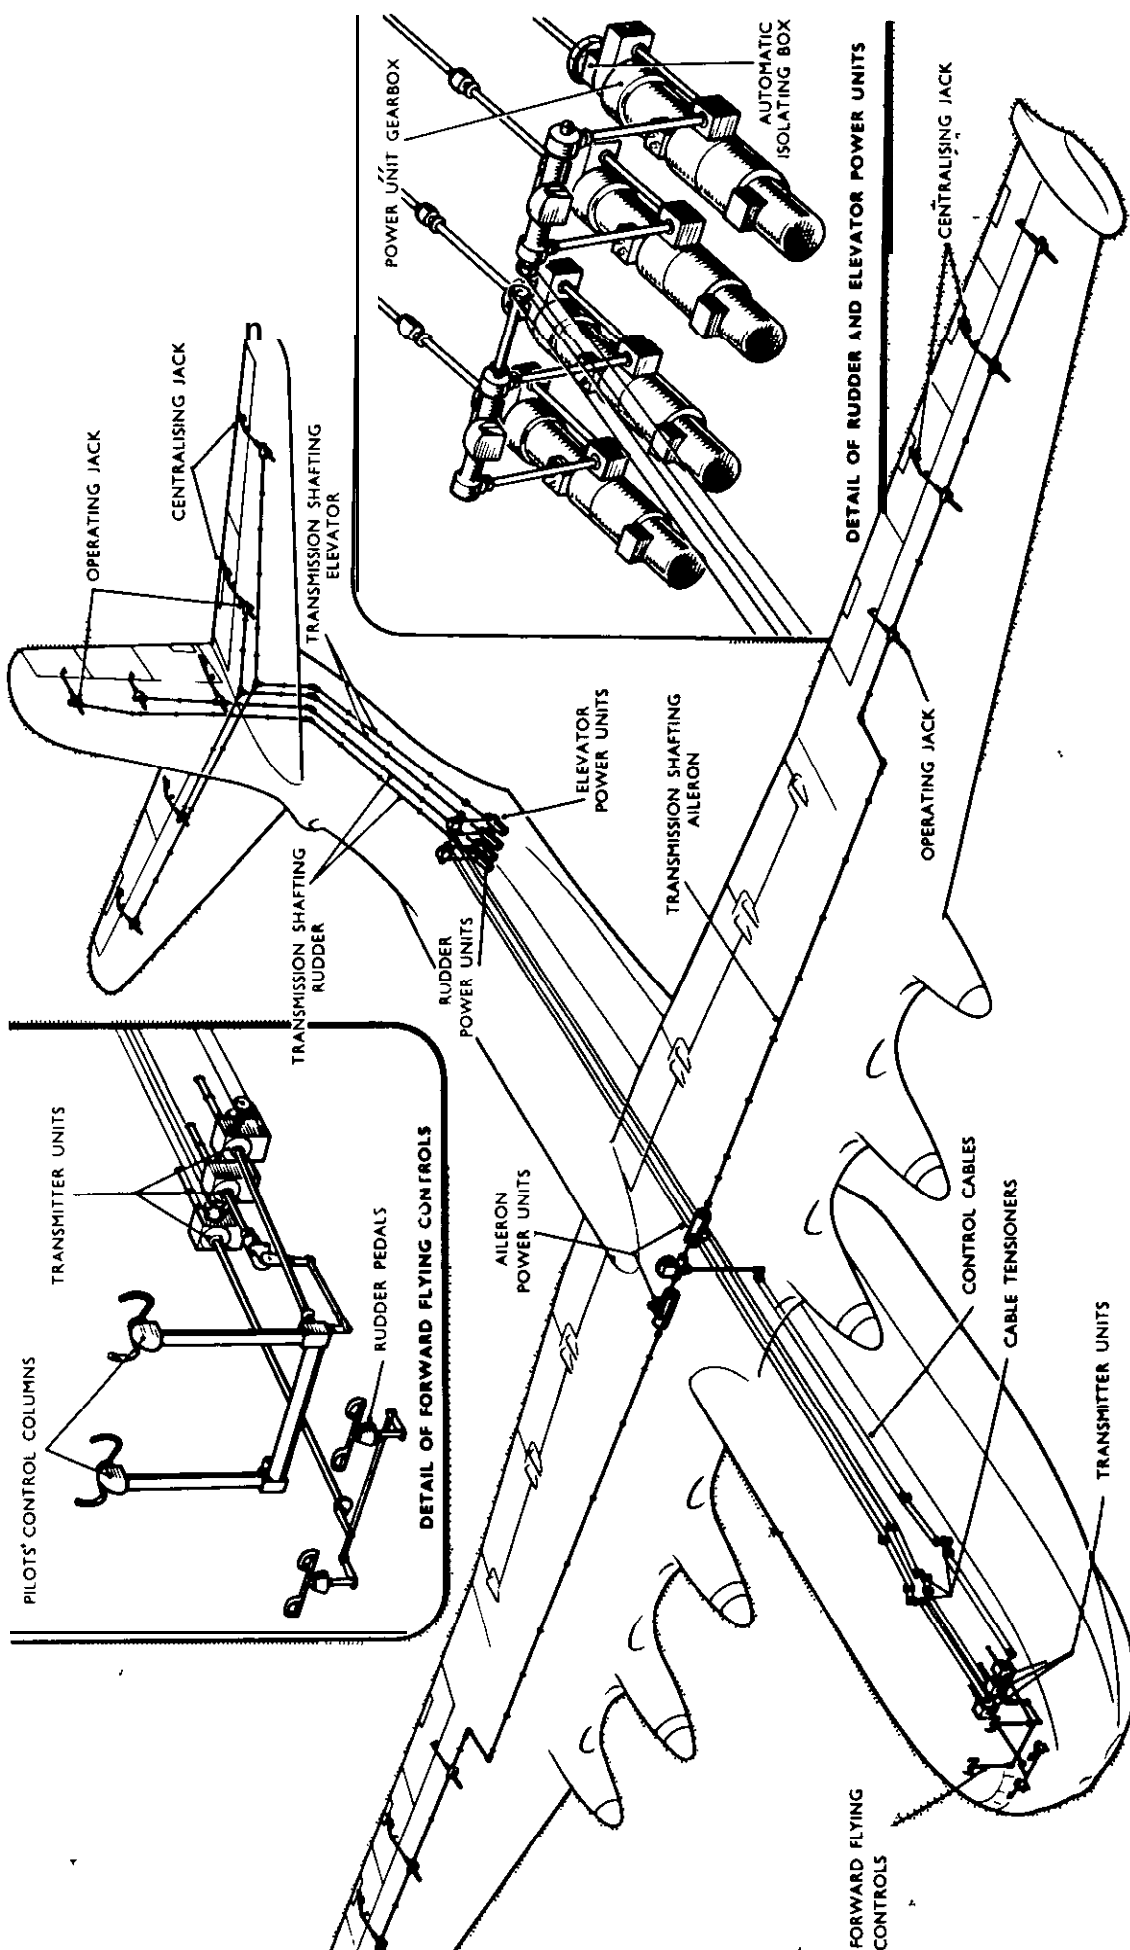
DIAGRAMMATIC LAYOUT
OF POWERED FLYING CONTROLS

A diagrammatic arrangement of the powered flying controls is shown in Figure 7. From this it will be seen that control column and rudder bar movements were taken by cables, via a transmitter unit, to a pair of electrical/hydraulic power units for each of the three flying controls. The power units in turn operated the control surfaces by means of torque shafts and screw jacks. By splitting the surfaces into sections it was so arranged that one power unit of each pair operated half of the particular control surface. This ensured that a power unit failure would leave half of any control system operative. A means of centralising the surfaces, in the event of such a failure, was also provided by fitting separate actuators in the surface operating lever, aft of the main screw jack. A full description of the installation is given in Section 3, Chapter 4 of Reference 4.

Secondly, the motor generator sets which provided A.C. current for the centralising actuator motors were not satisfactory. These sets, Type B.T.H. D2A1, were running under stand-by conditions (no load) during all flights, current only being required from them in the event of a flying control power unit failure. The functioning of these generator sets is discussed in Paragraph 4.

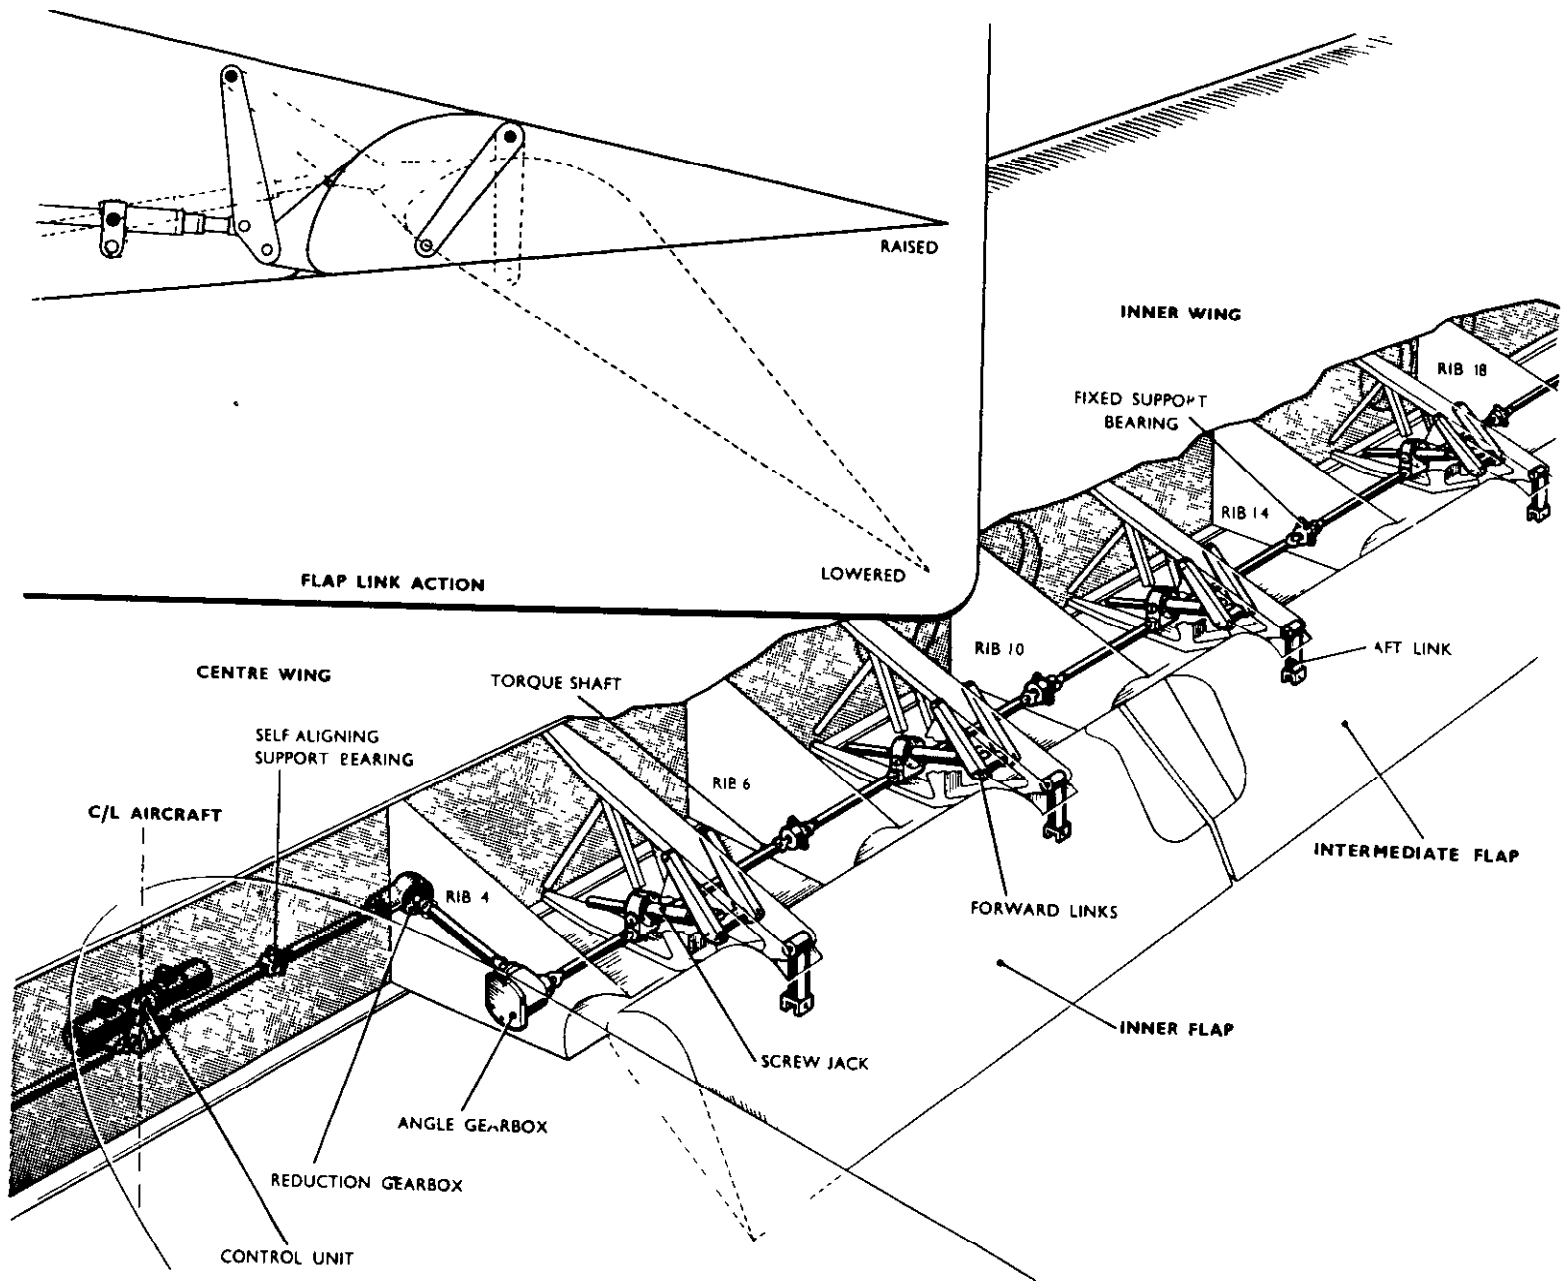
FIG. 8

As can be seen from Figure 8, two electric motors driving through a differential gear box operated screw jacks, two on each unit. In the event of one motor failing, an automatic electrical brake came into operation, allowing the other motor to drive the system at half speed; flap movement at half speed was satisfactory.

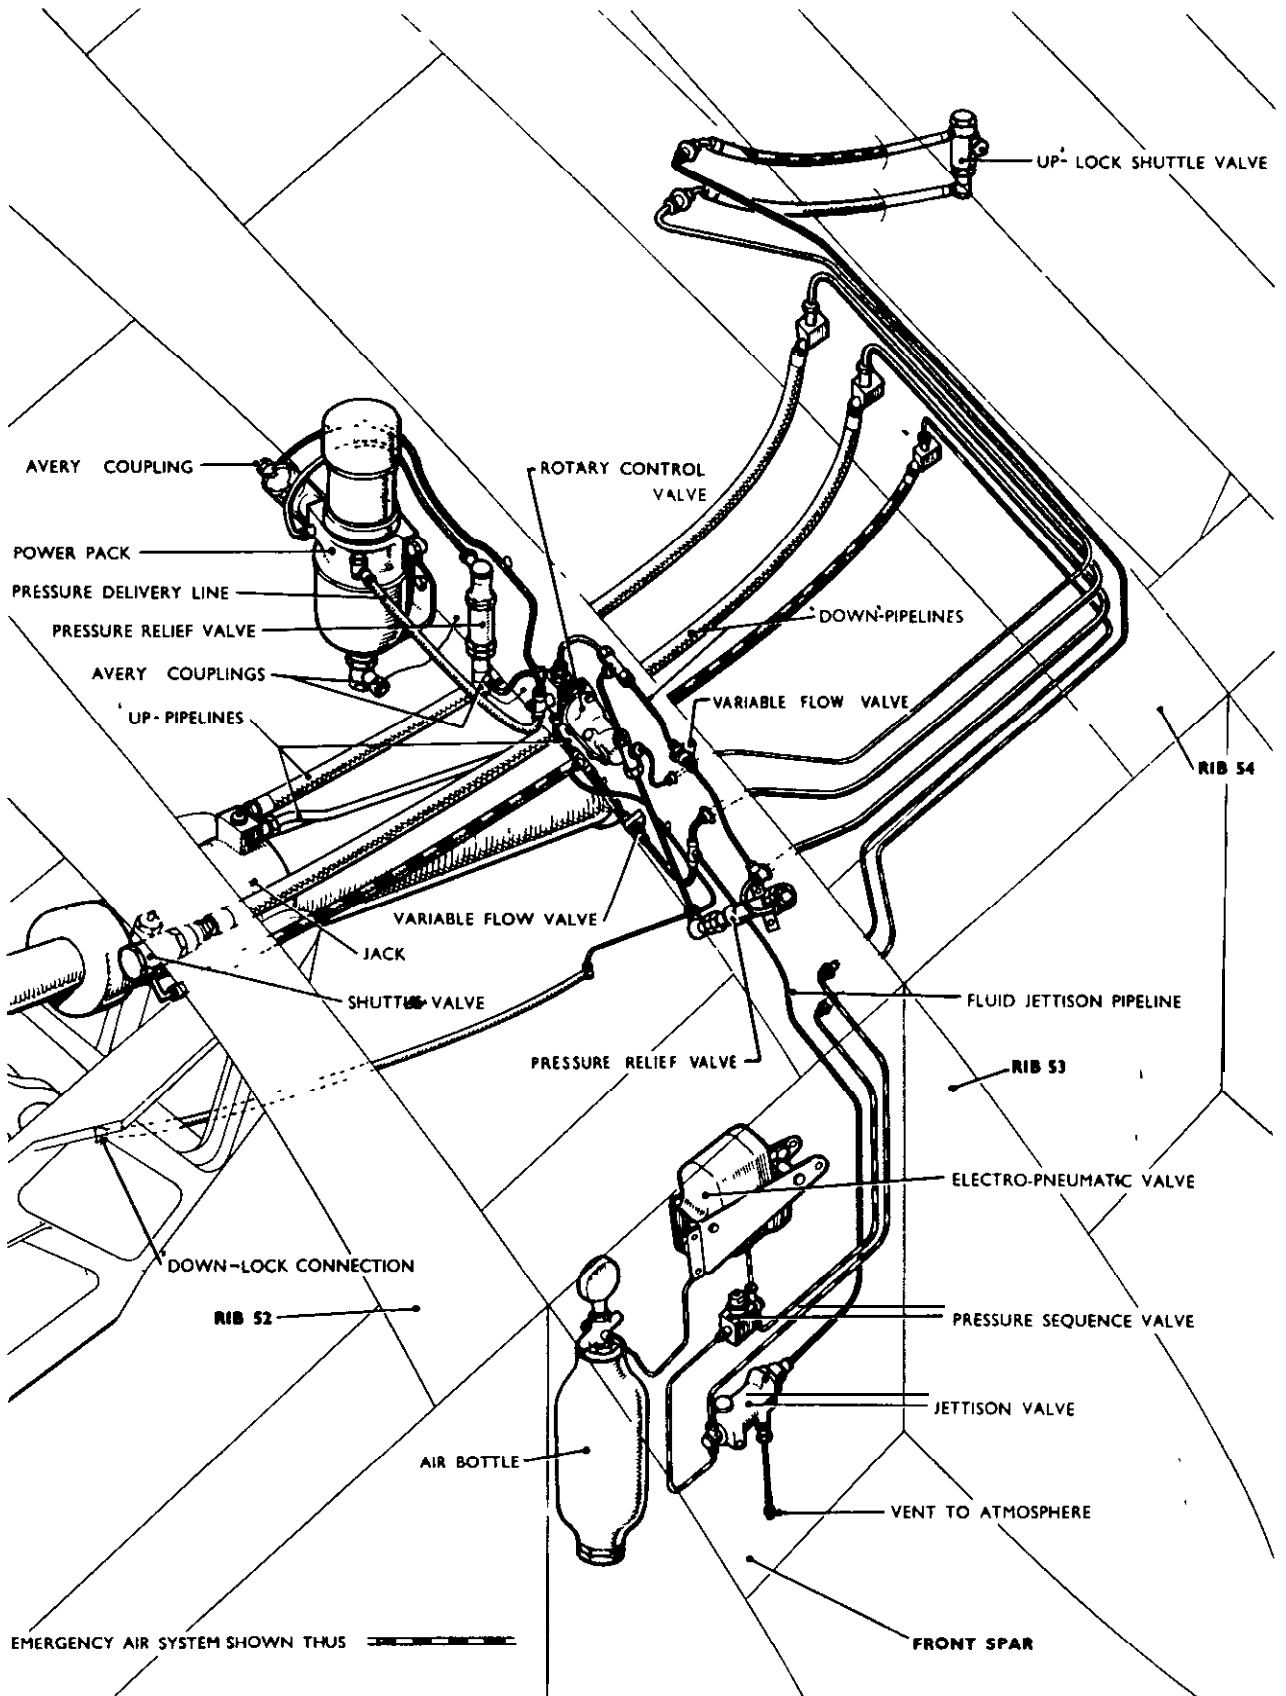
FLOAT HYDRAULIC AND EMERGENCY AIR SYSTEMS-PORT SIDE

The emergency air system could be used to lower the floats in the event of a hydraulic failure and when operated allowed air from a storage bottle to release the uplock and actuate the jack ram. The systems are shown schematically in Figure 9. A full description is given in Section 3, Chapter 5 of Reference 4.

Initially, trouble was experienced with the uplock micro-switches. The type fitted did not allow for sufficient over-swing of the float during retraction, and consequently were crushed. Modified switches and brackets were fitted, which proved completely satisfactory. During early flights, occasional rapid float retractions occurred, taking approximately half the normal time of from 10-12 seconds, and resulting in fractured hydraulic reservoir seals. This was overcome by fitting an additional variable flow and pressure relief valve in the return line from the jack to the rotary control valve.

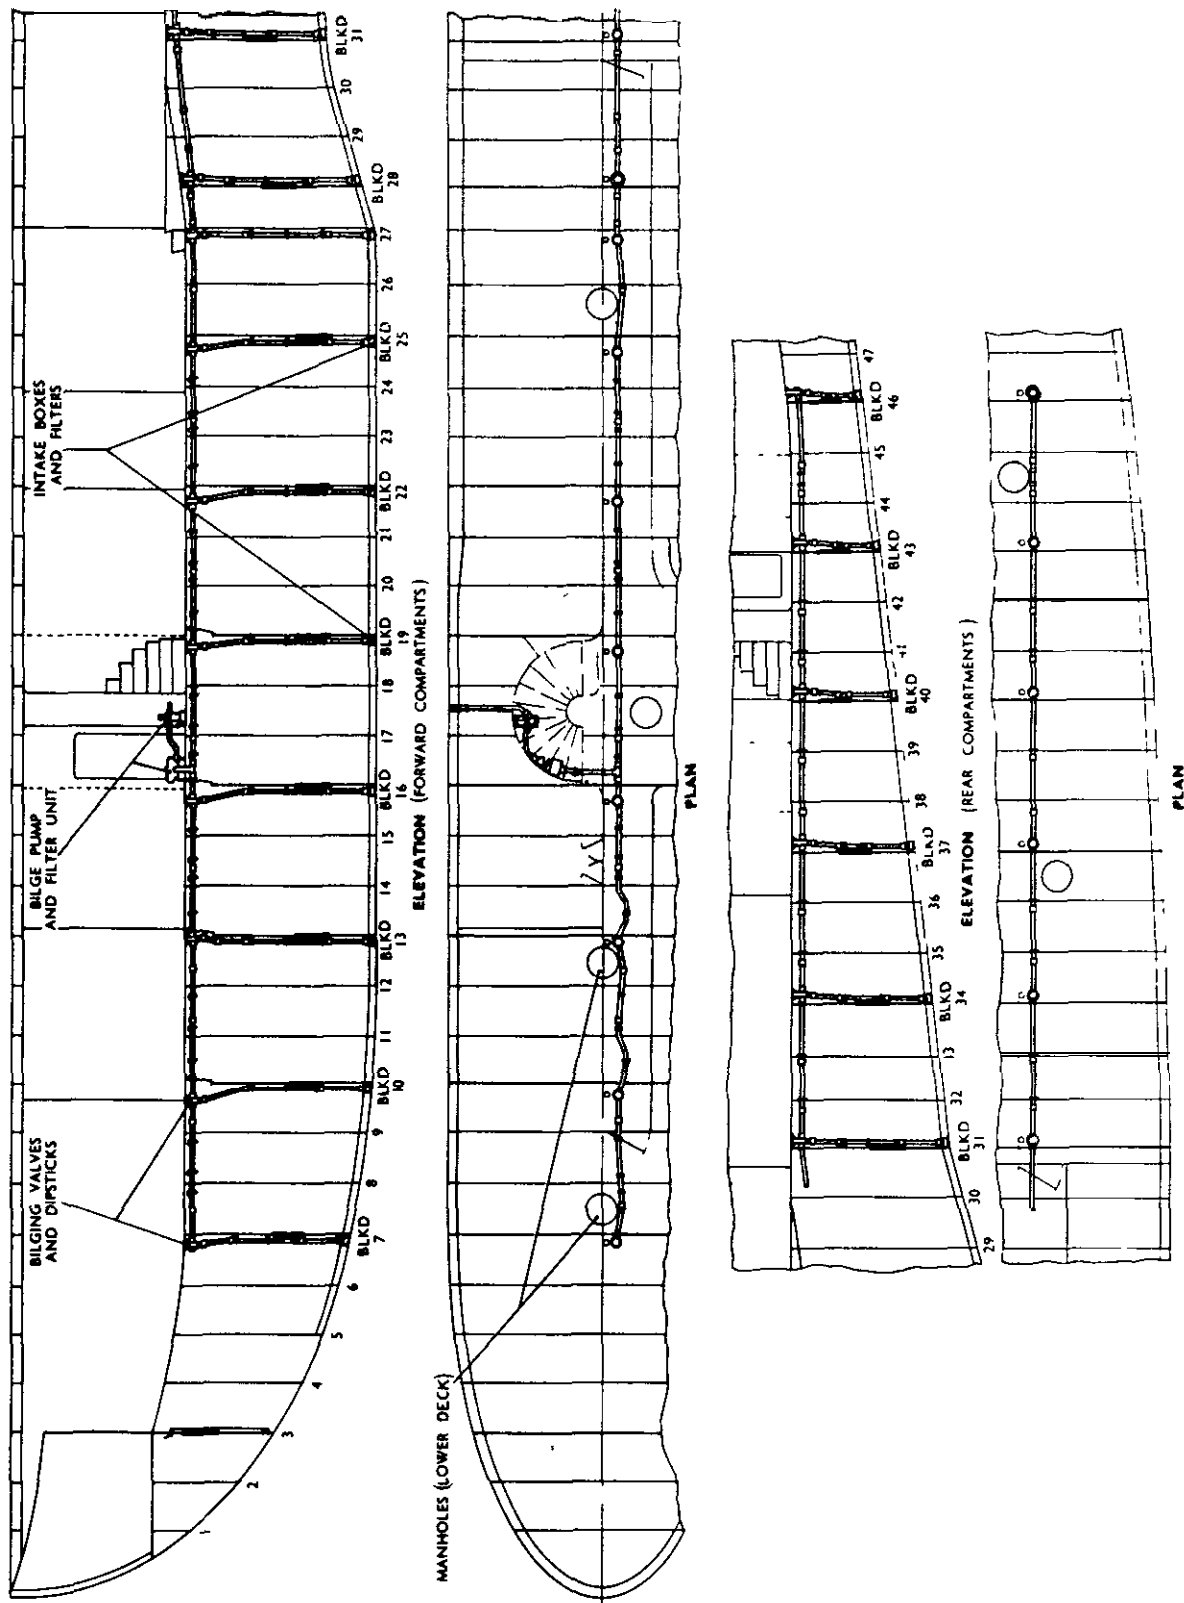
DIAGRAM OF BILGING SYSTEM

The troubles encountered on the main bilge pump were the result of corrosion in the units due to the dissimilar metals in the pump, which was aggravated by the effects of salt water. Fresh water was pumped through the unit, but this did not overcome the electrolytic action of the dissimilar metals.

The rubber sealing rings in the disc valves had to be changed on several occasions. These rings were generally damaged whilst sliding past the main gallery unions. The rings expanded into the gallery as the valve was being opened or closed, and were cut away by the continual action of the valve. This process was aggravated by the effects of salt water on the seats, which perished the rubber. A leak in one valve could render the system unserviceable.

The hose piping used for connections at various points in the system was affected by sea water and replacement was necessary on several occasions.

Improvements should be made to prevent the corrosion which occurred of several components, and hence reduce the amount of maintenance necessary on the installation.
