AERONAUTICAL RESEARCH COUNCIL
REPORTS AND MEMORANDA

Behaviour of Skin Fatigue Cracks at the Corners of Windows in a *Comet* I Fuselage

*Reports and Memoranda No. 3248**

June, 1960

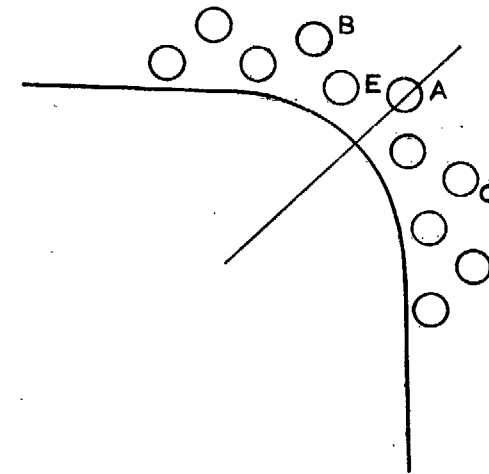
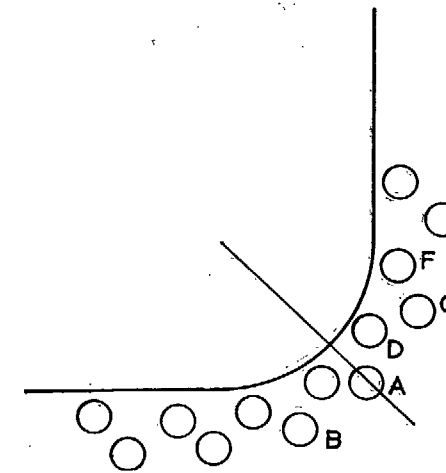
5. Discussion. 5.1. *Origins of the Fatigue Cracks.* All the fatigue cracks originated at the countersunk rivet holes in the skin at the window and escape hatch corners. Those cracks which eventually became catastrophic started at outer-row rivet holes. The few cracks that originated at holes in the inner row grew inwards to the edge of the aperture and did not become catastrophic. No cracks originated at the edges of the apertures.

Rivet holes at which the cracks occurred.

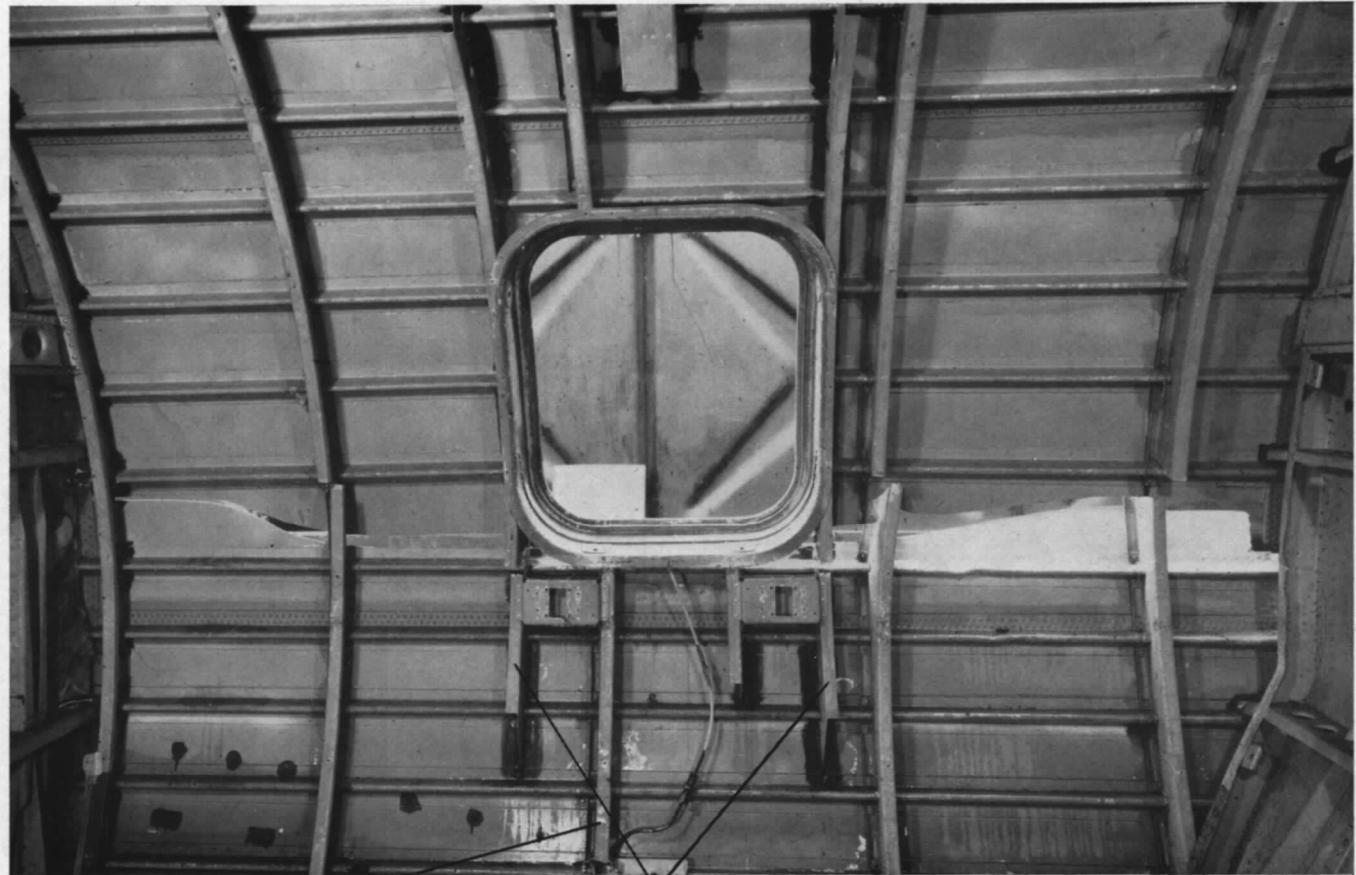
Differences of behaviour occurred during growth towards the frames and across the frames. During the first stage, several cracks became critical when about 3 in. long, *i.e.*, between the aperture and the frame. This condition was noted at most of the windows in the centre section where the skin was also riveted to the frames. The presence of this extra attachment appeared to have a strong influence in delaying crack growth across the frame, and was clearly demonstrated in the case where a crack extended a distance of 2 in. in one pressure cycle (Fig. 22). An exception however, occurred at the port forward escape hatch (where the riveted frame was a partial frame only—Fig. 6) when the crack at the bottom forward corner caused a catastrophic failure when 2.75 in. long (Fig. 6).

FIG. 6. Internal partial frames at forward escape hatches.
Failure at port forward escape hatch at 11,246 cycles.

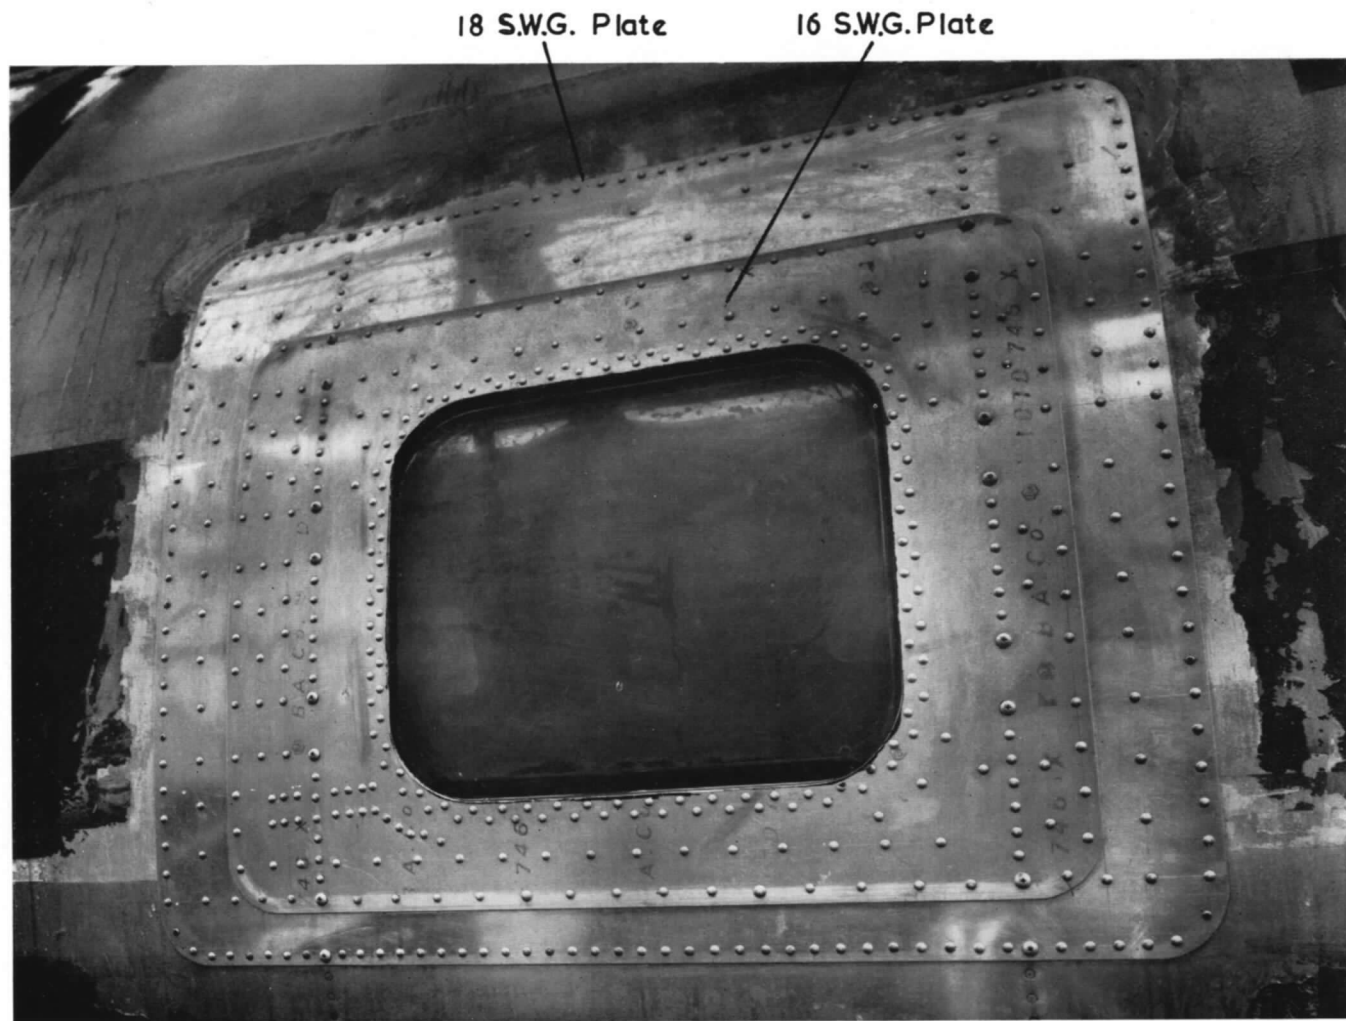
FIG. 13. Typical window repair.

Detailed visual inspections were made at frequent intervals. When a fatigue crack was found its subsequent development was observed continuously with an inverted periscope. When it was judged that a fatigue crack would soon develop catastrophically the affected aperture was repaired to prevent excessive damage to the specimen (Fig. 13).

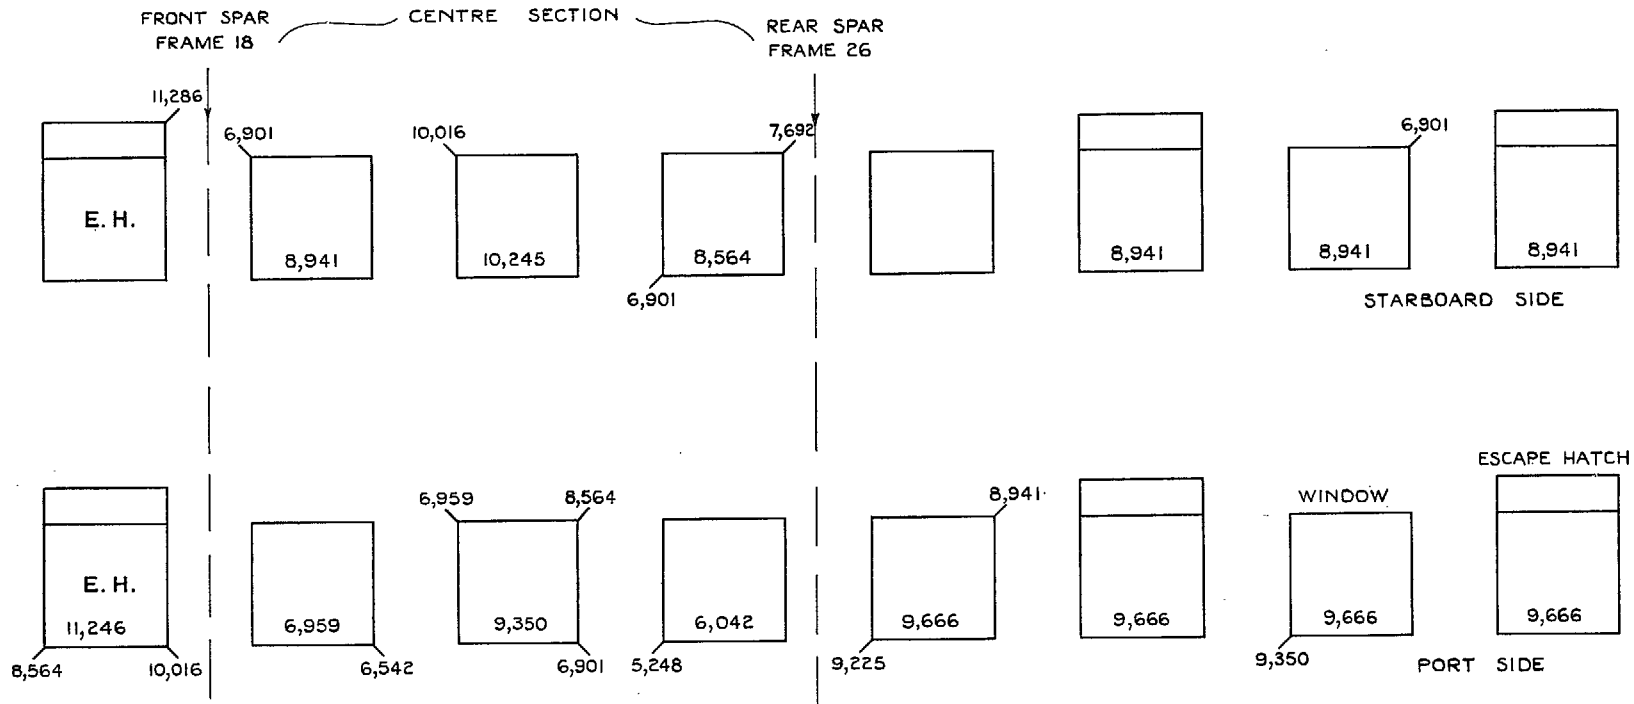
FIG. 20. Distribution of fatigue cracks at window and escape-hatch-aperture corners.

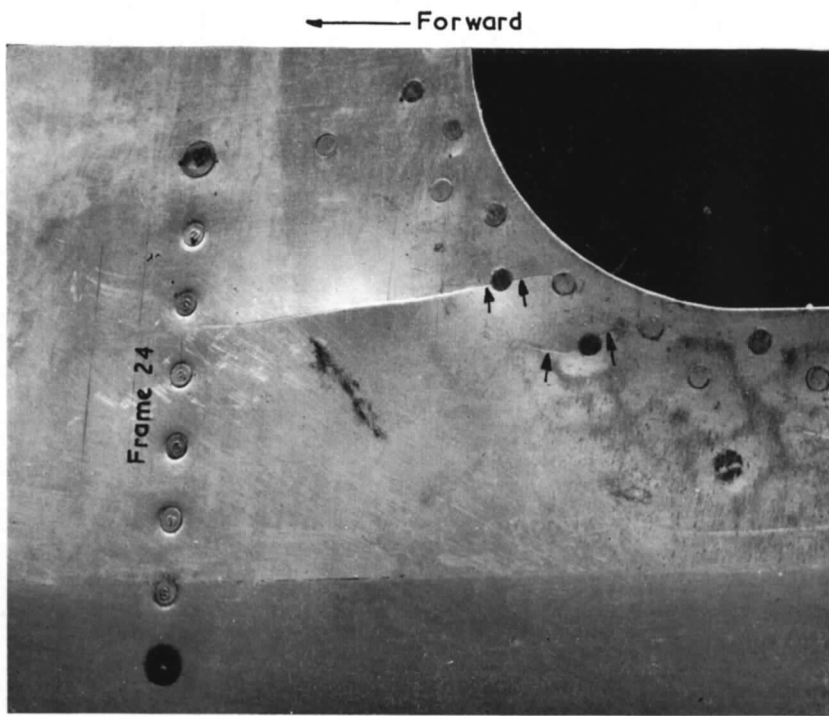
FIG. 31. Third port window corner, 5,951 cycles.

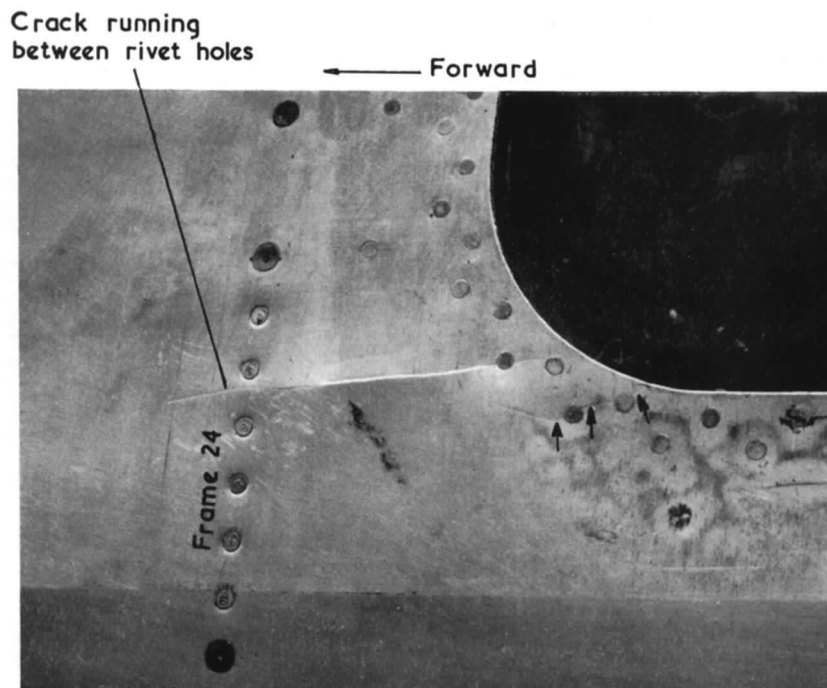
FIG. 32. Third port window corner, 6,042 cycles.

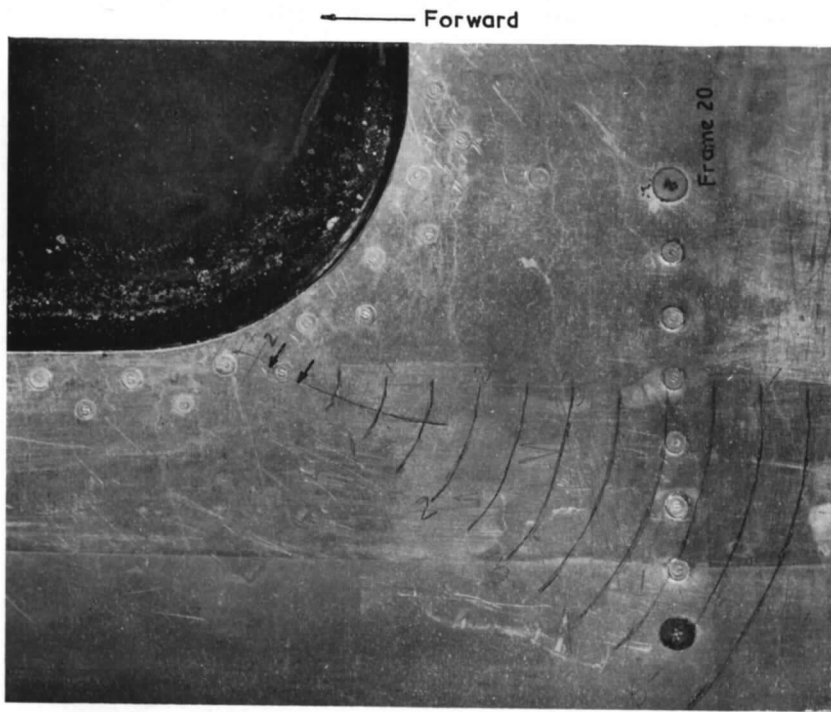
FIG. 33. First port window corner, 6,901 cycles.

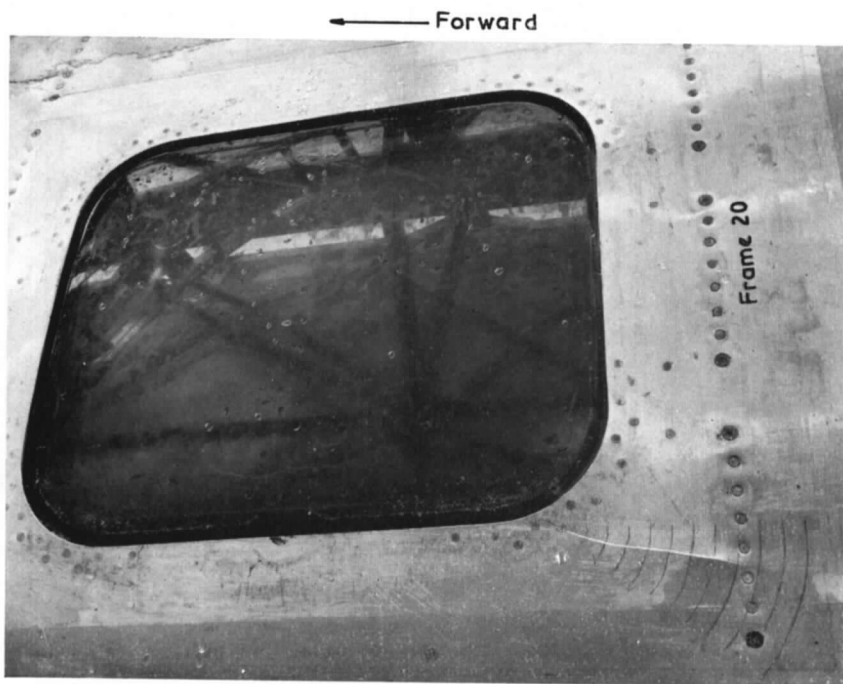
FIG. 34. First port window corner, 6,959 cycles.

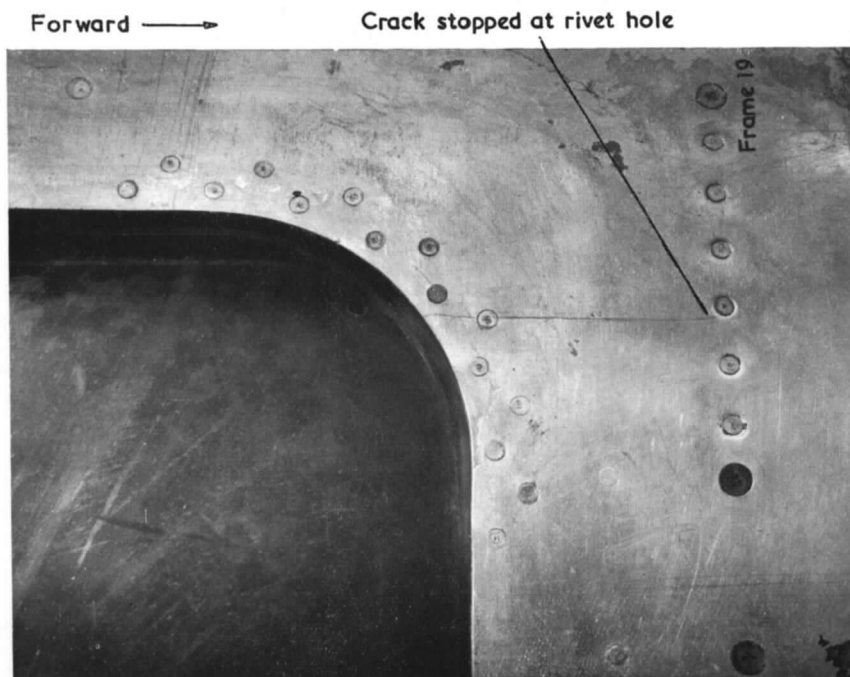
- (1) The frame with the normal bolted attachment appeared to have no influence whatever on crack growth.
- (2) Where the skin was riveted to the frames:
 - (a) Cracks passing between rivet holes were slowed down, but not stopped altogether.
 - (b) Cracks entering rivet holes were stopped temporarily; *e.g.*, one crack was contained for more than 1,800 cycles.

FIG. 35. Crack stopped at rivet hole in frame, 6,901 cycles.
First starboard window.

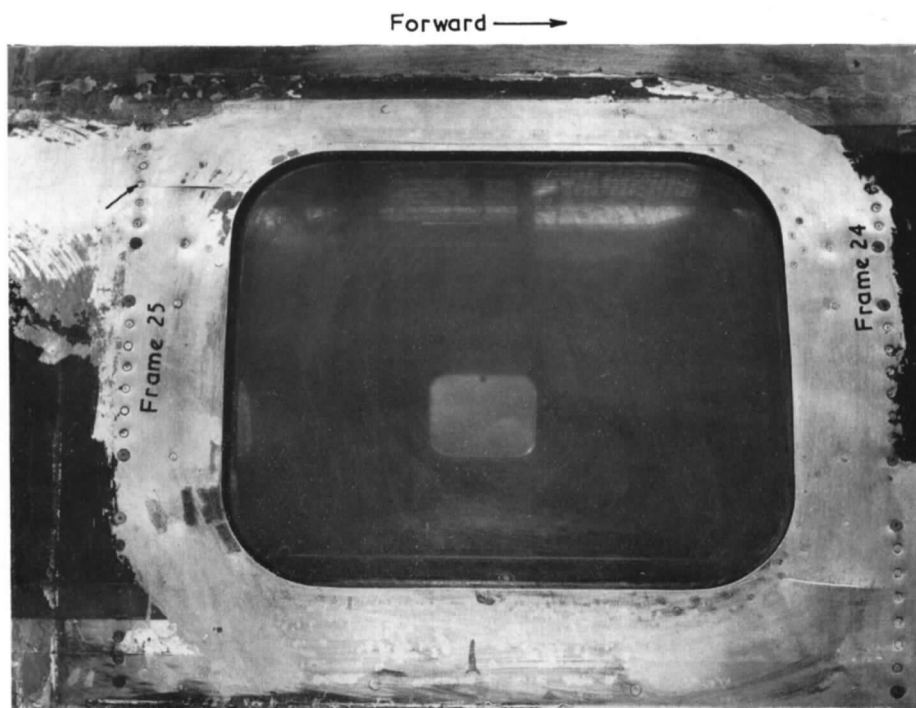
FIG. 36. Cracks stopped at riveted frames, 8,564 cycles.
Third starboard window.

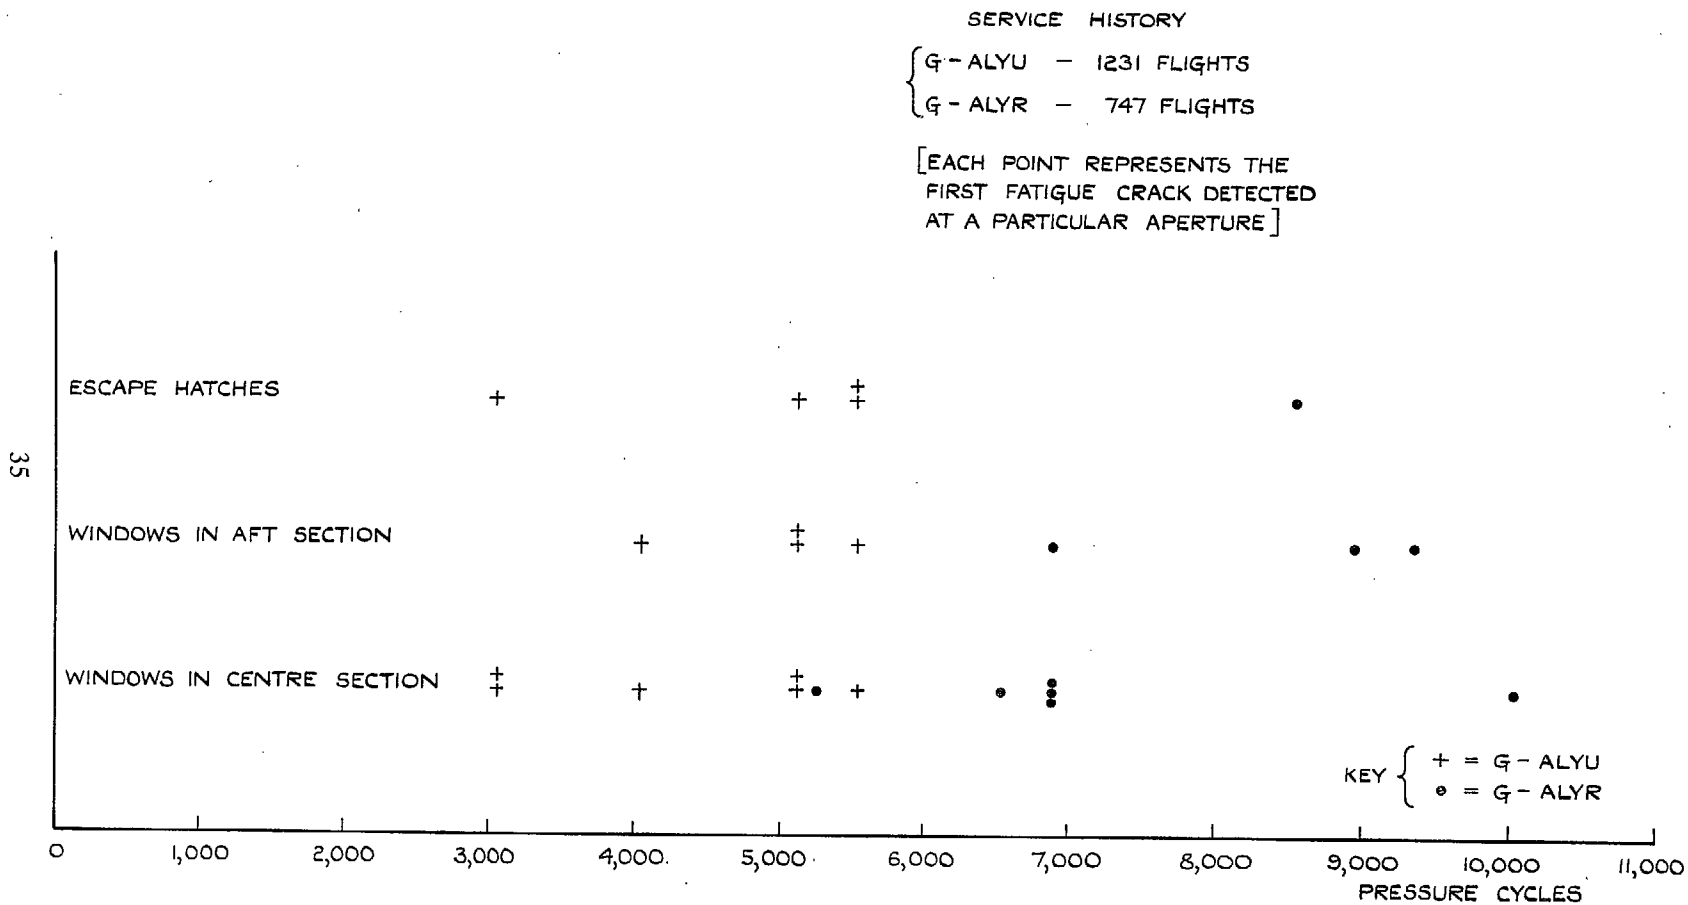
5.2. *Locations of the Fatigue Cracks.* The test on G-ALYR showed that fatigue cracks were initiated earliest and most numerous at the windows in the centre section, and though the first failure in G-ALYU was at a forward escape hatch⁴, fatigue cracks had also formed at several windows in the centre section by the time of this failure (Fig. 37).

FIG. 37. Distribution of fatigue cracks at apertures.
