NACA RM No. E8120

COMPARISON OF NATIONAL BUREAU OF STANDARDS CERAMIC

COATINGS L-7C AND A-417 ON TURBINE BLADES

IN A TURBOJET ENGINE

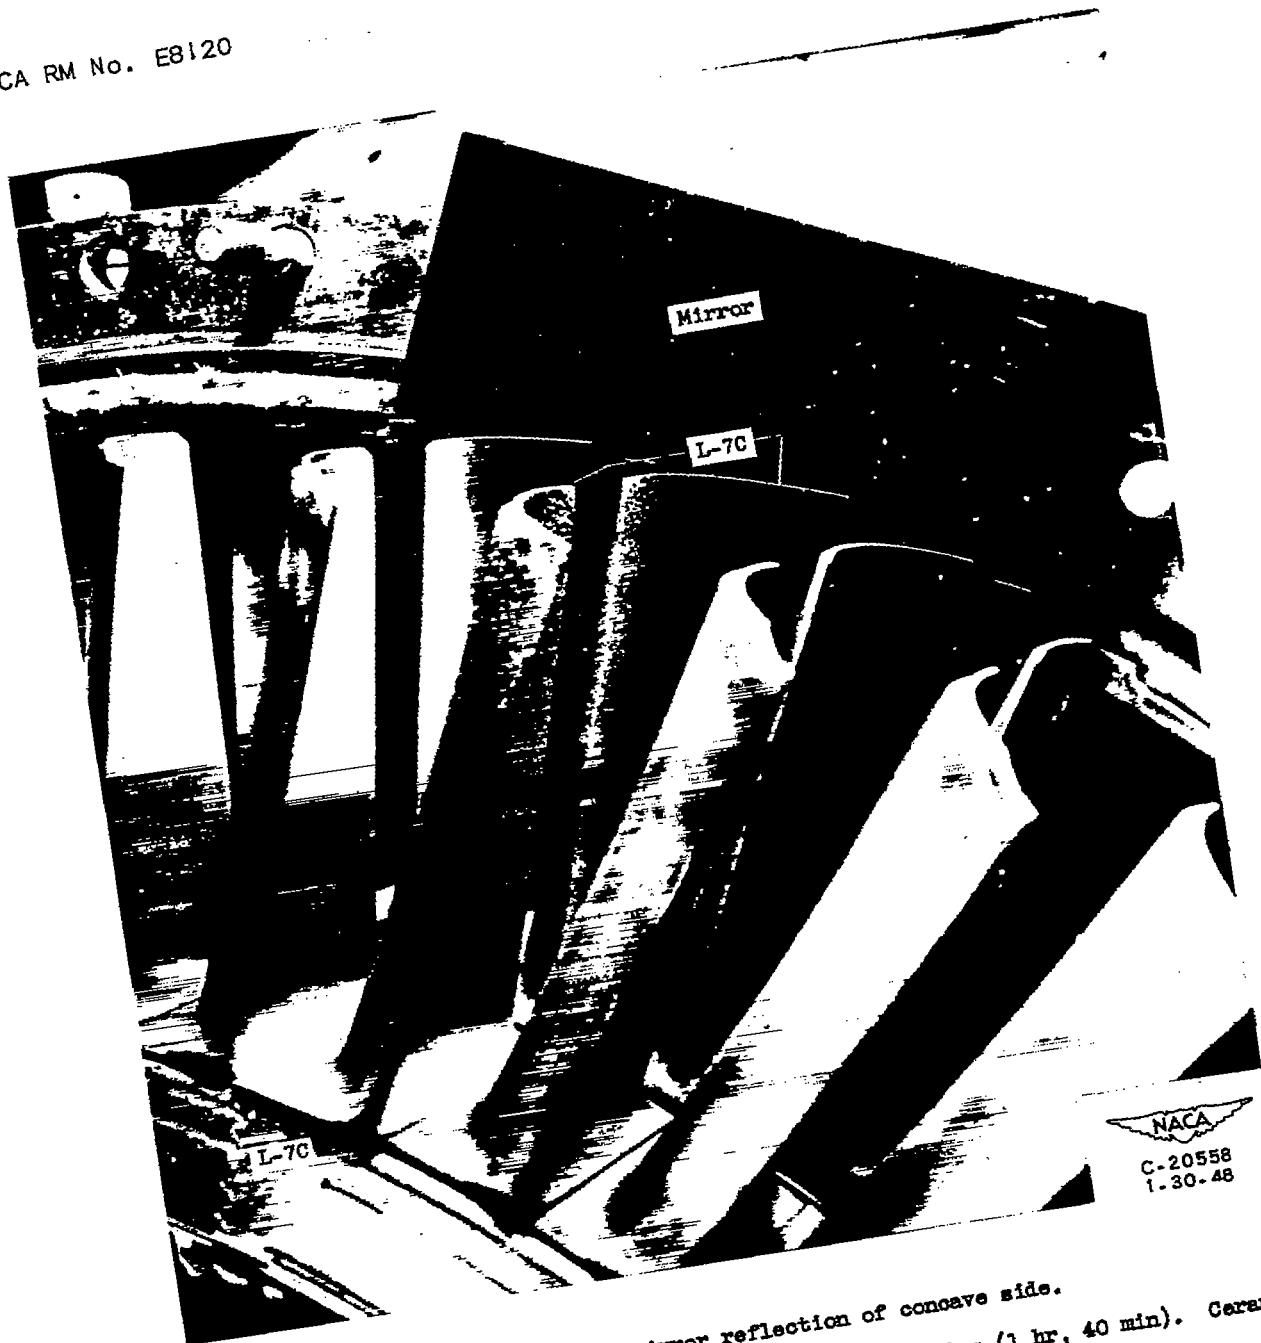
(a) Leading edge and mirror reflection of concave side.
Figure 3. - Turbine blade 1 after five engine operating cycles (1 hr, 40 min). Ceramic coating L-7C.

At the end of five cycles, coating L-7C was rough and small ceramic beads and radial-flow lines appeared, indicating that the fusion temperature of the ceramic coating had been exceeded. Ceramic coating A-417 showed no evidence of flow. At the conclusion of 100 cycles, many of the L-7C beads that were formed during the first five cycles had apparently been thrown off but coating A-417 still showed no evidence of flow. Both coatings flaked off to a slight extent at the tips of the blades but this flaking was probably the result of dents in the blades caused by foreign particles hitting the blades and by accidental contact with the tail cone during work on the engine. Elongation measurements showed that the rate of elongation of the coated blades was within the same range as that of newly operated uncoated cast Vitallium blades.

A ceramic-coated blade before installation in the engine is shown in figure 2. The coated blades had no previous running time and the appearance of all four blades was similar. Figure 1 shows the locations of the ceramic-coated blades in the turbine wheel. Blade 1 is shown in figure 3 after five operating cycles. During this first run, coating L-7C became rough and small ceramic beads and radial-flow lines appeared (probably as a result of the starting temperatures, which may have exceeded the 1650° F fusion temperature of the material). Turbine blade 3 had this same appearance. Blade 2 after the first five cycles is shown in figure 4. This A-417 coating, which has a fusion temperature of 1850° F, showed no evidence of flow. The appearance of blade 4 was similar.

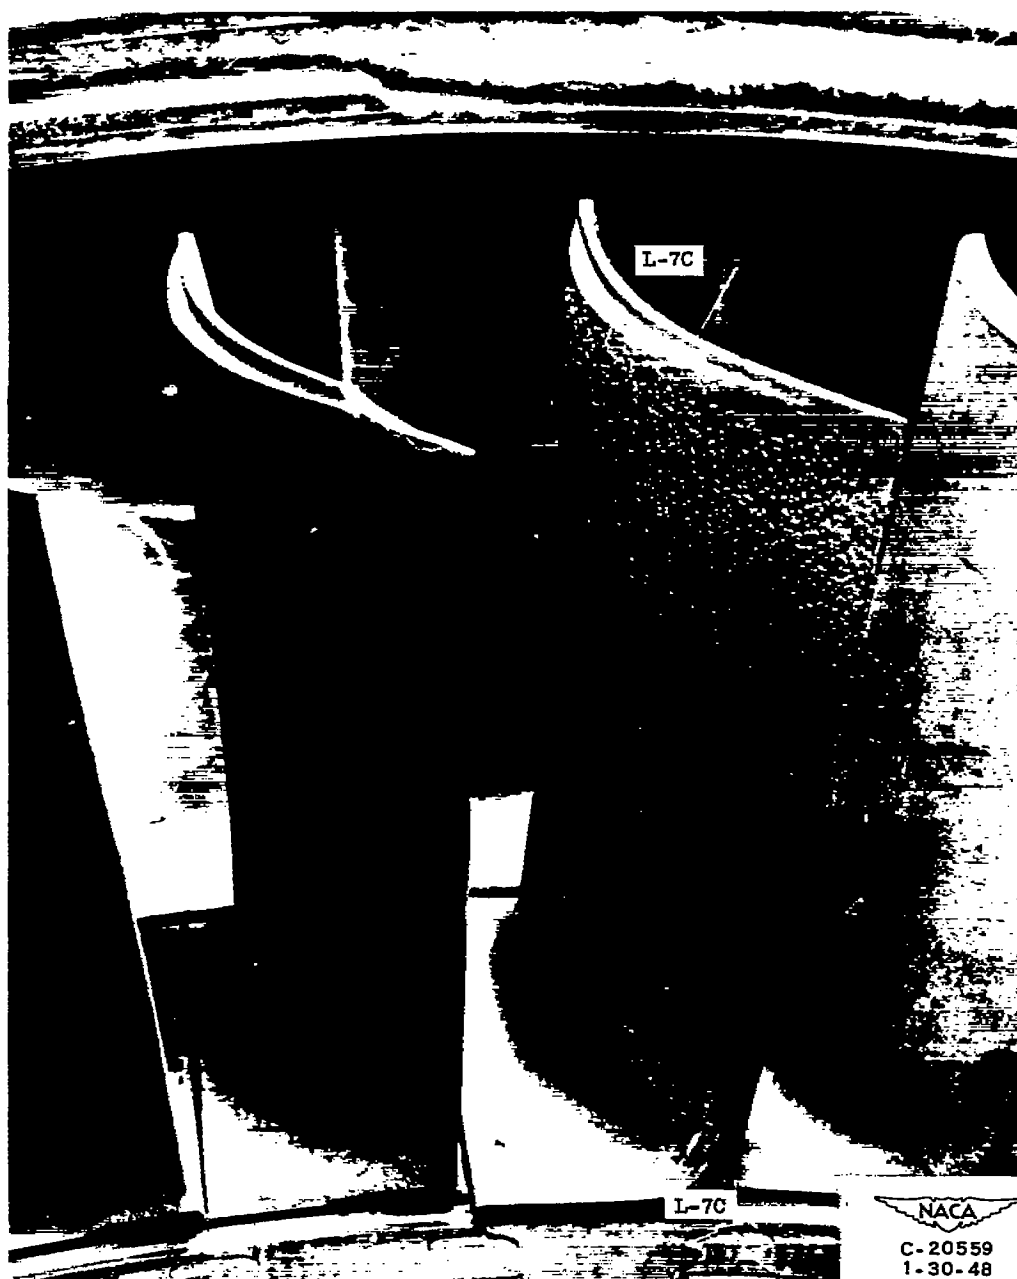
(b) Trailing edge and convex side.

Figure 3. - Concluded. Turbine blade 1 after five engine operating cycles (1 hr, 40 min).
Ceramic coating L-7C.

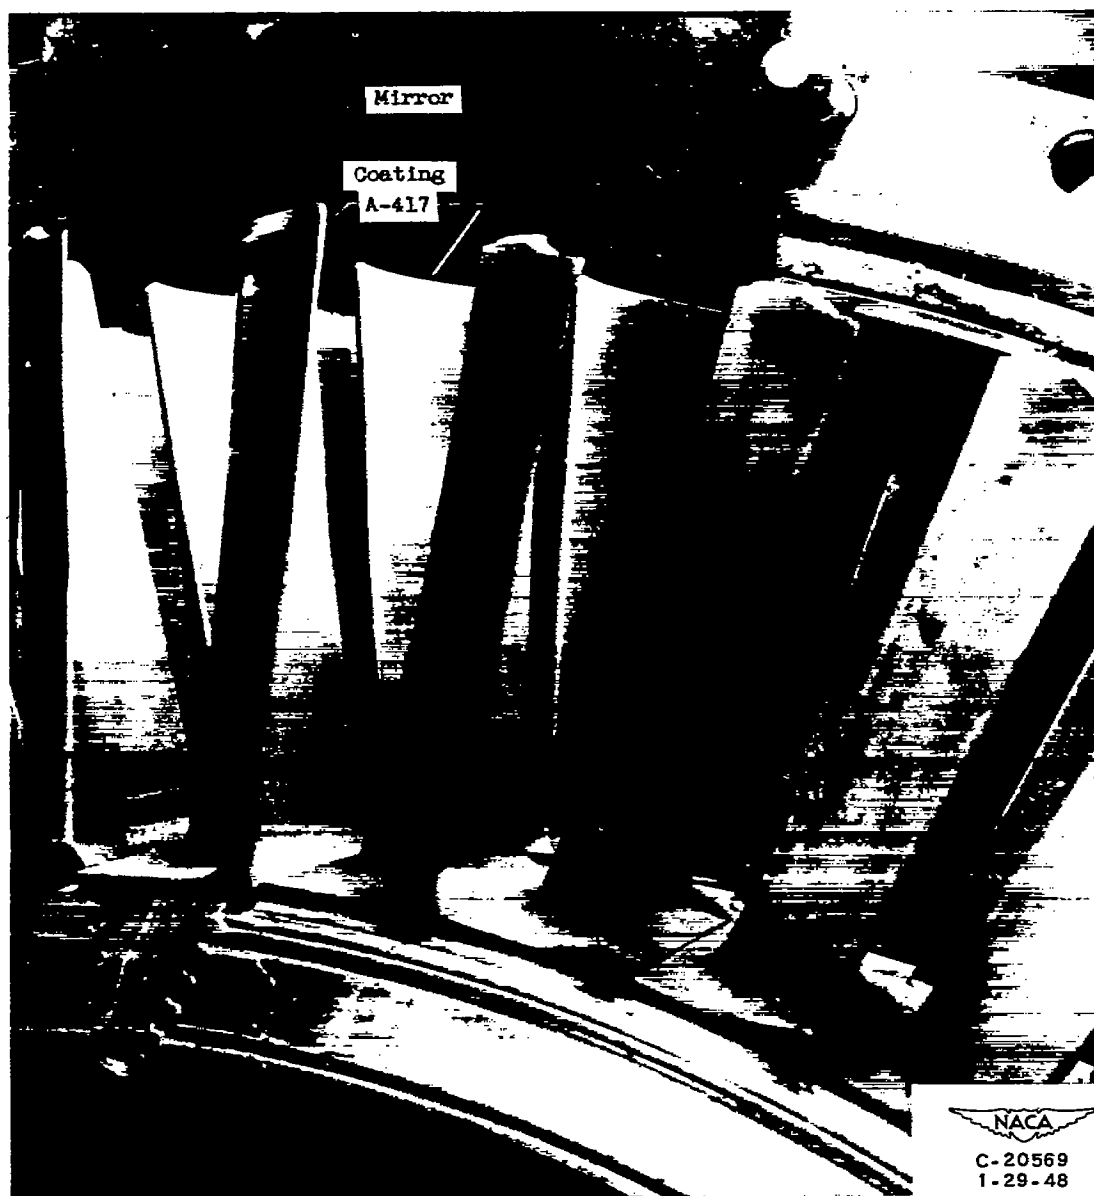
(a) Leading edge and mirror reflection of concave side.

Figure 4. - Turbine blade 2 after five engine operating cycles (1 hr, 40 min). Ceramic coating A-417

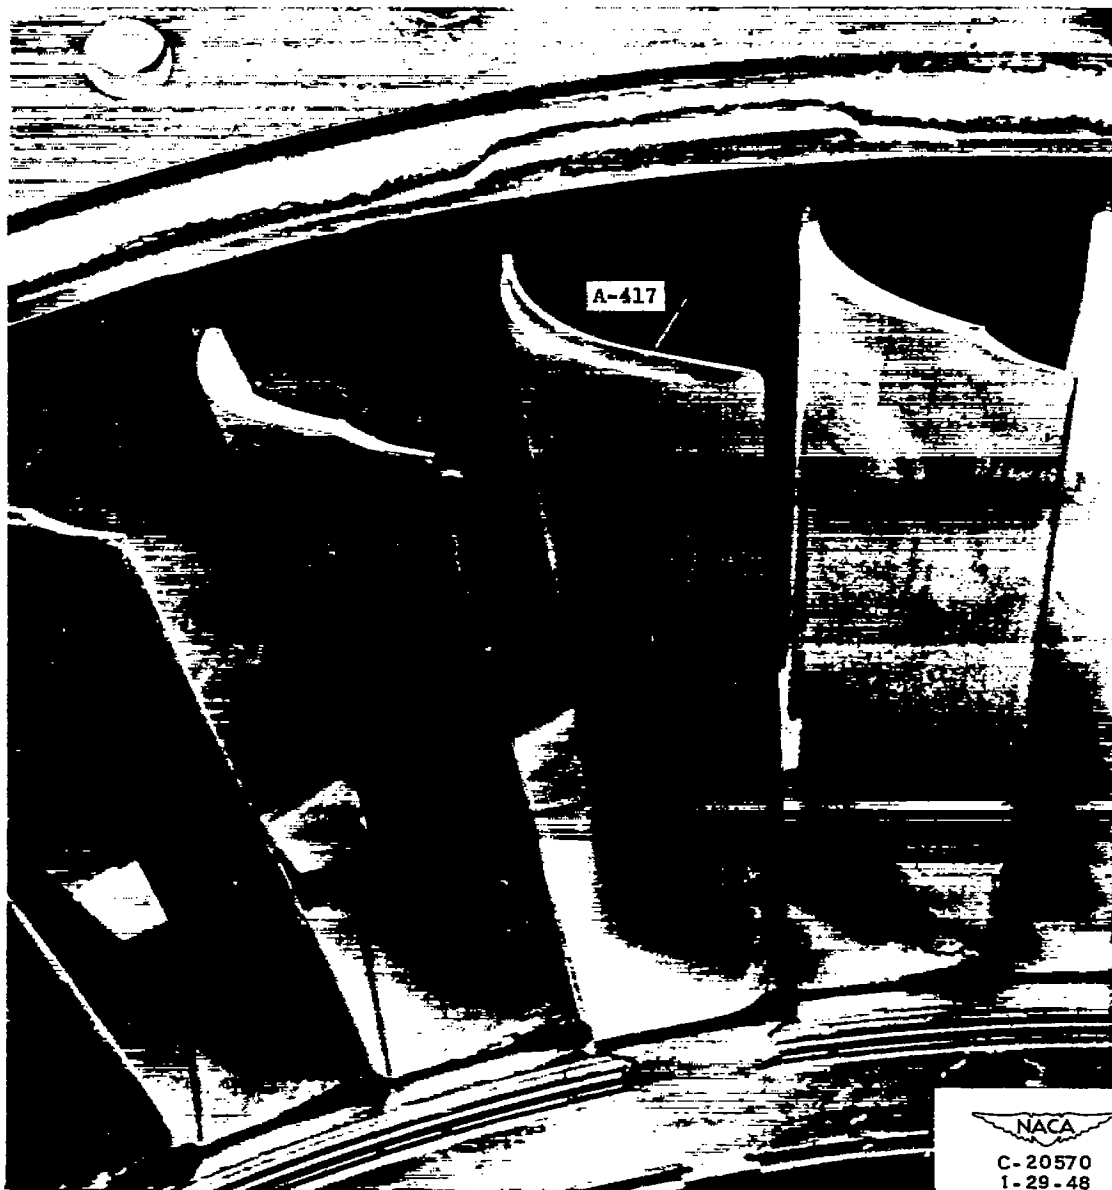
(b) Trailing edge and convex side.

Figure 4. - Concluded. Turbine blade 2 after five engine operating cycles (1 hr, 40 min).
Ceramic coating A-417.

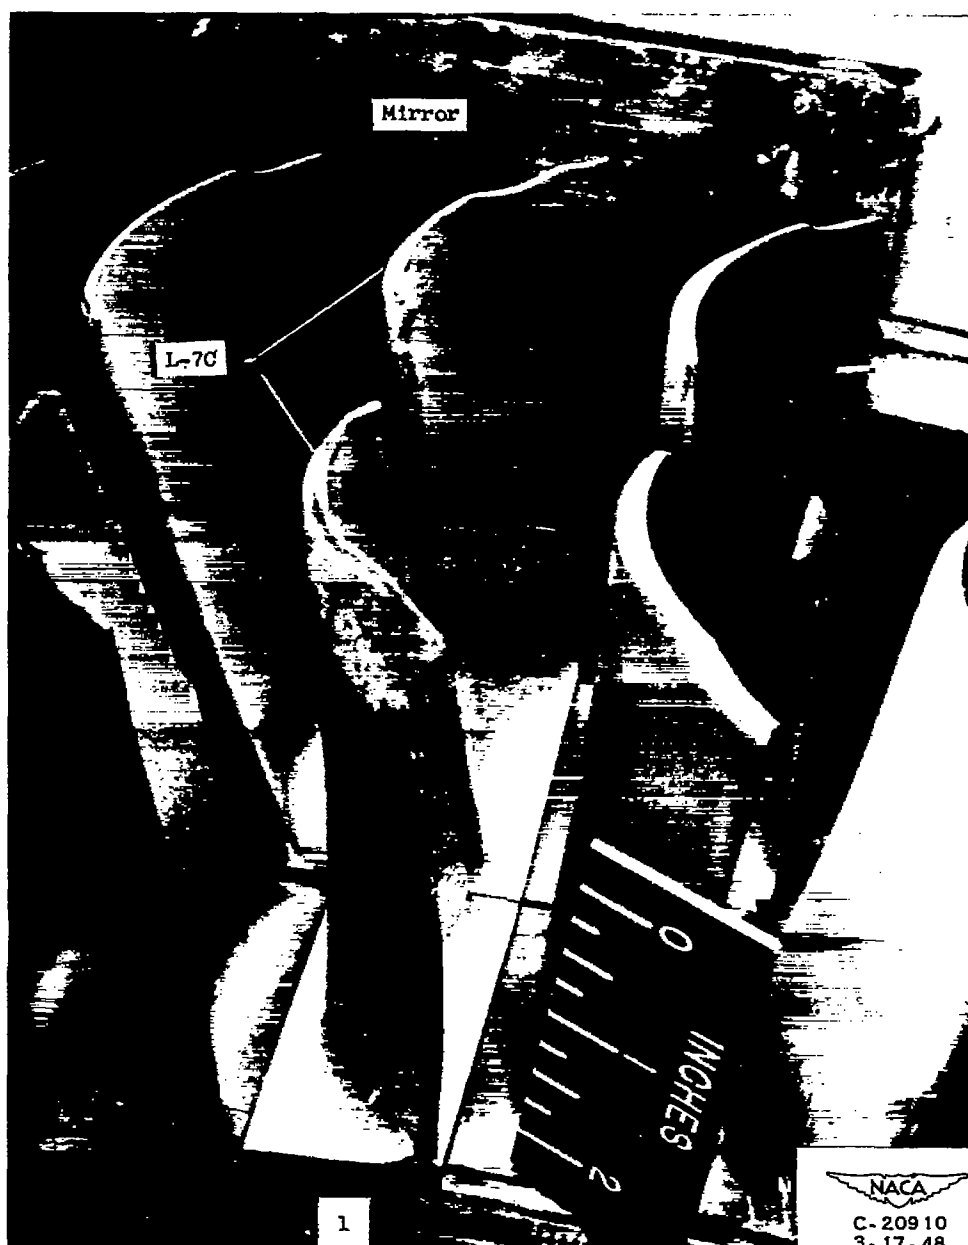
(a) Leading edge and mirror reflection of concave side.

Figure 5. - Turbine blade 1 after 100 engine operating cycles (33 hr, 20 min). Ceramic coating L-7C.

Blades¹ and 2 at the end of 100 cycles are shown in figures 5 and 6, respectively. Many of the ceramic beads (coating L-7C), which were formed during the first five cycles, have disappeared but coating A-417 shows no evidence of flow. Both coatings flaked off somewhat at the tip of the blades, but this flaking is probably the result of dents in the blades caused by foreign particles hitting the blades and by accidental contact with the tail cone while it was being removed in order to inspect the turbine wheel.

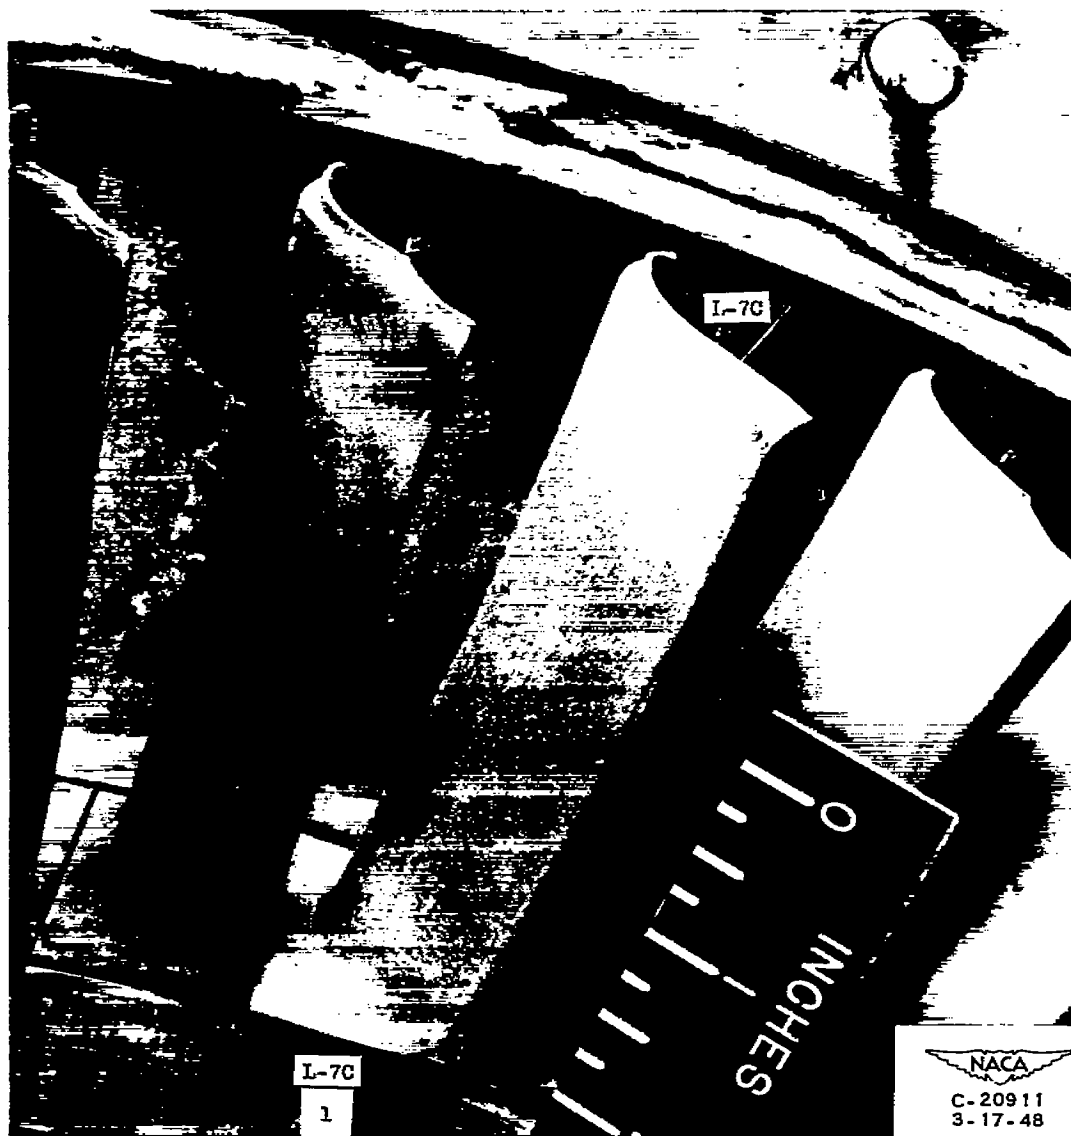
(b) Trailing edge and convex side.

Figure 5. - Concluded. Turbine blade 1 after 100 engine operating cycles (33 hr, 20 min).
Ceramic coating L-7C.

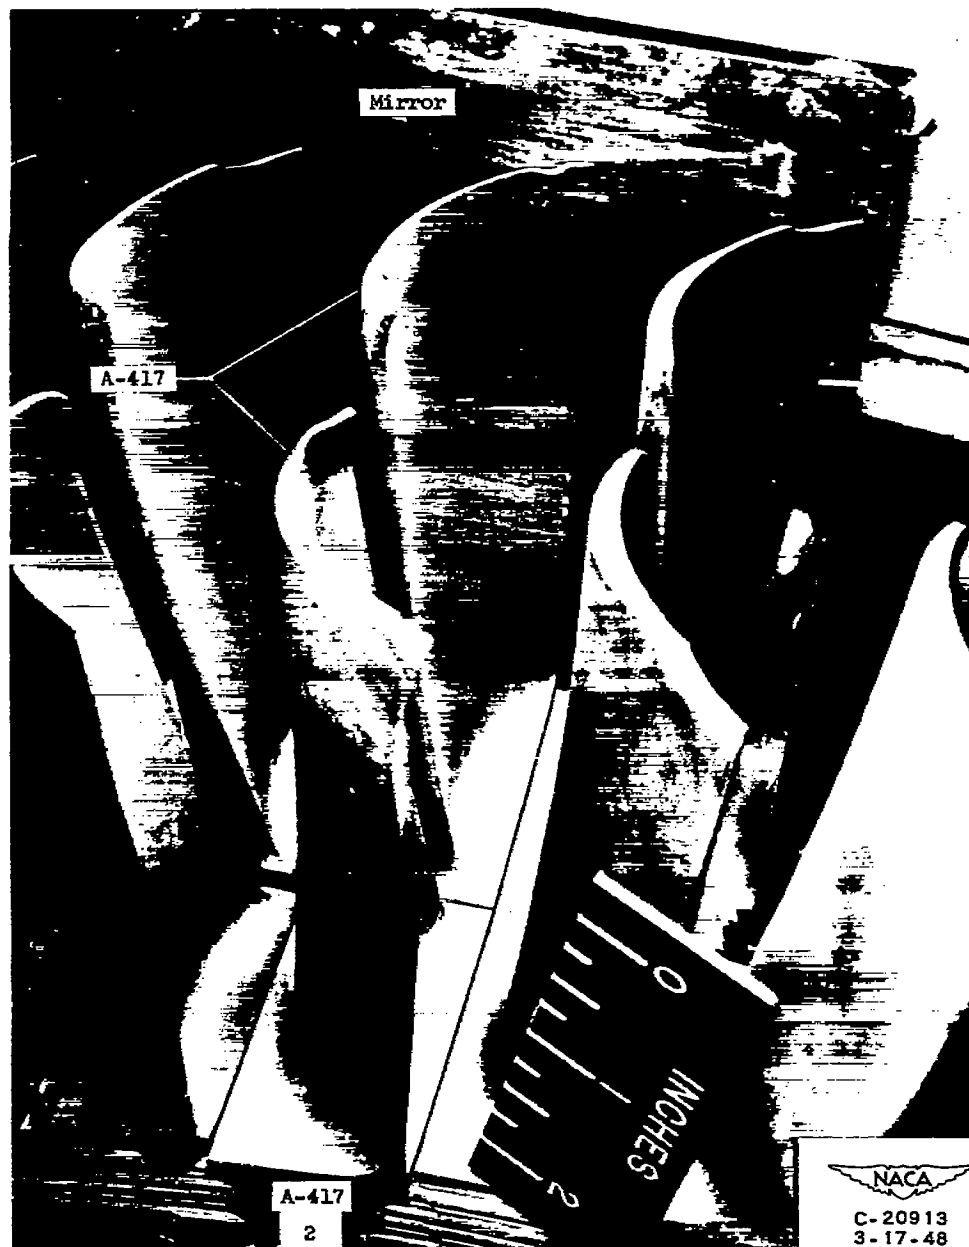
(a) Leading edge and mirror reflection of concave side.

Figure 6. - Turbine blade 2 after 100 engine operating cycles (33 hr, 20 min). Ceramic coating A-417.

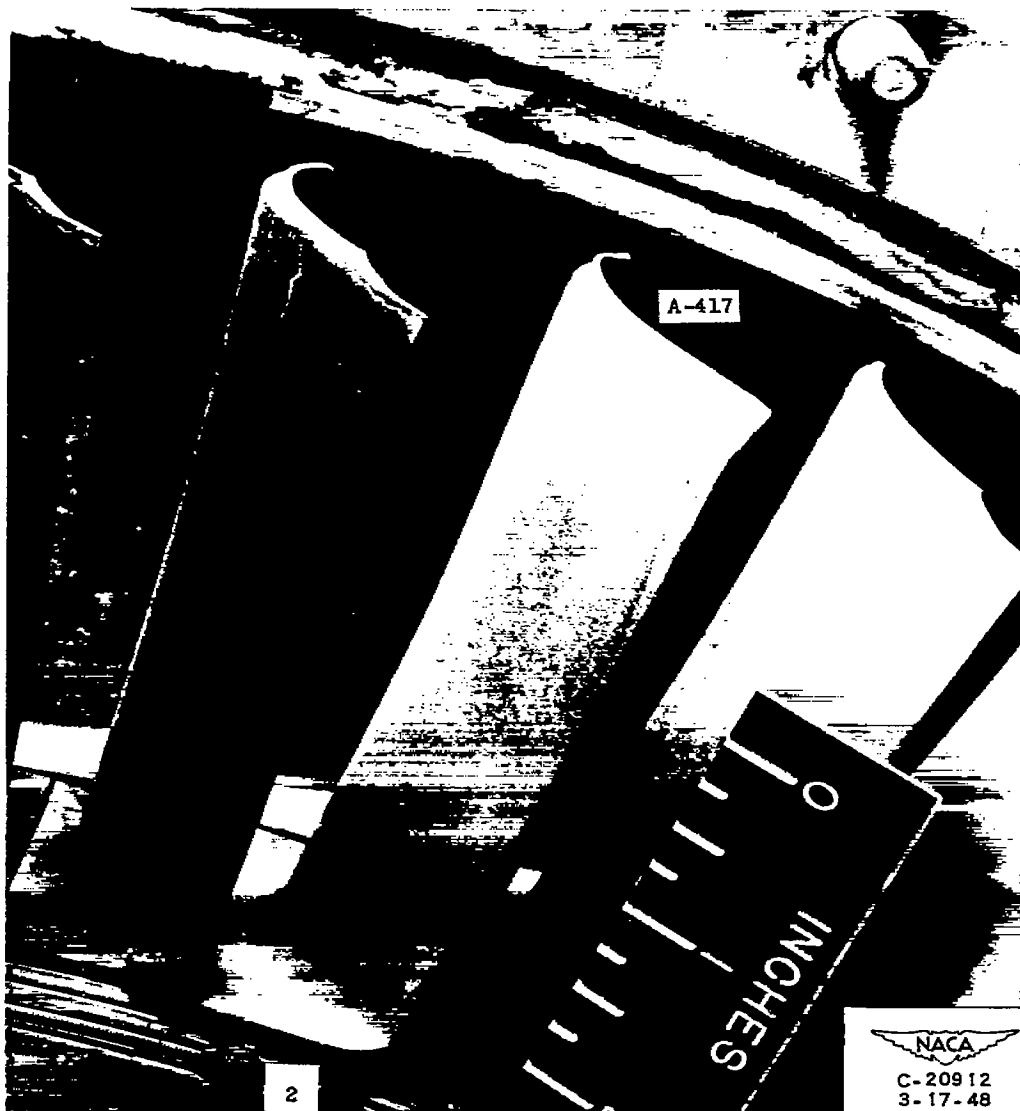
(b) Trailing edge and convex side.

Figure 6. - Concluded. Turbine blade 2 after 100 engine operating cycles (33 hr, 20 min).
Ceramic coating A-417.
