NACA TN 2039

TECHNICAL NOTE 2039

INVESTIGATION OF FRETTING CORROSION

BY MICROSCOPIC OBSERVATION

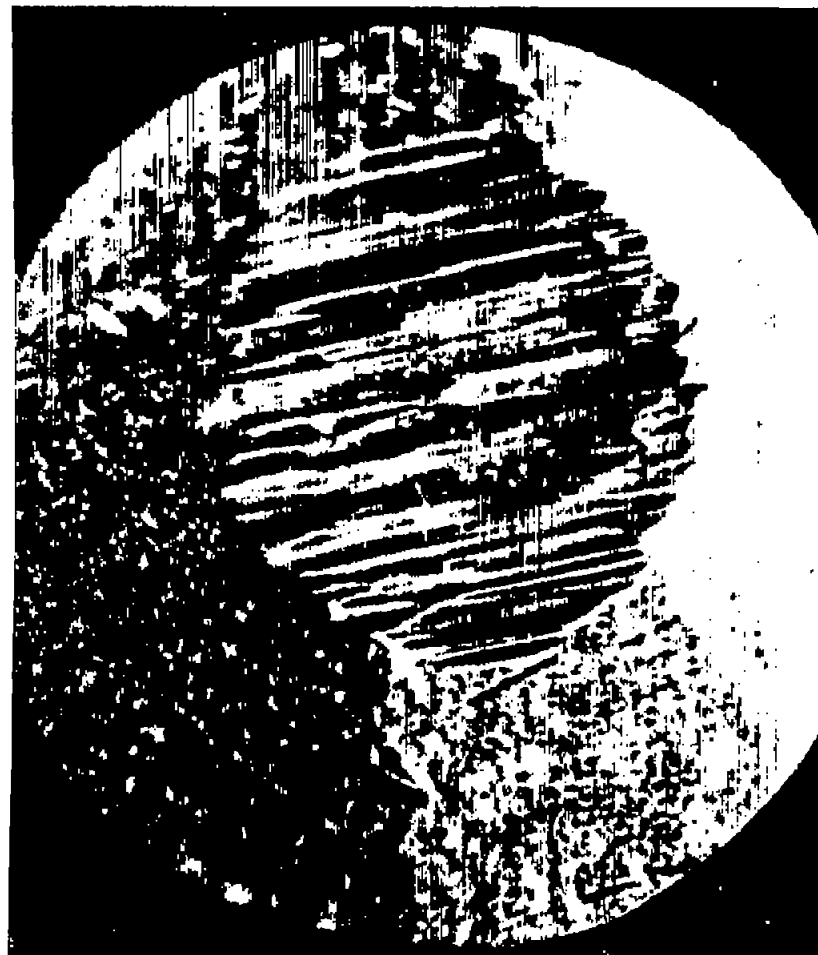
(a) Before cleaning.

(b) After cleaning.

Figure 4. - Photomicrographs showing fretting-corrosion area on chrome-alloy steel ball after 1800 cycles. X140.

After approximately 20,000 cycles, the action stabilized to a steady-growth condition with continued generation of material in the black spots surrounded by brown semifluid oxide and the formation of fine powder-like oxide. The black color of the active areas indicated the presence of finely divided iron; this indication was further confirmed by subsequent change to dark brown and then to rust brown. If the vibration was stopped, the trapped black material could be seen to gradually turn brown. Finely divided iron, ferrous oxide  $\text{FeO}$ , and ferrosferric oxide  $\text{Fe}_3\text{O}_4$  are black; whereas, ferric oxide  $\text{Fe}_2\text{O}_3$  and its hydrated form  $\text{Fe}_2\text{O}_3 \cdot \text{H}_2\text{O}$  are reddish. Because the fretting-corrosion debris of steel was identified by electron diffraction as  $\text{Fe}_2\text{O}_3 \cdot \text{H}_2\text{O}$ , the color changes that occurred show the progressive oxidation of the iron. Fretting corrosion is apparently initiated by the loosening, due to inherent adhesive forces, of extremely finely divided and apparently virgin material that is extruded and reacts with oxygen simultaneously. Examination of the ball after the experiment revealed a flat oxide-encrusted spot (fig. 4(a)), which on subsequent cleaning was revealed to be a clean abraded flat spot (fig. 4(b)). The sticky oxide on the glass was removed with difficulty but completely with acids and a striated, cracked area was revealed. The striations could not be brought into sharp focus with the microscope, indicating appreciable depth and irregularity (fig. 5(a)). If the action was continued for longer periods, the glass fragmented locally (fig. 5(b)) and was pitted.

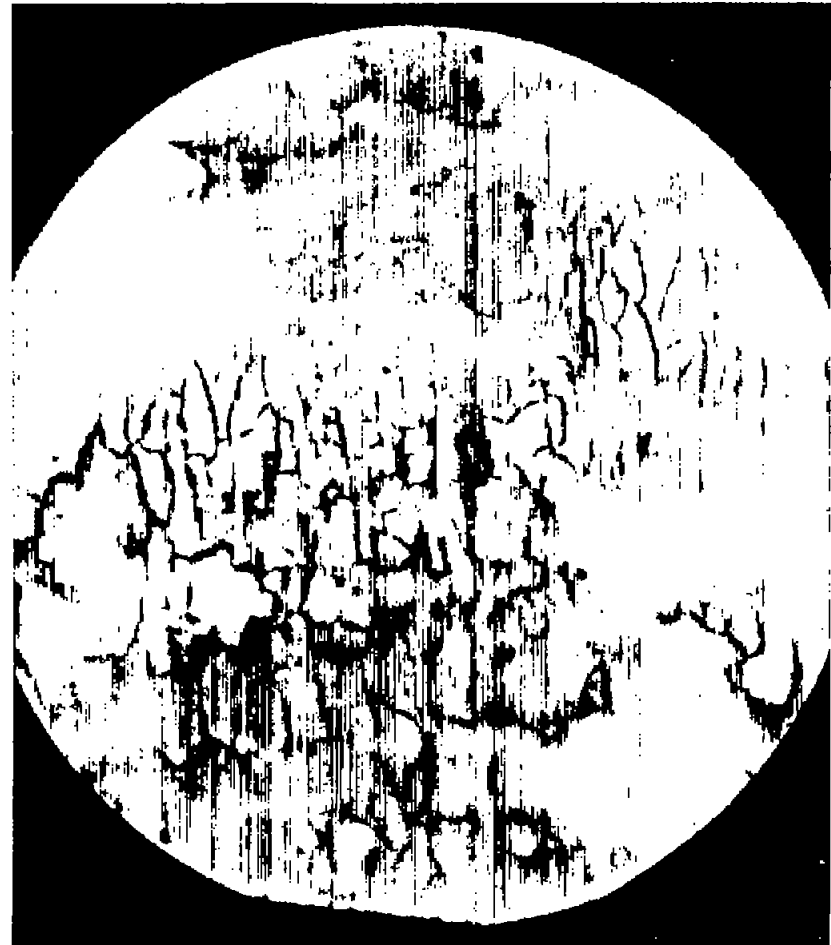
(a) Early stage, X140.

(b) Later stage, X300.

Figure 5. - Photomicrographs of cleaned wear area on glass showing cracking and striations produced by vibration of contacting chrome-alloy steel ball.

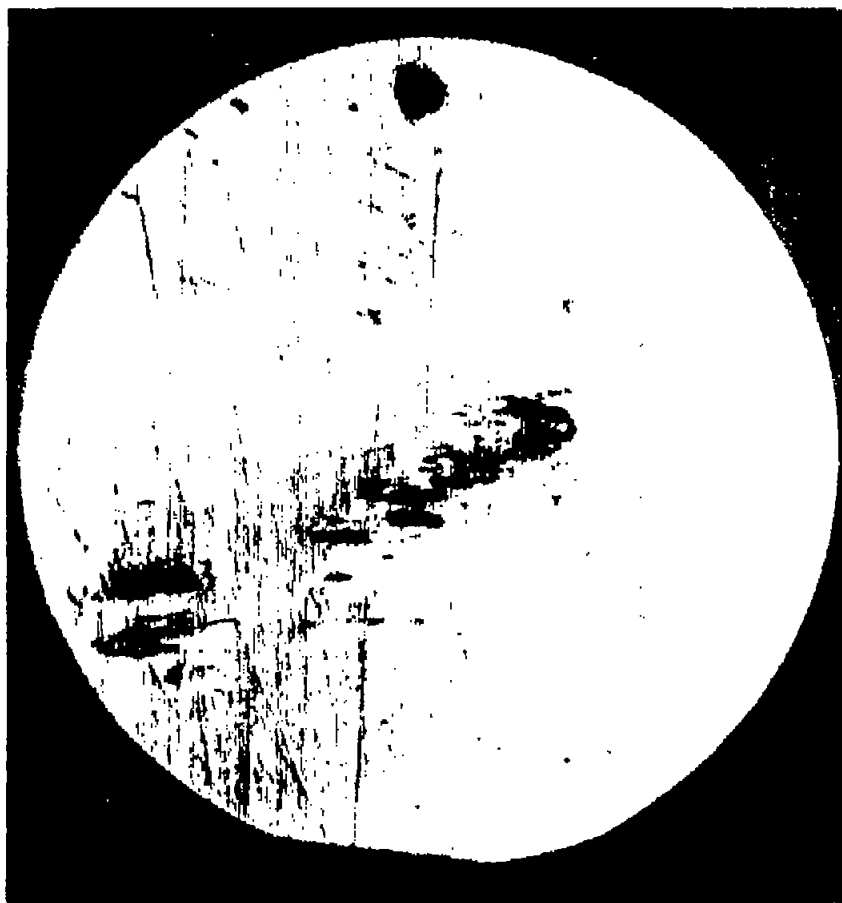
(a) Early stage.

(b) Advanced stage.

Figure 6. - Photomicrographs of convex platinum surface through glass slide showing wear and debris produced. X140.

Other metals vibrated against glass slides supported the explanation of fretting corrosion deduced from the steel-glass experiments. In one experiment, flame-cleaned platinum foil supported by a steel ball was vibrated in contact with clean glass. The generation of a black powder in the characteristic way was observed (fig. 6). This powder remained black and that which

adhered to the glass could be completely removed only by a 4-hour treatment in aqua regia. Color, acid resistance, and source indicate that the material was finely divided platinum (platinum black). Because platinum will not oxidize in air at any temperature, the theory that oxidation is the primary action of fretting corrosion is not supported.

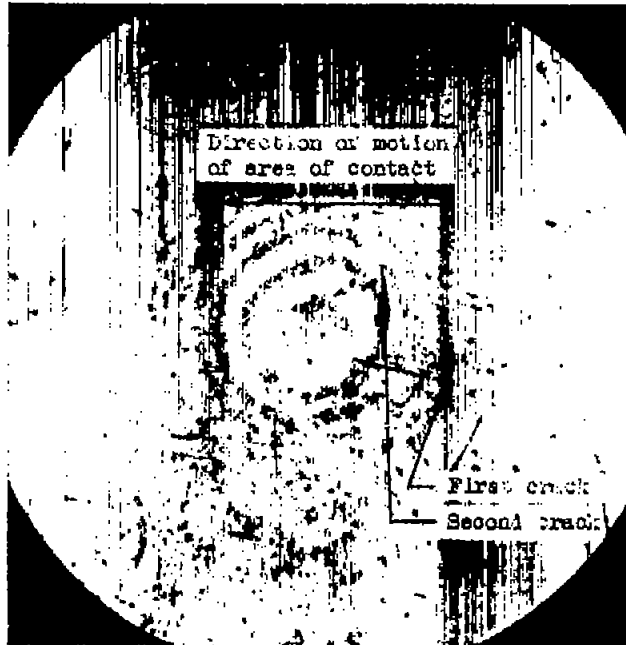
(a) View of glass slide showing amount of debris transferred from roughened steel.

(b) View of ball through glass showing second crack being formed in glass on trailing edge of area of contact.

(c) View of glass slide showing resultant row of cracks.

Figure 7. - Photomicrographs showing effects of one-half cycle vibration between glass and steel surface. X140.

Under the conditions of the 1/2-cycle experiment two types of action were observed. If the surface of the ball was previously roughened with 2/0 emery paper, the glass would polish the contact area on the ball and become smeared with the semi-fluid oxide, which would again tenaciously adhere to the glass. The amount of debris accumulated in three 1/2 cycles of vibration is shown in figure 7(a).
