FLIGHT-TEST MEASUREMENTS OF AILERON CONTROL SURFACE BEHAVIOUR AT SUPERCRITICAL MACH NUMBERS

Harvey H. Brown,
George A. Rathert, Jr., and
Lawrence A. Clousing

Ames Aeronautical Laboratory
Moffett Field, Calif.

April 23, 1947

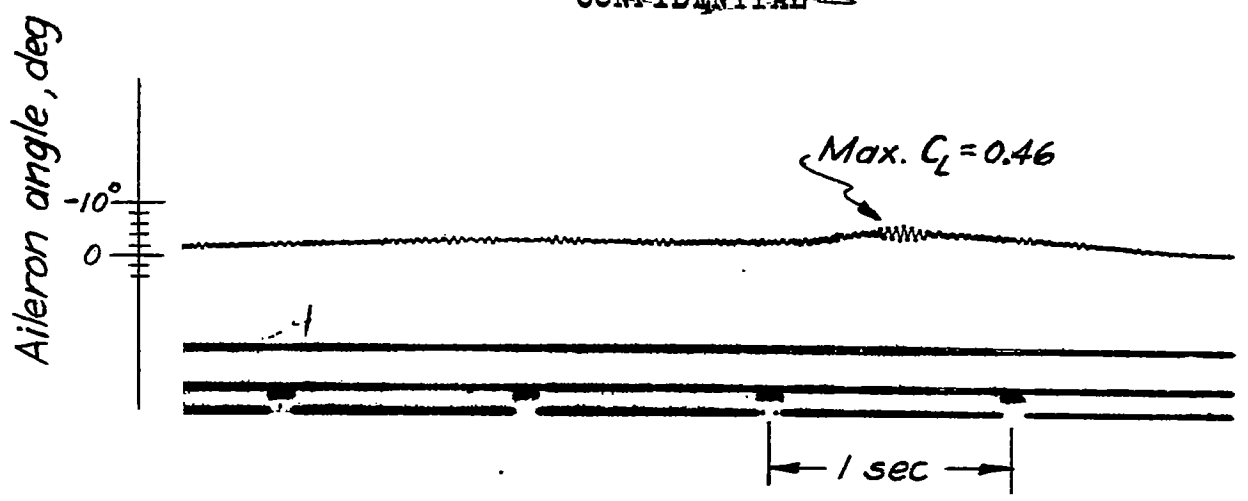
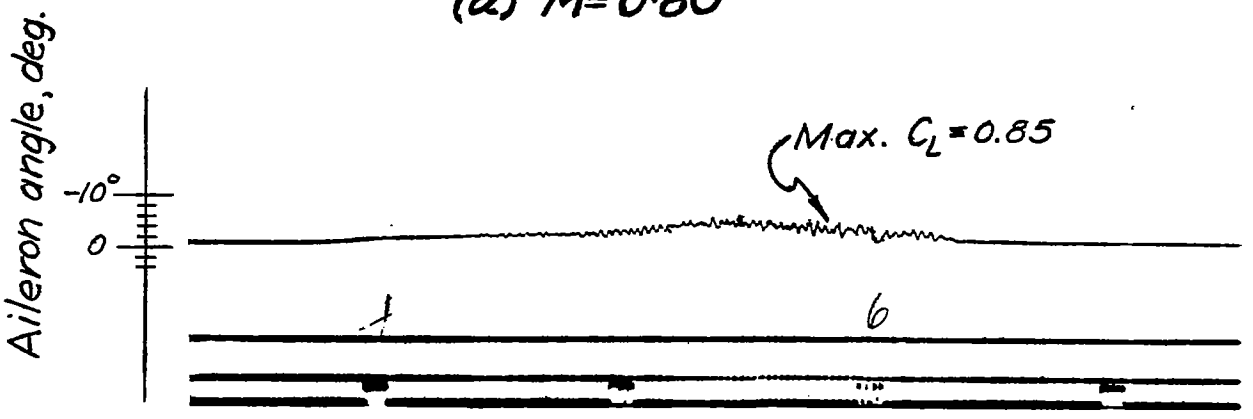
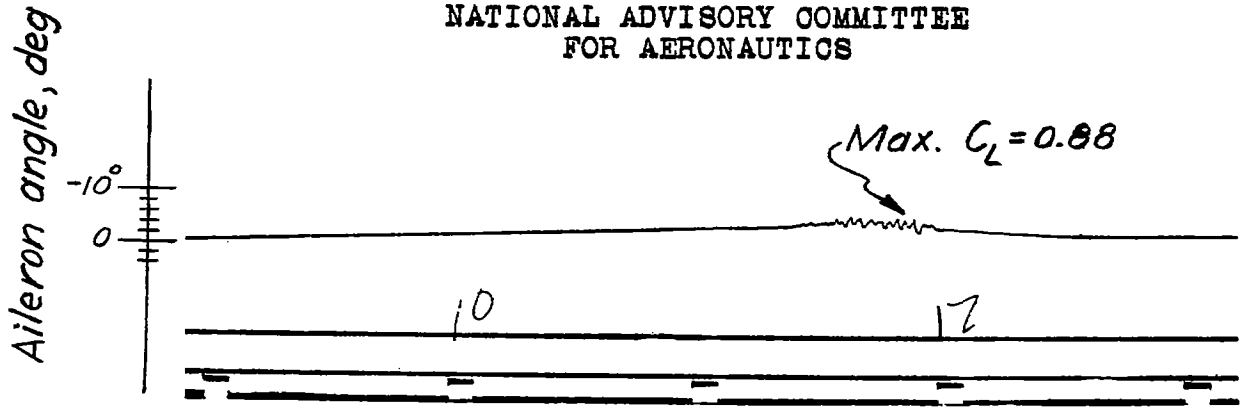
A low-amplitude aileron oscillation known as "buzz" was encountered several times during the flight tests. This buzz was spasmodic when first encountered but as the speed increased became a sustained oscillation with a frequency of approximately 28 cycles per second and a range of movement of about 2°. Typical aileron-angle records during buzz at various Mach numbers are reproduced in figure 9. Figure 10(a) is a photograph of the left aileron taken during the buzz, showing the blurred image of the trailing edge. The angle between the converging images of the upper edge of the black stripe across the aileron indicates the small amplitude of the motion.

Figure 9.- Typical records of right aileron position during pull-ups at various Mach numbers showing oscillations.

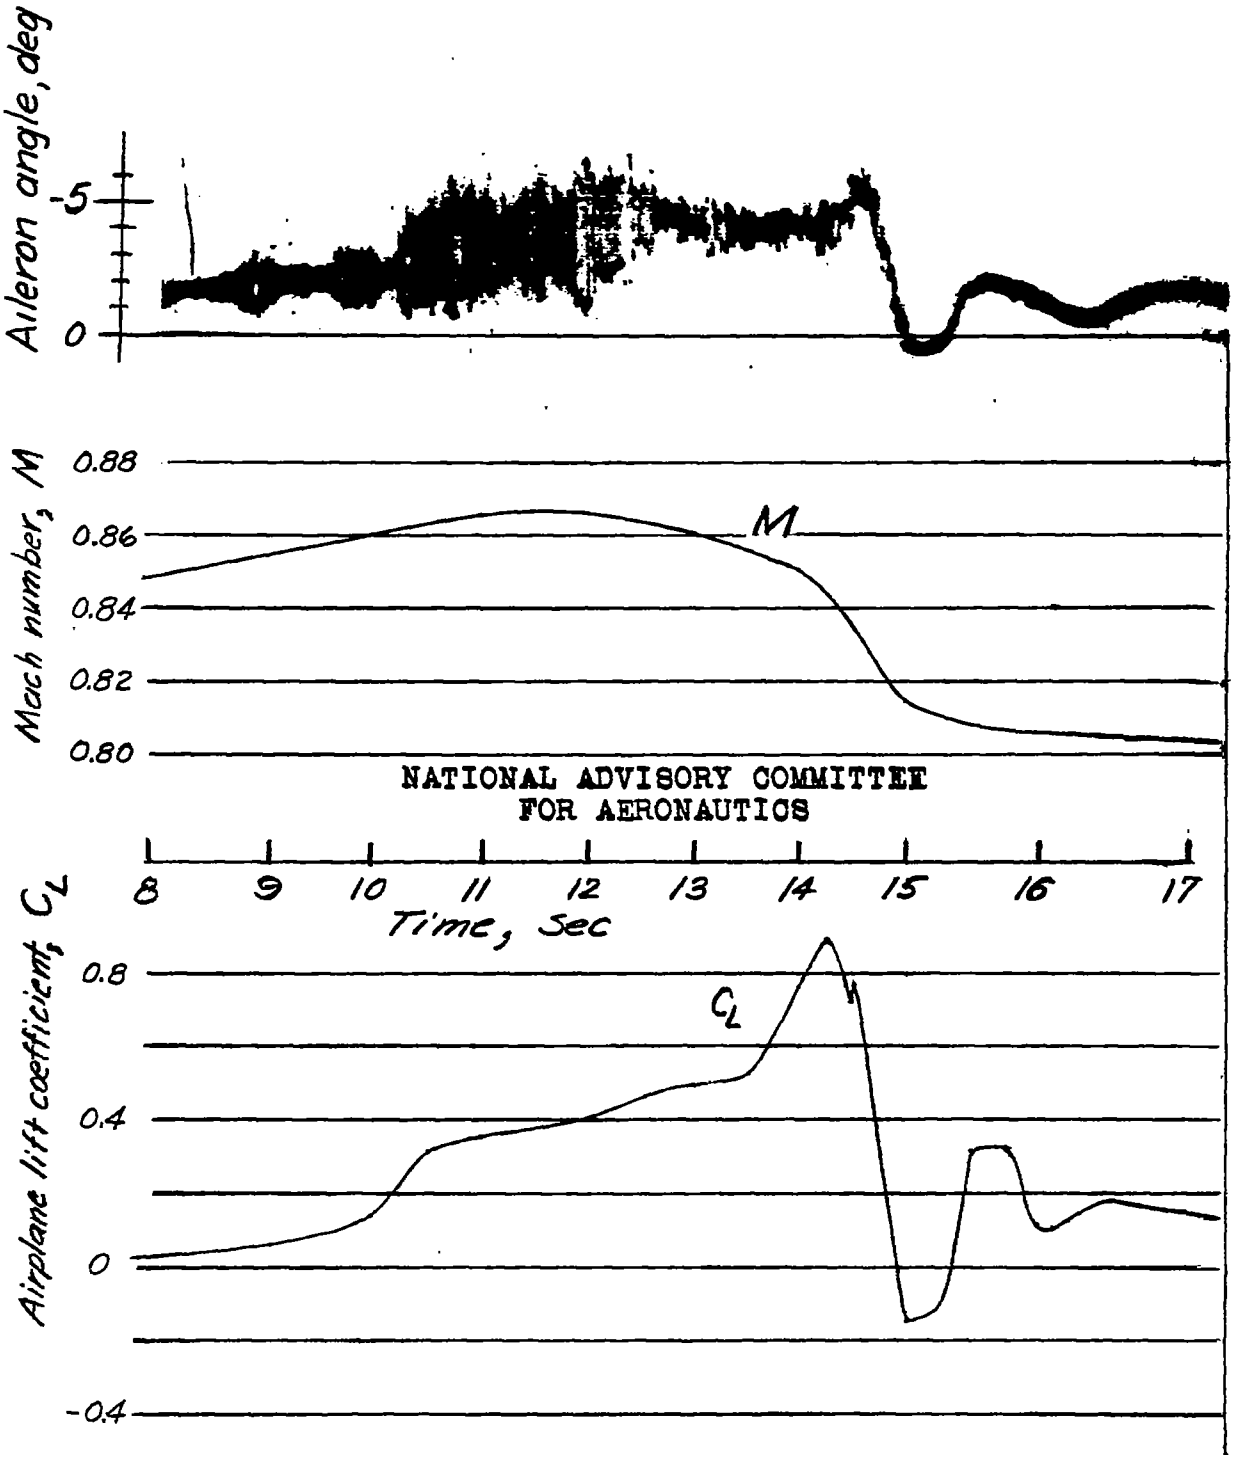
At a Mach number of about 0.85 during a high-speed dive the buzz developed into a much higher amplitude oscillation of sufficient violence to cause the trailing edge of the left aileron to buckle. Figure 11 is a time history of a portion of this dive and pull-out showing the record of the right aileron position. The records indicated that the aileron oscillated about an up-position over a range of about 6°, but the frequency could not be determined. The photograph of the left aileron during the flutter (fig. 10(b)) shows the considerable increase in the angle formed by the images of the edge of the black stripe. The double image of the star insignia indicates the amount of general buffeting accompanying the aileron oscillations.

Figure 11.- Records of right aileron upfloat and oscillations during dive recovery at Mach number and airplane lift coefficient shown.
