NATIONAL ADVISORY COMMITTEE FOR AERONAUTICS

TECHNICAL NOTE

No. 1432

CHANGES FOUND ON RUN-IN AND SCUFFED SURFACES OF STEEL

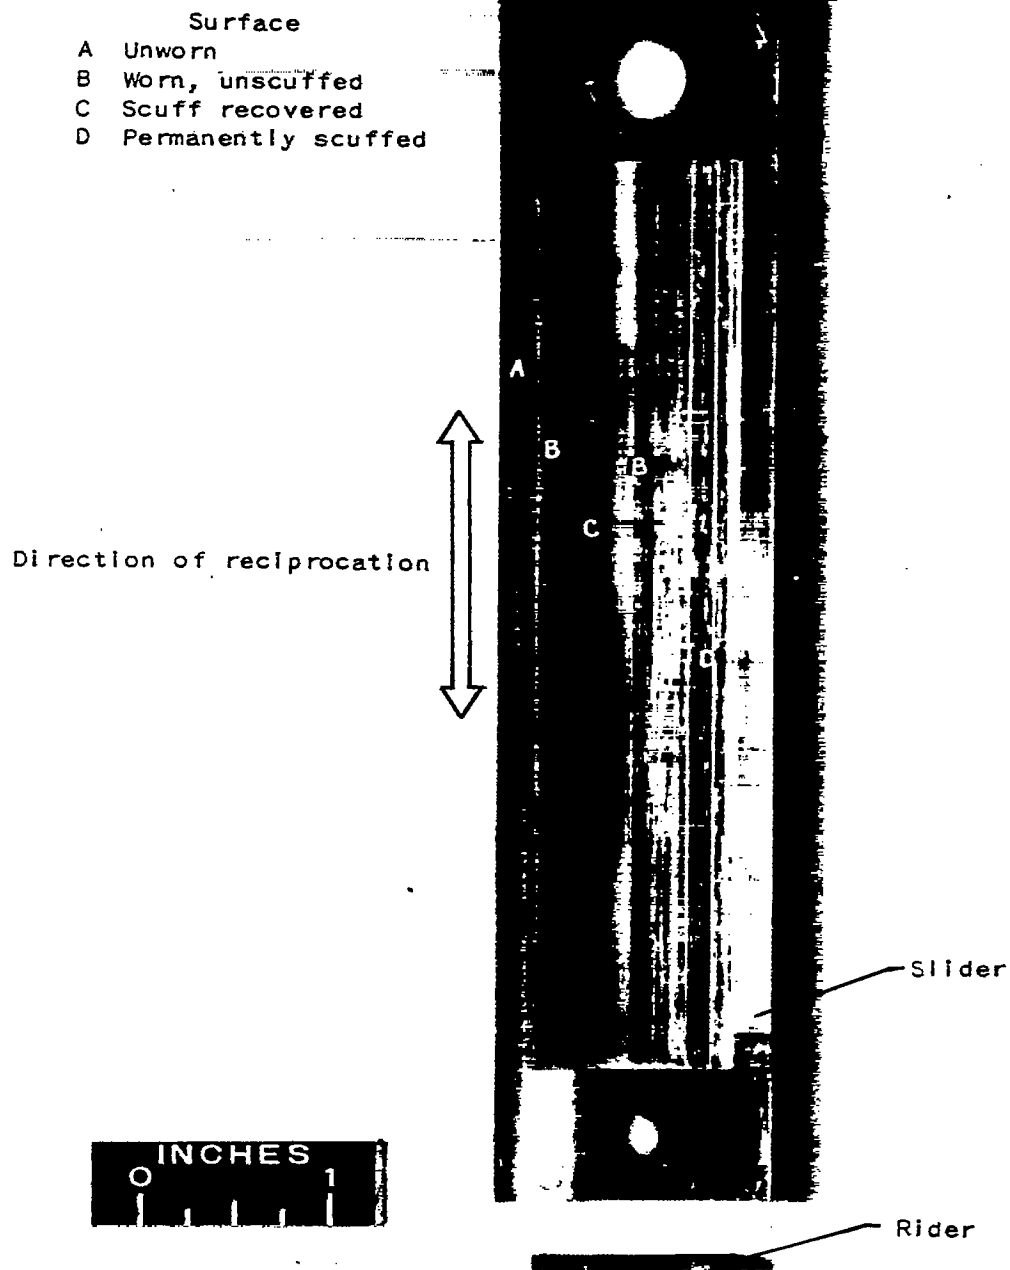
Figure 2. - Run-in and scuffed SAE 4140 steel slider and cast-iron rider
showing types of surface on slider.

With the slider-rider combination of SAE 4140 steel and cast iron, several conditions occurred successively in strips, or zones, on the steel slider (fig. 2). The production of more than one surface condition on one specimen was due to slightly imperfect mating of rider and slider. The manner in which surface changes progressed represents various steps in increased loading until failure. Identification of the surface conditions is as follows: A represents the original unworn (unrun) surface; B represents a worn but unscuffed surface; and C represents a surface that appeared to have entered an initial condition of scuff rather early in the experiment but to have almost immediately recovered. Close observation during the run revealed a momentary darkening in color and then a change to dark gray. The permanently scuffed surface that developed in several stages, which succeeded each other within a few seconds, is represented by D. The first stage of formation was indicated by the momentary appearance of a dark-brown or reddish-brown surface color, which changed to black. The change in color was accompanied by the appearance in the recovered oil of a sediment whose major constituent was analyzed as alpha ferric oxide $\alpha\text{-}Fe_2O_3$ by X-ray diffraction methods.

The appearance of bright spots and heavy scuff marks on the surface
accompanied by a sharp increase in temperature indicated permanent
scuff. It appears that because of the initial imperfect mating a
shifting of load took place, which led to variations and irregularities
in local load concentrations. Surface B may be considered to have
carried a large portion of the load during the mating procedure and
therefore to have been able to support the load as it was increased.
As the load was increased, surface C suddenly appeared. This
appearance occurred as a result, possibly, of slight warping as the
temperature rose and because surface C may have been insufficiently
mated at the time the load increased. As the load was further increased,
strip D appeared, possibly because of a combination of higher load
and further warping until the surface scuffed rapidly with so much
progressive damage that the scuff became extensive and permanent.

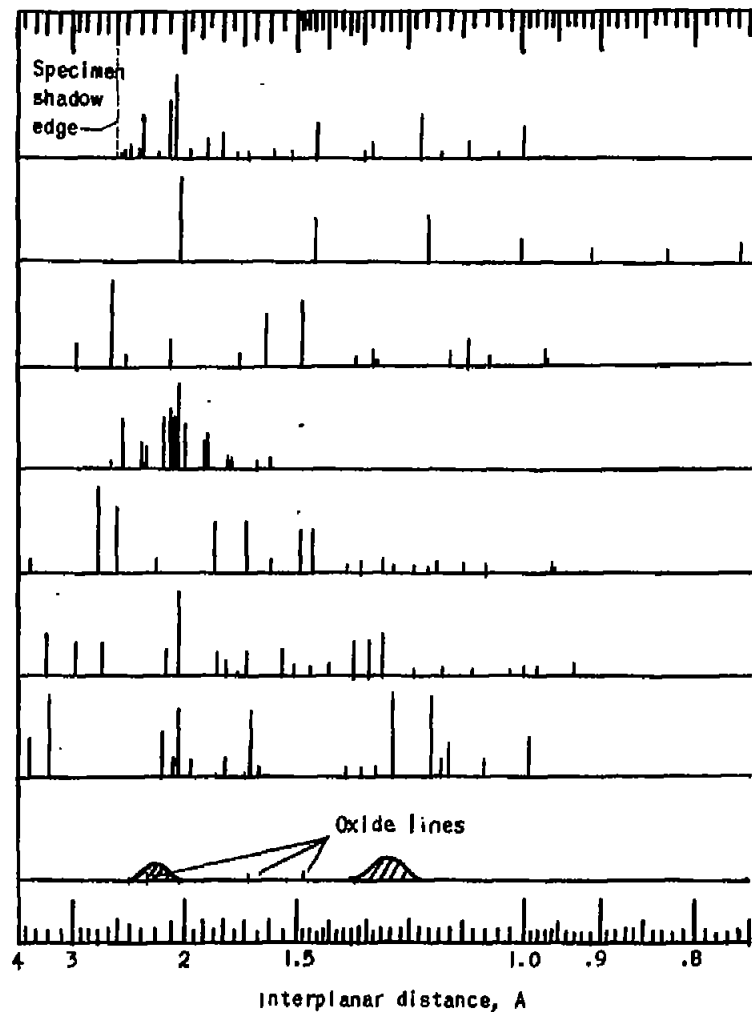
Figure 3. - Typical electron and X-ray diffraction patterns from surfaces of specimens of SAE 4140
steel slider and aircraft-engine cylinder barrel and standard X-ray diffraction patterns of materi-

Identification of alpha iron, α-Fe, ferrosoferric (ferrosic)
oxide, Fe_3O_4, and iron carbide, Fe_3C, in these surfaces was made
by X-ray diffraction. (See fig. 3.) (Whenever Fe_3O_4 is mentioned
herein, the possibility that it could also be γ-Fe_2O_3 should be
considered, because the two are indistinguishable by usual diffrac-
tion methods.) On all four surfaces (A, B, C, and D), Fe_3O_4 was
considered present and gave an apparent maximum diffraction intensity
for scuff-recovered and a decreased intensity for scuffed conditions
as judged from the number of lines and from the changes in visual
intensity. The identification of Fe_2O_3 on surfaces B, C, and D
was questionable. Iron carbide was identified on the scuffed sur-
face D and questionably identified on scuff-recovered surface C.
The intensities were greater for the scuffed than the scuff-recovered
surface. No Fe_3C was identified on the unscuffed surfaces.

The strength of the Fe_3O_4 diffraction pattern from the scuff-recovered steel and the strong evidence of the Fe_3C from the scuffed steel indicated that Fe_3O_4 can be associated with scuff resistance and that Fe_3C can be associated with scuff. Caution should be used, however, in basing such a comparison on the evidence in this investi-gation alone. Evidence for the association of different oxides with different surface conditions may be found in references 4 and 5. A specially prepared Fe_3O_4 surface was found to have excellent properties partly, at least, because it allowed rapid surface-profile break-in without subsequent high wear or scuffing. This oxide was desirable for an extremely fine and granular structure firmly rooted to the base material. It was not too tenacious to resist abrasion and broke down into a very fine polishing medium during rubbing (reference 4). Whenever in the preparation of the oxide surface the red Fe_2O_3 formed, unfavorable results were obtained. The red oxide was soft and nonadherent (reference 5).

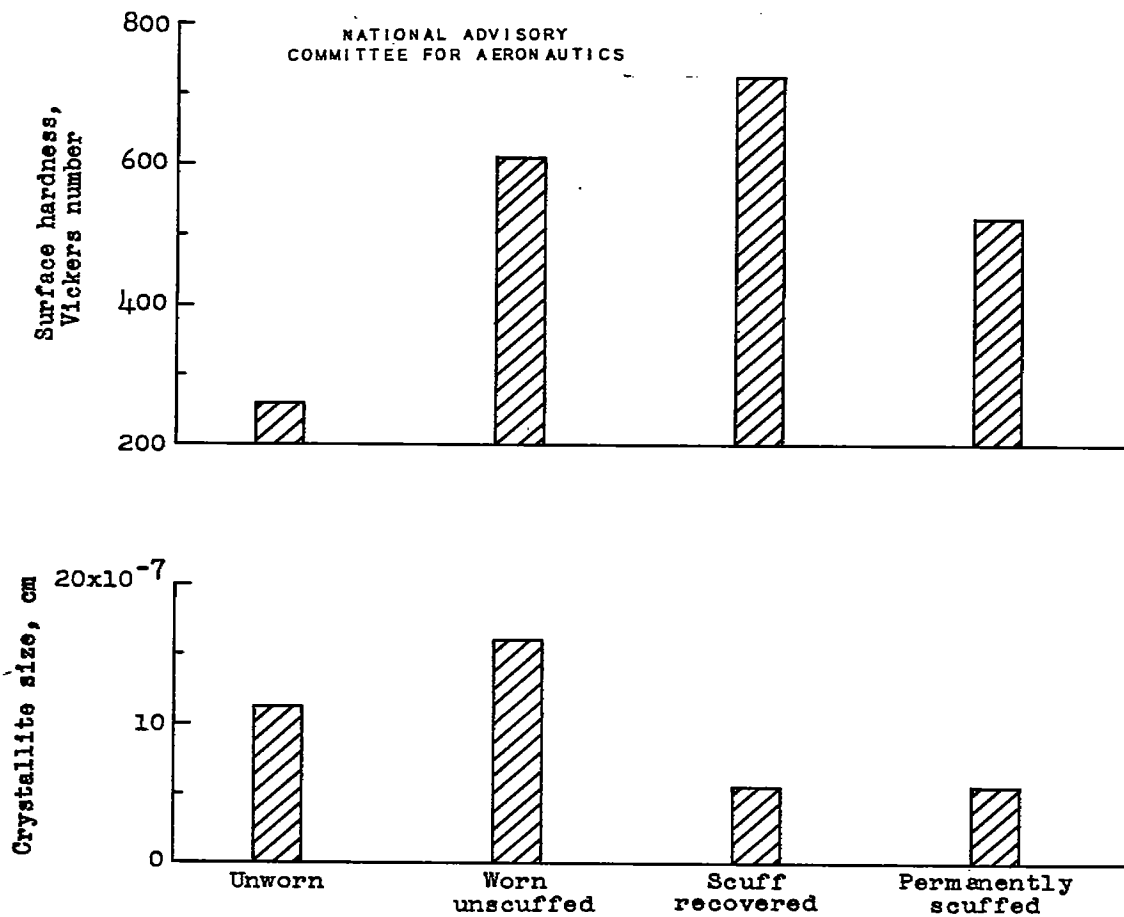
Figure 4. – Relation between surface changes and surface condition of SAE 4140 steel slider specimens.

The results of the determination of crystalite sizes are presented
in figure 4 and the X-ray patterns showing the differences are shown
in figure 5. The hardness of the four surface conditions is also
shown in figure 4; maximum hardness existed on the scuff-recovered
surface.

The crystallite size and the hardness of the wearing surfaces are
possibly as important as the chemical reactions. The relations between
crystallite size and hardness for steel, chrome, and cast iron vary as
shown in figures 4 and 9 and are somewhat complex. The average hard-
ness of the SAE 4140 steel for the scuffed and scuff-recovered surfaces
was greater than the average hardness of the unscuffed surfaces, and by
similar comparison the crystallite size was smaller. In conjunction
with these facts, the formation of the iron oxides and carbide on the
scuffed surfaces is noted. If the change in hardness is to be attributed

to one of the other changes, it seems to follow chemical reaction best. The occurrence of Fe_3O_4 in its greatest quantity coincided with the greatest hardness on the scuff-recovered surface, and a drop in hardness on the scuffed surface coincided with an indicated reduction in the amount of Fe_3O_4. This concept of a general relation of hardness to chemical reaction may or may not be weakened, however, by the occurrence of Fe_3C with the lower hardness of the permanently scuffed surface.

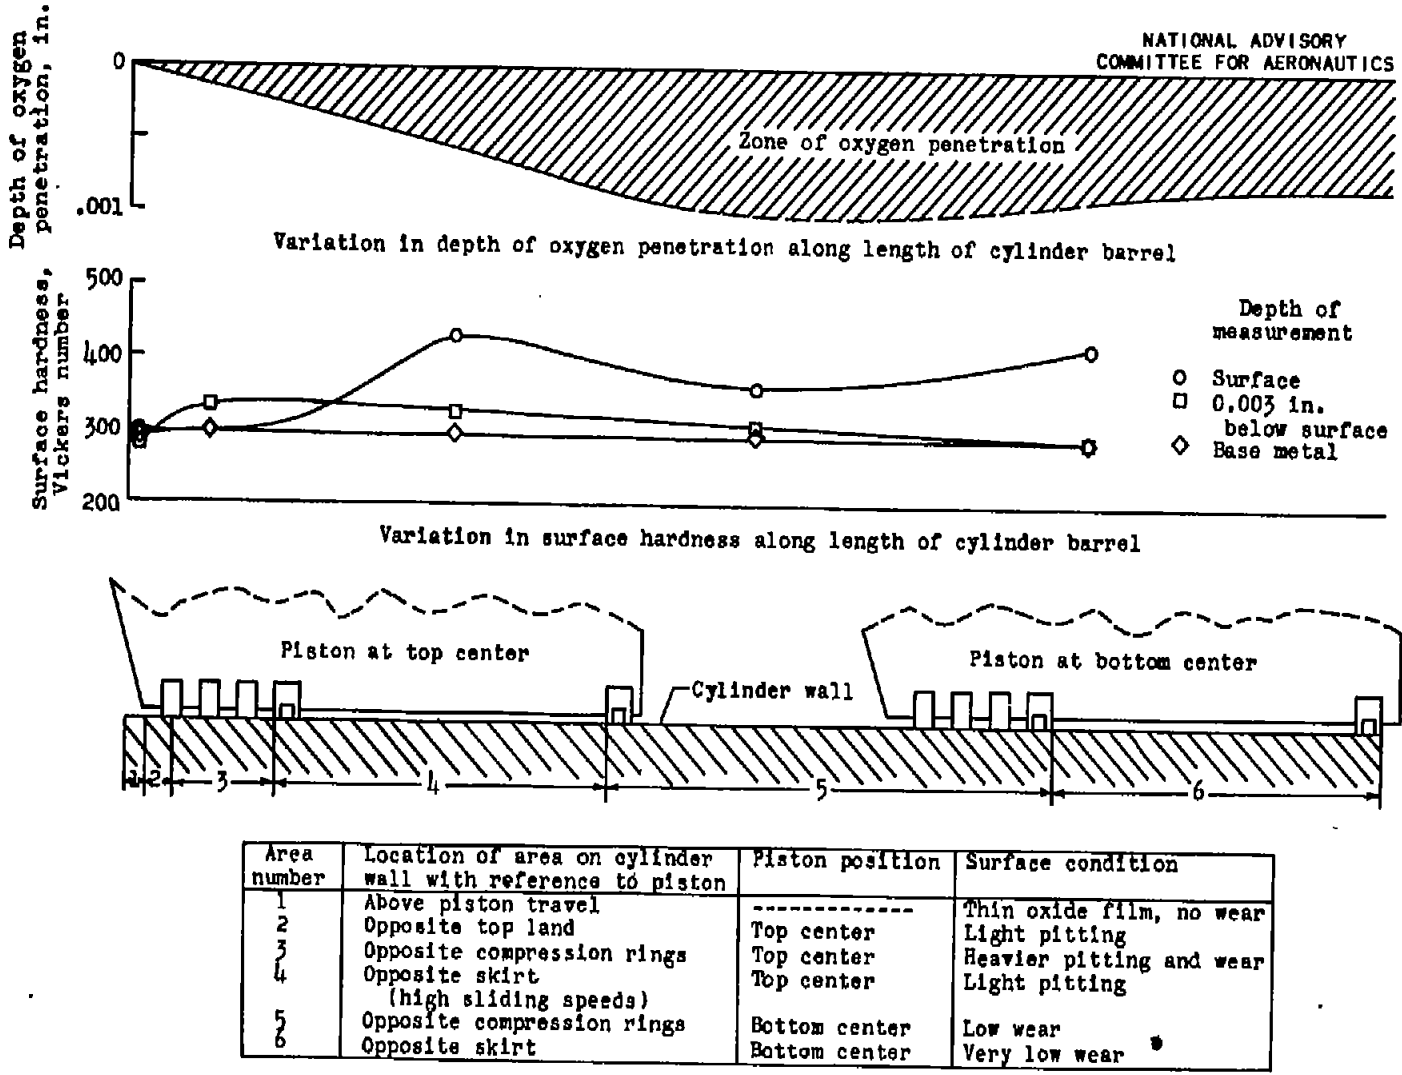
Figure 6. - Relations among surface condition, material hardness, and depth of oxygen penetration found on worn — unscuffed SAE 4140 steel aircraft-engine cylinder barrel.

This oxidation is shown in more detail in figure 6 and is labeled depth of oxygen penetration. Oxides existed beneath the surface of the metal everywhere the cylinder had been rubbed. The top 1/8 inch of the barrel was subjected to conditions within the combustion chamber but to no rubbing during engine operation because it was above the region of piston contact. In that top area the oxide existed only as a tenacious blue surface film under a carbon deposit. Variation in surface hardness is plotted on the same abscissa as the oxygen data in figure 6. These data were taken at five representative points along the barrel length.

The wear profile of engine cylinders showed a depression, or highest
wear, at the top of compression-ring travel. In this region of high
wear where less oxygen penetration seemed to have occurred, the surface
had been worn away almost as fast as the penetration progressed.
Farther down the length of the cylinder barrel the rate of oxygen
penetration seemed to exceed the rate of wear. As a result, oxides
formed within a relatively pliable matrix of steel and possibly gave
rise to a desirable surface, combining pliability with decreased
abrasion, which was continually renewed under the slow abrasion of
operating wear.

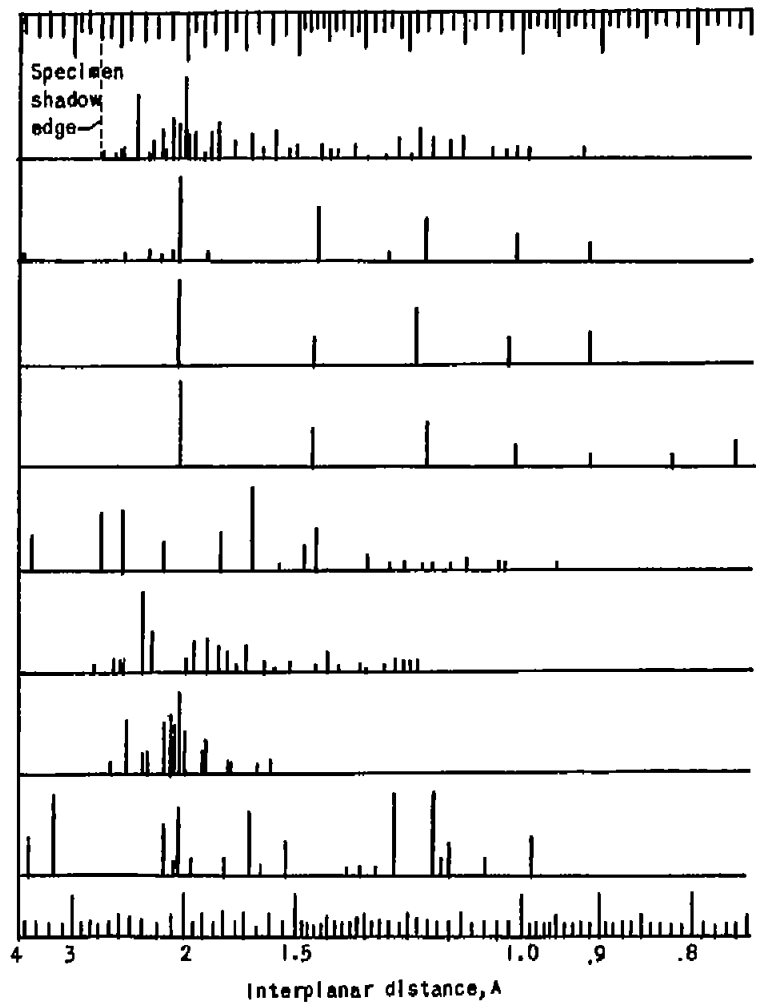
Figure 7. — Typical electron and X-ray diffraction patterns from specimens of chrome-plated cast-iron
and cast-iron riders and standard X-ray diffraction patterns of materials identified.

The chrome pattern predominates in all the surface X-ray diffraction patterns. Diffraction examination showed no presence of any chromic oxide, Cr_2O_3, on the unscuffed surface although this surface was expected to contain at least a small amount of this oxide, possibly in the amorphous condition. The compounds Cr_2O_3 and chromium carbide, Cr_3C_2, were easily identified on the burnished and scuffed surfaces. An X-ray diffraction pattern containing evidence for these compounds on the scuffed surface is shown in figure 7. A number of diffraction lines that stand alone and belong to none of the previously mentioned compounds may be parts of the diffraction patterns of Fe_2O_3, Fe_3O_4, the chromium nitrides, Cr_2N and CrN, the chromium carbides, $Cr_{23}C_6$, Cr_7C_3, and also Fe_3C (on the scuffed surfaces). No completely reliable quantitative trends could be found because of some difficulty in rating diffraction intensities, but the intensities of Cr_2O_3 and Cr_3C_2 appear to be greater on the scuffed than on the burnished portion. Under the microscope, patches of loose-appearing material with the color and texture of red and black iron oxides and giving dissolution reactions for iron were observed in the surface depressions, apparently as left after pickup from the mating steel slider.

Two cast-iron slider specimens were examined that had been subjected respectively to a normal and to a prolonged run-in procedure. The prolonged run-in increased load-carrying capacity. Figure 7 lists an X-ray diffraction pattern from an unrun surface showing the presence of α-Fe and one weak ring (interplanar spacing, 4.5 A) that coincides with the strongest line of the graphite pattern. A number of weak lines and one strong line coincide with all the strong lines of Fe_3C, and several unidentified lines also show. On all the surfaces, α-Fe was observed. The presence of graphite was more completely indicated on the worn and scuffed surfaces. Hardness values showed decrease as scuff condition was approached (fig. 9) and crystallite sizes increased.

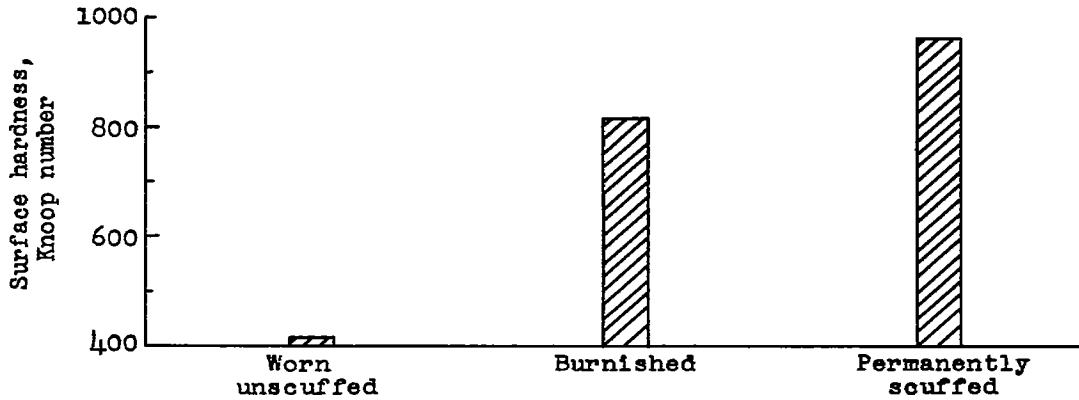
Figure 8. – Relation between hardness and surface condition of chrome-plated cast-iron rider specimen.

The variations in hardness among the different surface conditions are graphically illustrated in figure 8. Crystallite-size determination showed no large differences. A decrease in crystallite size was expected approaching scuff and such a trend was indicated, but the differences were within experimental error. The sizes were of the order of 14×10^{-7} centimeters.

The hardness of the chrome surface increased markedly for the burnished surface condition and corresponded with the formation of Cr_2O_3 and Cr_3C_2. The cast iron softened throughout the runs and the crystallite size increased. The end result at scuff was approximately the same for normal and for prolonged run-in. The prolonged-run-in surface, having the higher load at failure, showed slightly less softening than the normal-run-in surface. The more pronounced crystallite-size increase for the worn-unscuffed surface under prolonged run-in seems incompatible with increased resistance to failure. Chemical changes may account for the reversed trend for this material with respect to the over-all trend associated with the other materials, although such changes were undetectable in this case. Relatively, an opposite trend is indicated for any one of these materials when the change in hardness is compared with change in crystallite size between unscuffed and scuffed surface conditions.
