INVESTIGATION OF CERAMIC, GRAPHITE, AND CHROME-PLATED

GRAPHITE NOZZLES ON ROCKET ENGINE

By George R. Kinney and William G. Lidman

NATIONAL ADVISORY COMMITTEE
FOR AERONAUTICS
WASHINGTON
March 7, 1949

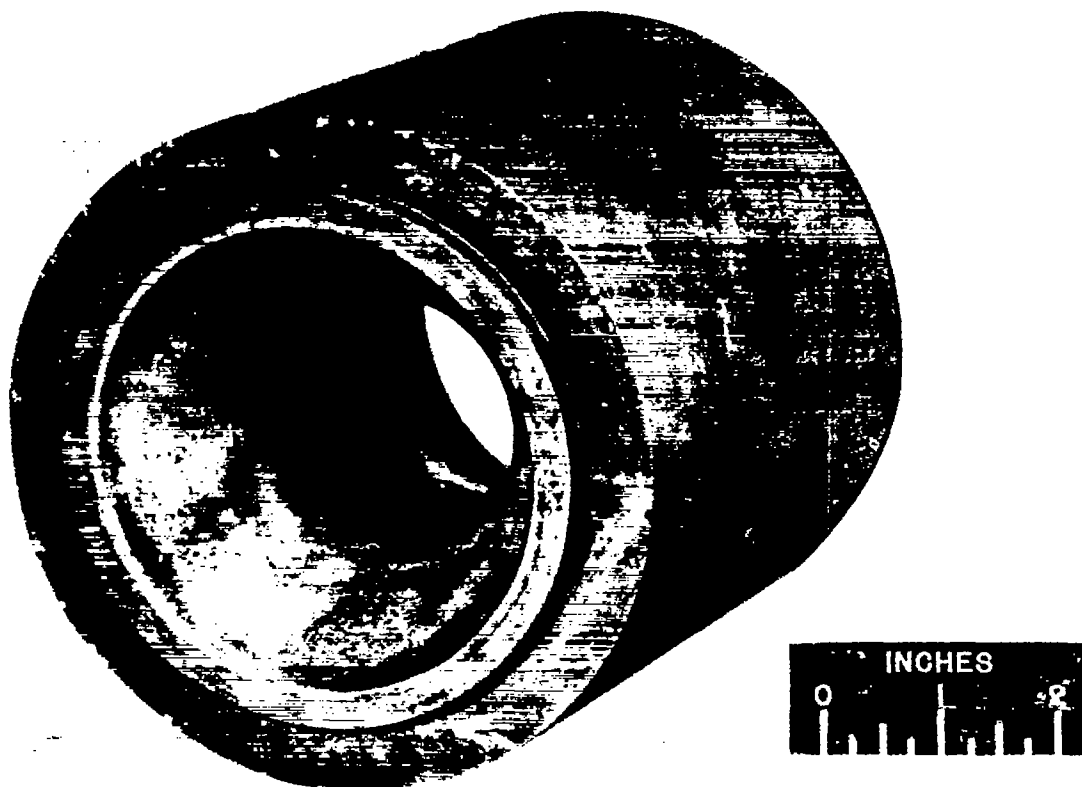
Figure 3. - Ceramic rocket nozzle (same nozzle used for run 1) after run 2 showing condition of convergent section. Additional operation, 10 seconds; near stoichiometric mixture ratio; estimated gas temperature, 2400° F.

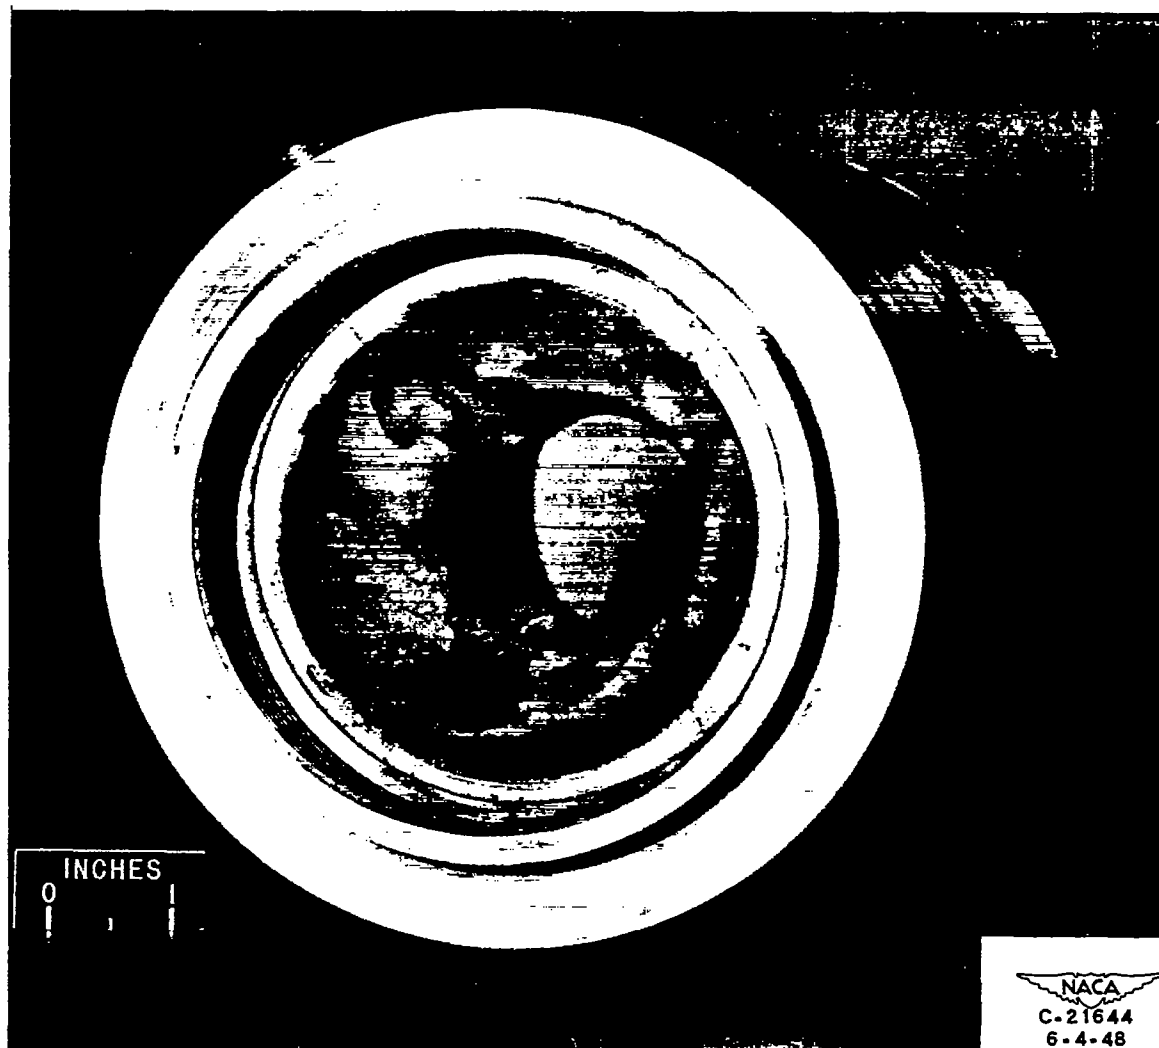
Graphite nozzles. - The graphite nozzle without surface plating
is shown in figure 4 after run 3 (17-sec operation, near stoichio-
metric mixture ratio, estimated gas temperature of 2400° F). The
nozzle cracked into four pieces of nearly equal size and erosion
at the cracks is considerable. The surface of the graphite shows
signs of oxidation and erosion in other regions, especially in the
convergent section. The erosion observed near the nozzle entrance
between cracks is probably caused by an excess of oxygen at those
places, whereas this excess of oxygen has apparently disappeared at
the throat. A local excess of oxygen could result from incomplete
mixing and combustion in the combustion chamber.

The cracking of the graphite during runs 3 and 5 is attributed
to the use of extruded graphite. As the result of the extrusion
process, the final graphite product is non-homogeneous and tends to
be striated. These striae would cause stresses in the graphite that
would in turn cause cracking and fracture when the graphite is sub-
jected to additional stresses. The use of molded graphite will
eliminate initial stresses in the material.

Figure 4. - Graphite rocket nozzle without surface plating after run 3 showing surface
condition of convergent section. Operation, 17 seconds; near stoichiometric mixture;

estimated gas temperature, 2400° F.

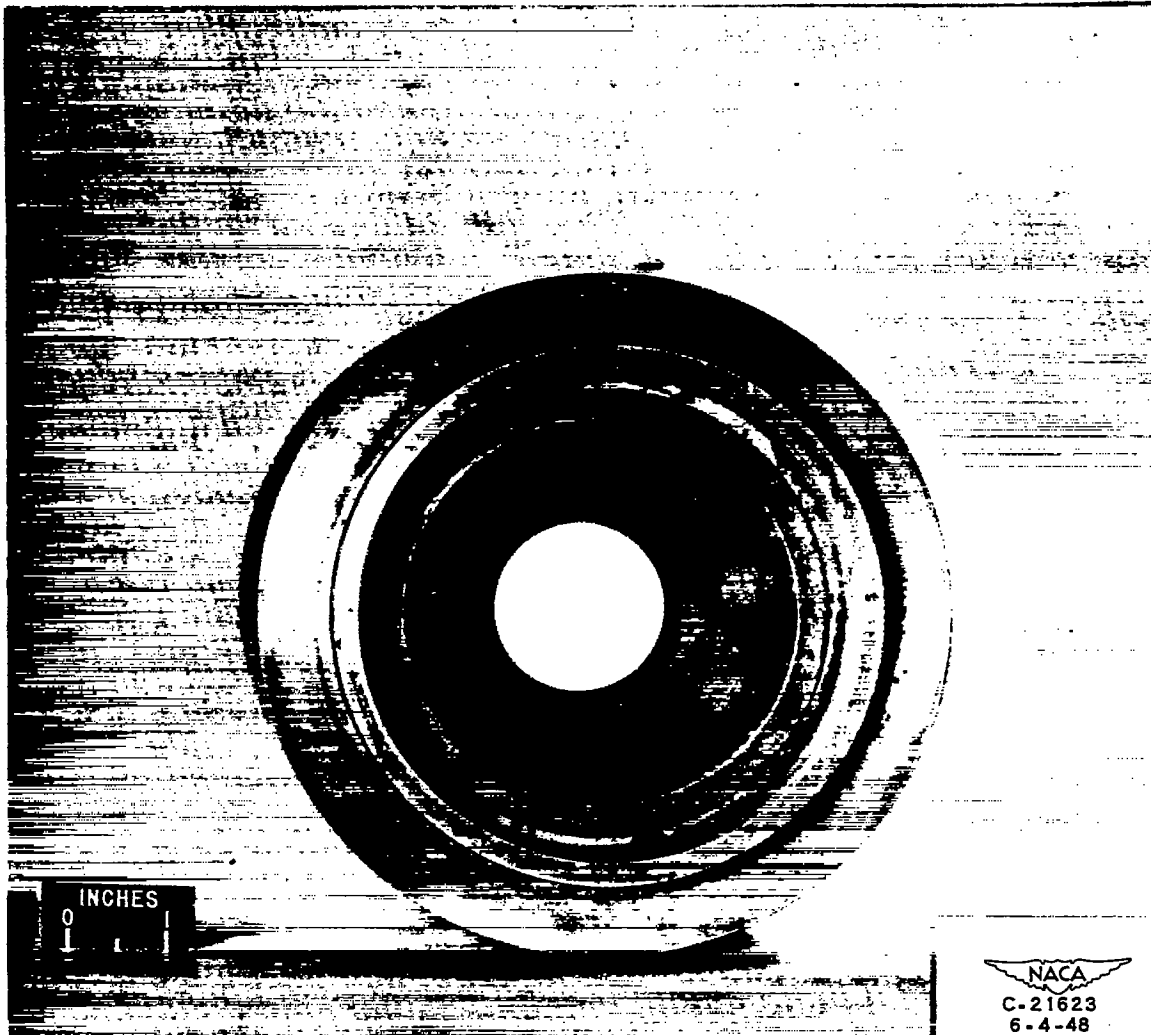
The graphite nozzle with chrome-plated internal surface, which
was used for run 5 (17-sec operation, near stoichiometric mixture
ratio, estimated gas temperature of 2400° F), is shown in figure 6.
The nozzle cracked at three places and was held in shape by the
metal housing. The chrome-plated surface was slightly pitted but
protected the graphite from oxidation and erosion. The chrome
plating was less pitted on this nozzle after a more severe operation
than it was on the nozzle used in run 4.. The nozzle used for run 5
probably had a better plating than the nozzle used for run 4.

Figure 6. - Chrome-plated graphite rocket nozzle after run 5 and removal of combustion deposit from convergent section. Operation, 17 seconds; near stoichiometric mixture ratio; estimated gas temperature, 2400° F.
