TECHNICAL NOTE

No. 1235

AN INVESTIGATION OF A THERMAL ICE-PREVENTION SYSTEM FOR A  
CARGO AIRPLANE. VIII - METALLURGICAL EXAMINATION OF THE  
WING LEADING-EDGE STRUCTURE AFTER 225 HOURS OF FLIGHT  
OPERATION OF THE THERMAL SYSTEM

April 1947

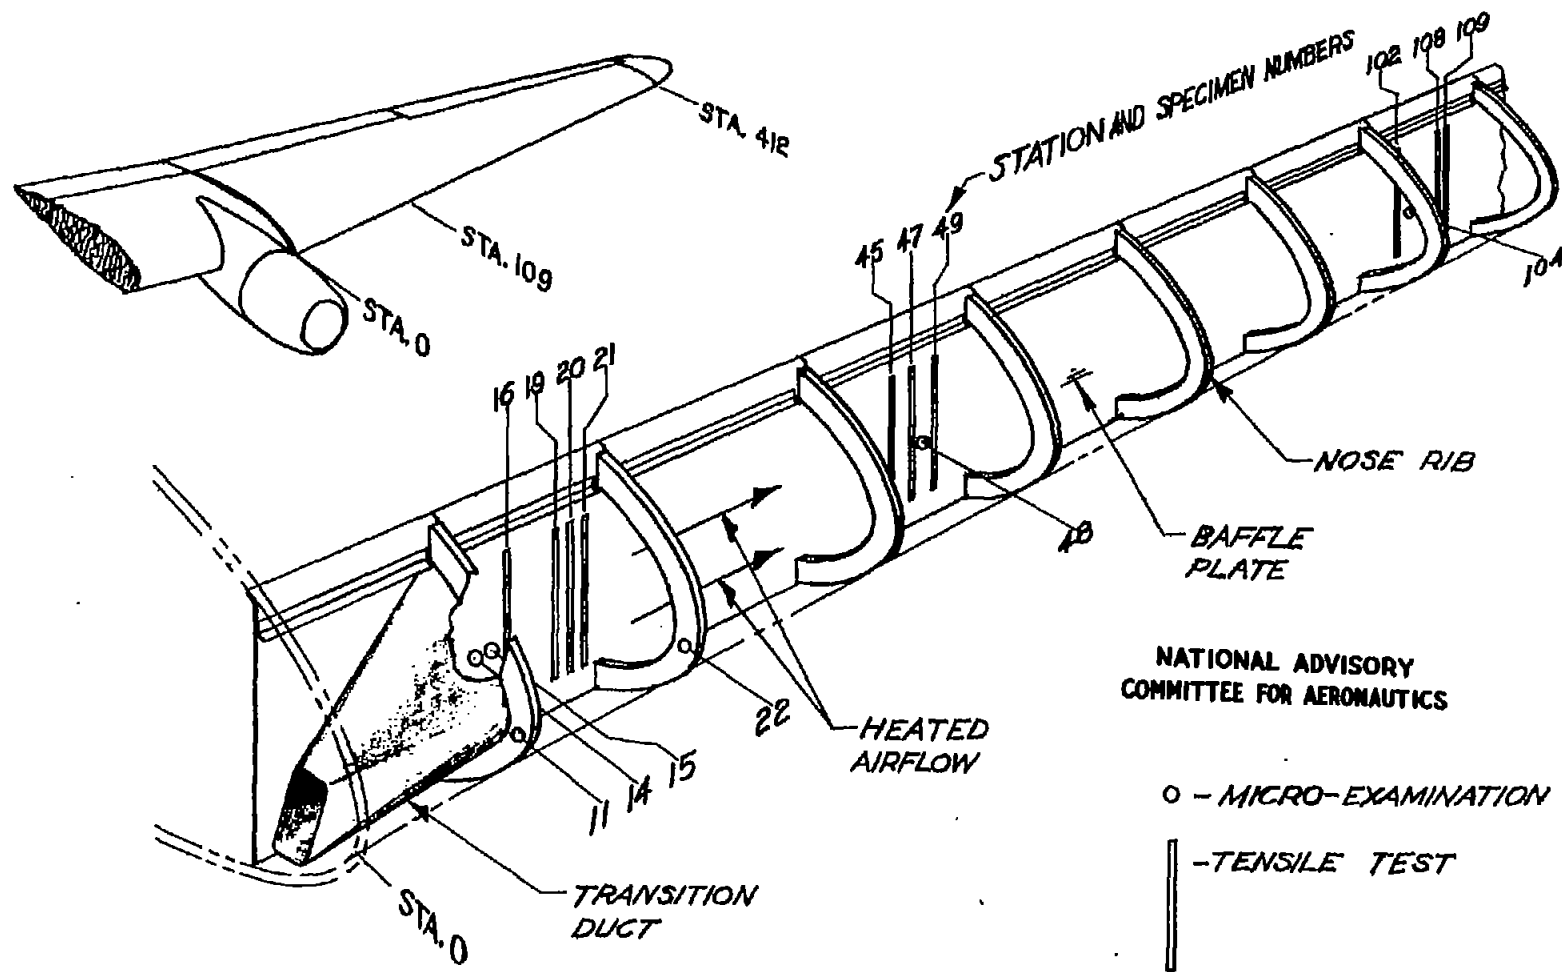
NOTE: SPECIMEN FROM LEADING EDGE OUTER SKIN TAKEN AT STATION 11 NOT SHOWN.

FIGURE 2.- LEADING EDGE OF THE LEFT WING OUTER PANEL SHOWING LOCATION OF SPECIMENS TAKEN FOR MICRO-EXAMINATION AND TENSILE TESTS, C-46 AIRPLANE.

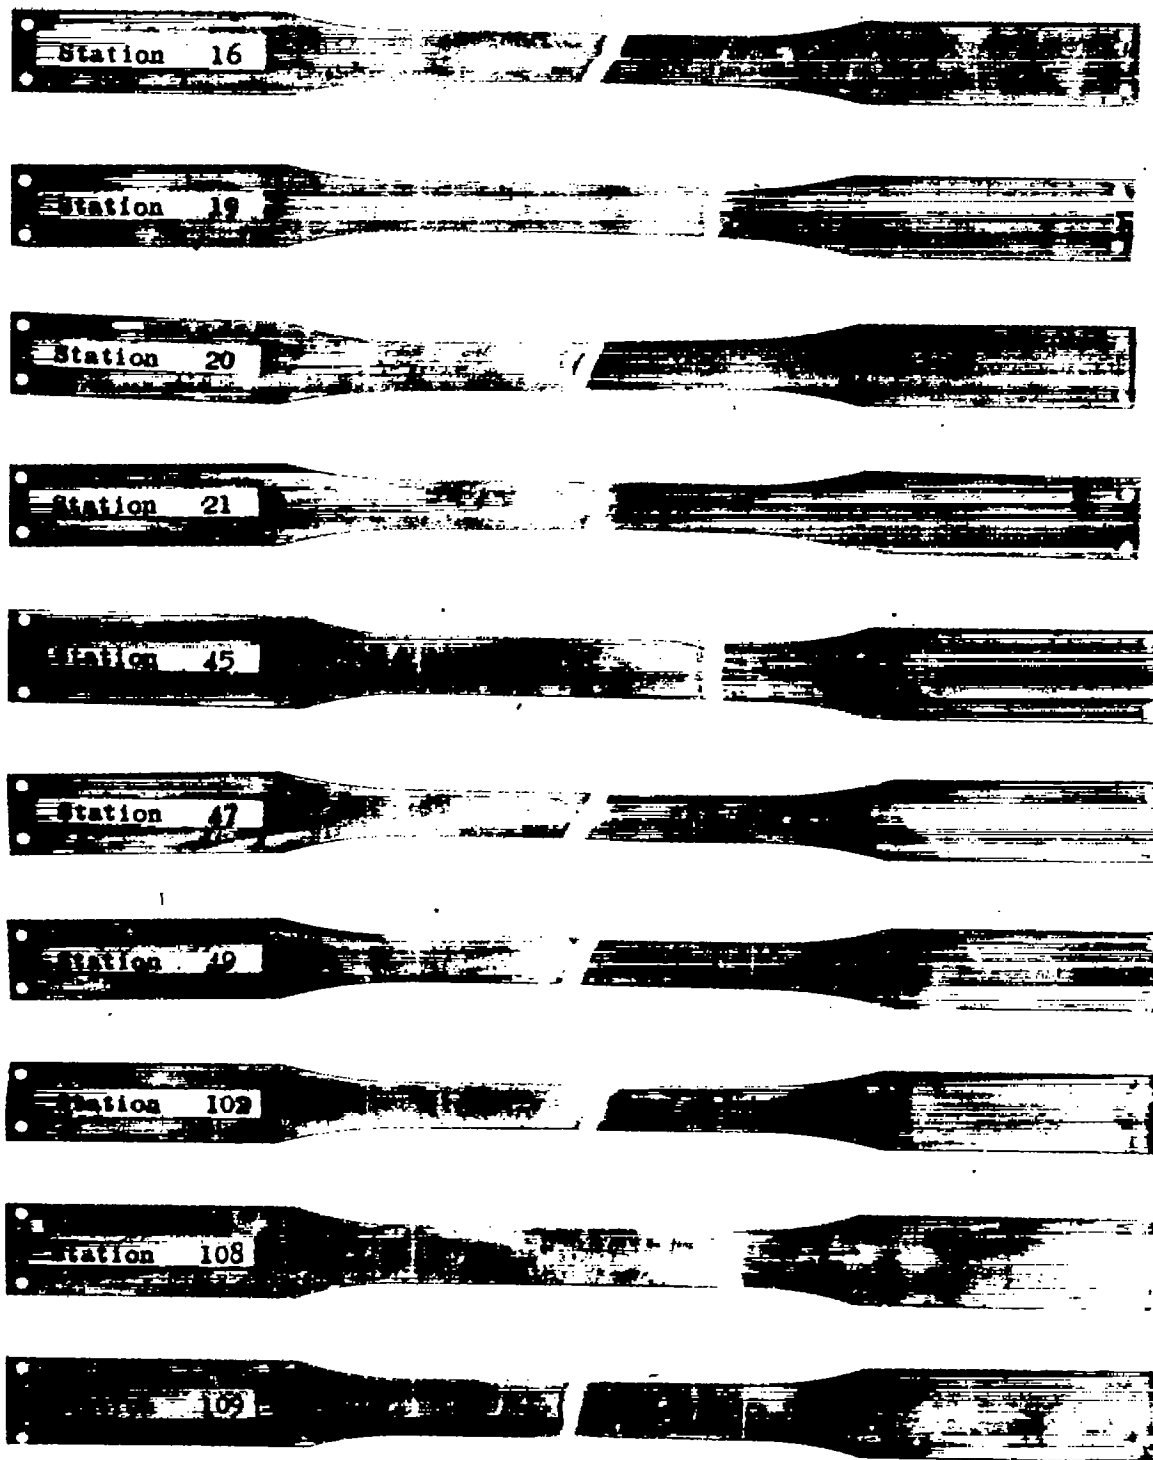
Figure 11.- Alclad 24S-T tensile specimens, taken from the baffle plate of the C-46 airplane wing thermal system, after fracture.
