MINISTRY OF TECHNOLOGY

AERONAUTICAL RESEARCH COUNCIL

Civil Aircraft Airworthiness
Data-Recording Programme.
Special Events Relating
to Handling and Control
(January 1963 to February 1966)

CAADRP Special Events Working Party

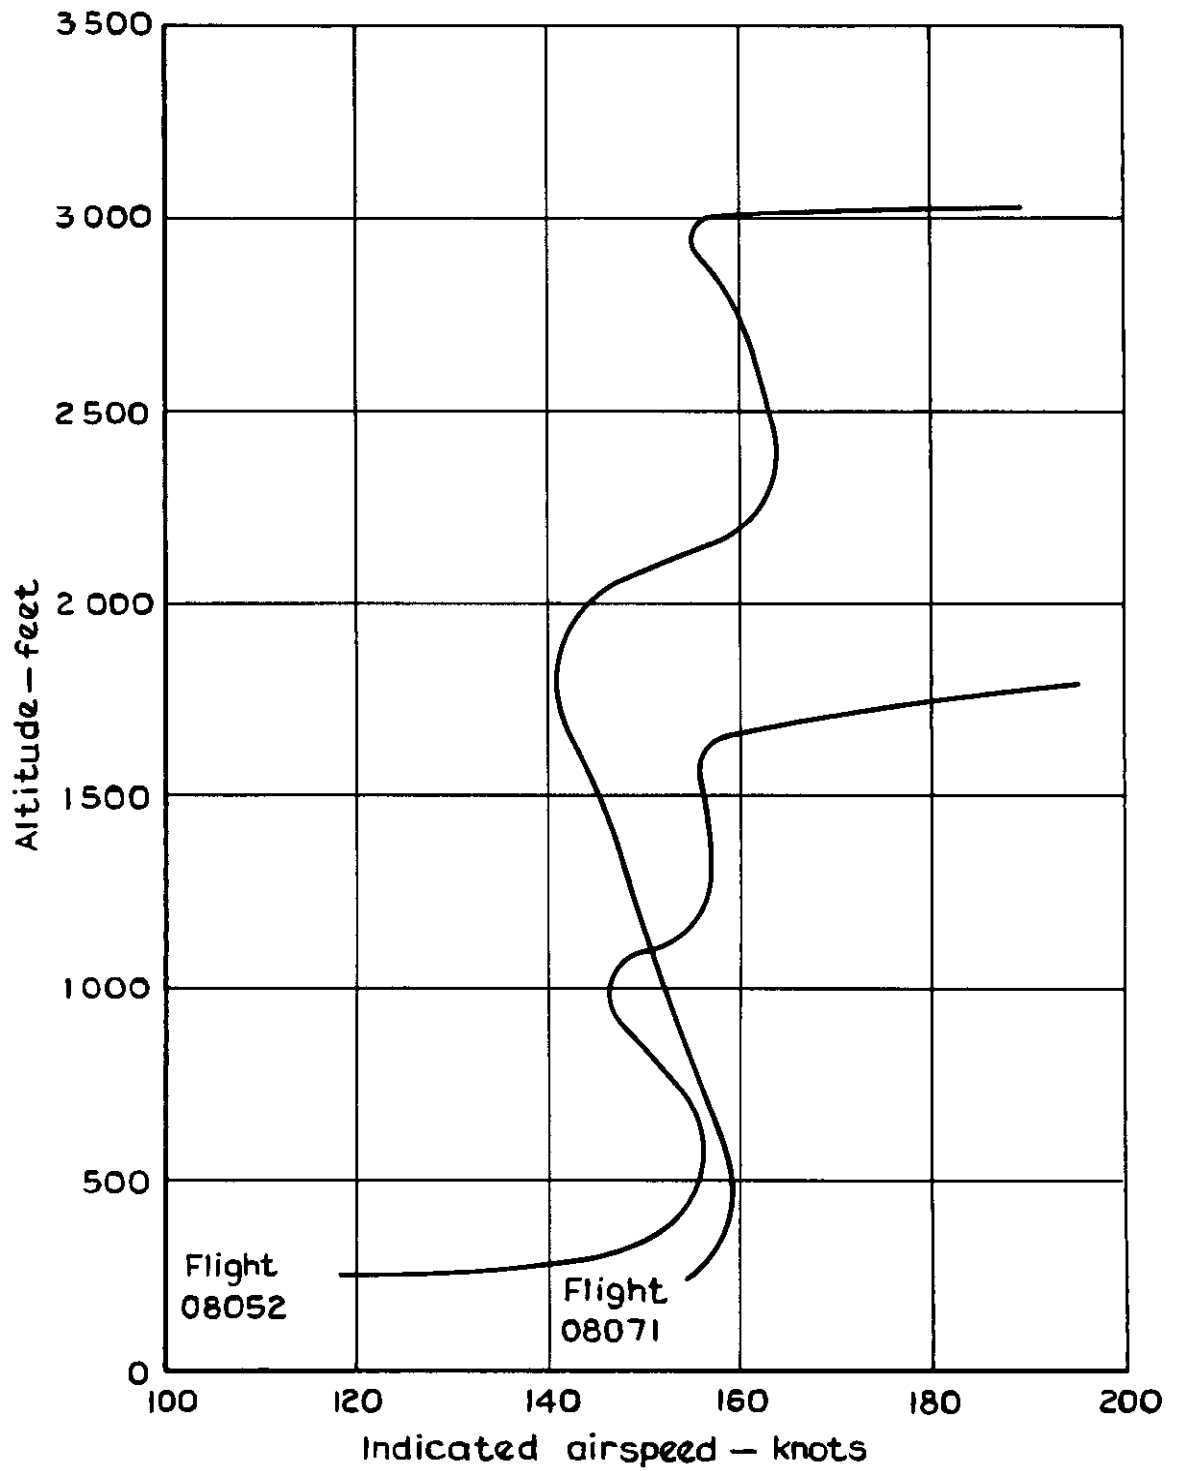
Fig.A6 c Change of airspeed with altitude

During each take-off, the indicated airspeed was allowed to fall back after attaining climb-out speed and thereafter fluctuated with about 10 knots amplitude and period of about $\frac{1}{2}$ minute until 2000 ft altitude was reached. A similar fluctuation occurred near the top of the climb with a period of 2 minutes. The first event is at night and it is probable that both events occurred during instrument flight conditions. (See Figs.A.6a, b, c.)
