Civil Aircraft Airworthiness Data
Recording Programme

Uneven Runways Encountered
by Subsonic Jet Transport Aircraft
during Scheduled Airline Operations

G. B. Hutton

CAADRP Technical Report 25

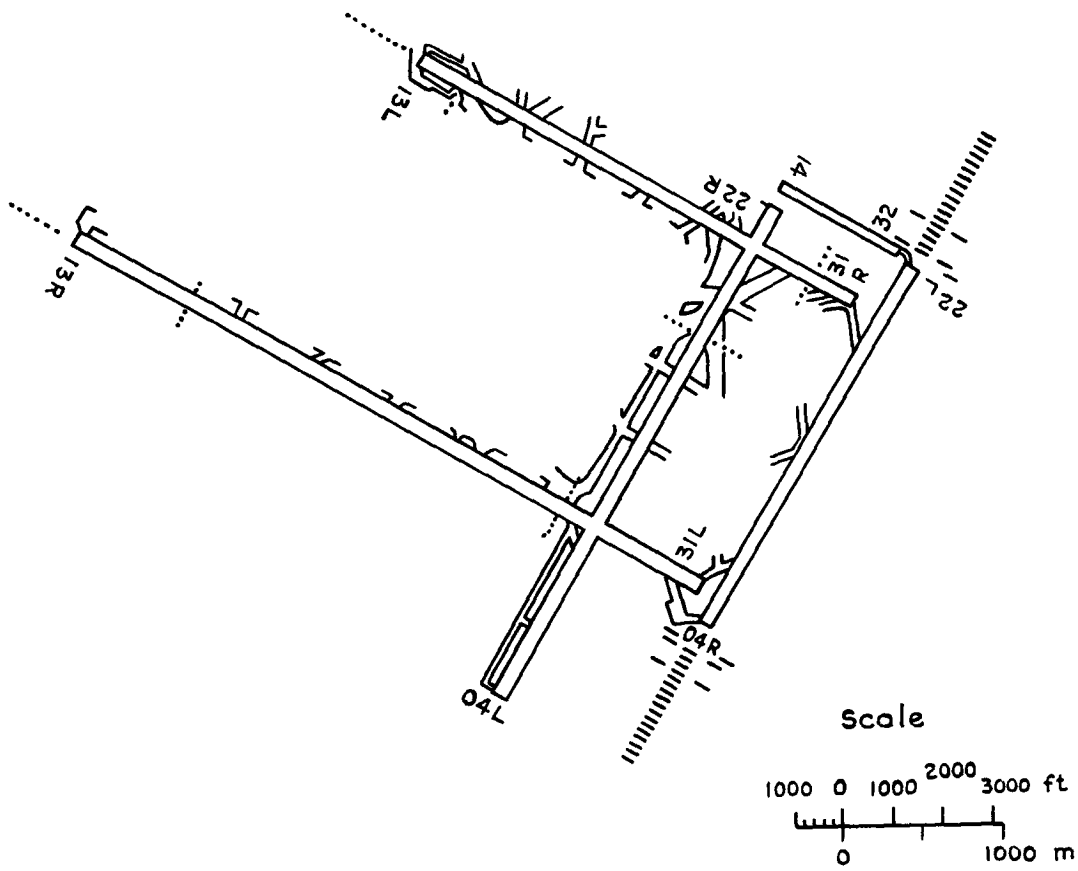
Fig. 2 Runway layout at airport No 53

the structure. The amplitude of the oscillation built up to a peak over several cycles suggesting that a succession of runway bumps excited the heave mode of the aircraft. Hall⁴ has shown that this mode is lightly damped on a typical undercarriage when the damping coefficient of the oleo legs are chosen to optimise heavy landing performance. The frequency of 1.5 Hz at 60 kn (the speed at maximum amplitude) corresponds to a wavelength of 67 feet. Information received from the aircraft's operator stated that the runway dips and is rough where it intersects with runway 31R. The runway layout is shown in Fig.2.
