INVESTIGATION AT SUPERSONIC SPEEDS OF THE COMPRESSOR
STALL AND INLET BUZZ CHARACTERISTICS OF A J34 -
SPIKE-INLET COMBINATION

By J. Cary Nettles and Robert C. Campbell

Lewis Flight Propulsion Laboratory
Cleveland, Ohio

WASHINGTON
March 5, 1958

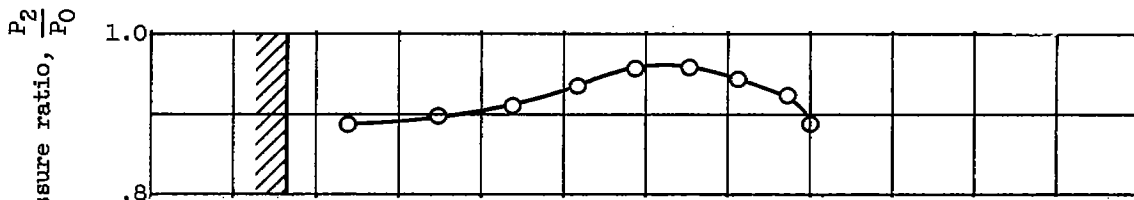
(a) Mach number at which conical shock intersects cowl lip, 2.4; referred engine speed ratio, 0.806; compressor pressure ratio, 2.68; compressor-face total-pressure distortion, 0.07; stall.

(b) Mach number at which conical shock intersects cowl lip, 1.8; referred engine speed ratio, 0.792; compressor pressure ratio, 2.45; compressor-face total-pressure distortion, 0.09; stall.

(c) Mach number at which conical shock intersects cowl lip, 1.8; referred engine speed ratio, 0.748; compressor pressure ratio, 2.45; compressor-face total-pressure distortion, 0.06; stall.

(d) Mach number at which conical shock intersects cowl lip, 1.6; referred engine speed ratio, 0.794; compressor pressure ratio, 2.61; compressor-face total-pressure distortion, 0.04; no stall.

Figure 6. - Typical compressor-face total-pressure profiles. Free-stream Mach number, 1.7.

Radial profiles of total-pressure recovery representative of the flow approaching the entire engine face are shown in figure 6 for conditions where stall was encountered and for a typical case from the data of figure 3 where maximum turbine temperature was obtained without stall. These profiles indicate that stall was encountered when there was a radial distortion of the flow. In particular, the stall appears to have been related to the presence of a pressure deficiency in the flow near the hub.
