MINISTRY OF SUPPLY

AERONAUTICAL RESEARCH COUNCIL
REPORTS AND MEMORANDA

The Effect of Tight Clamping on the Fatigue Strength of Joints

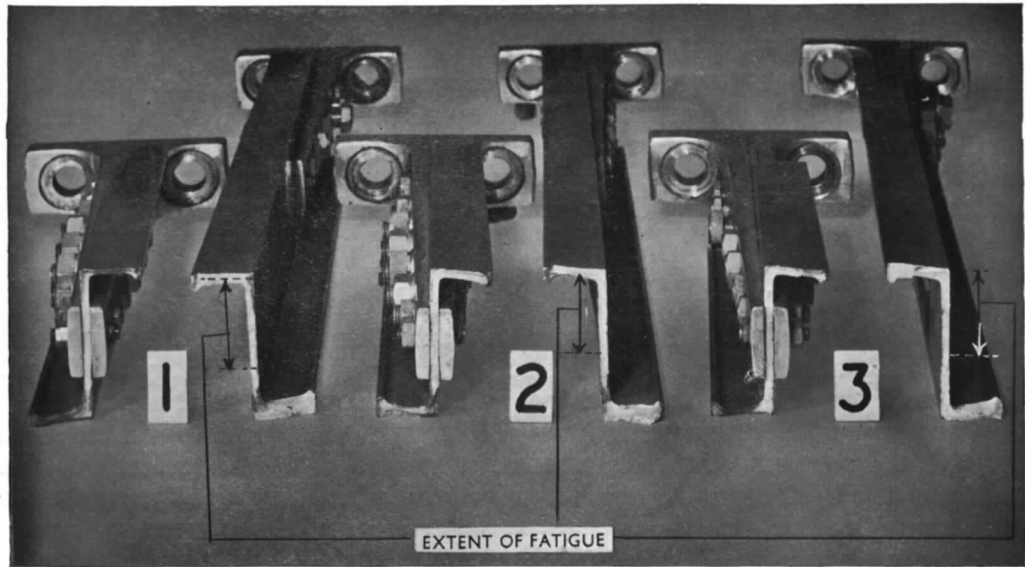
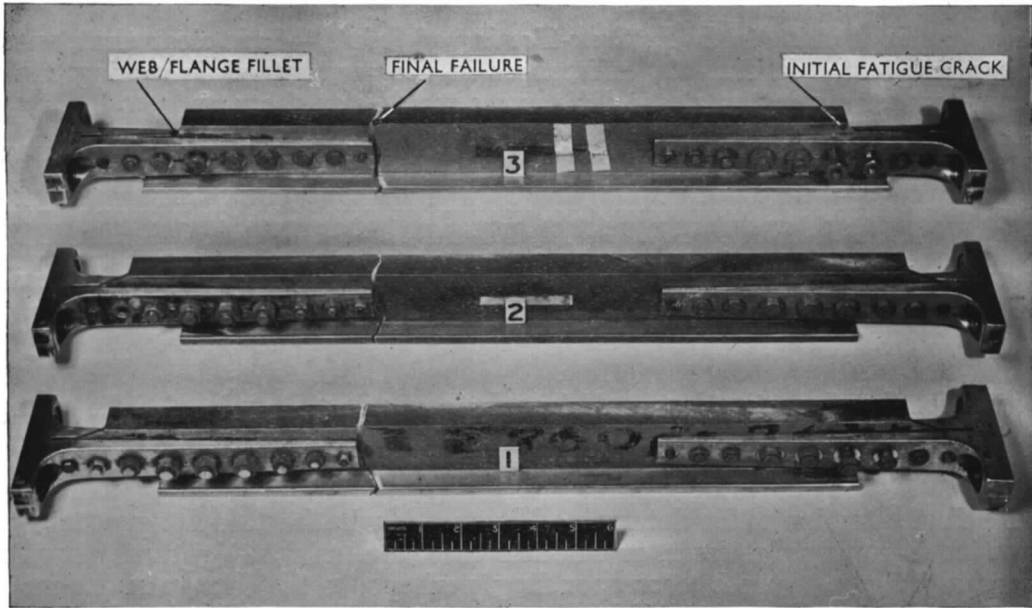
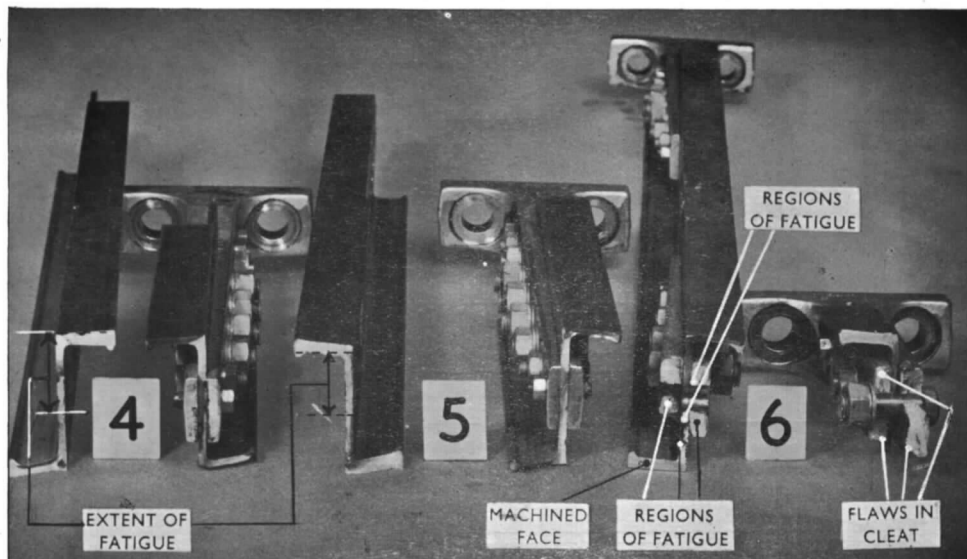
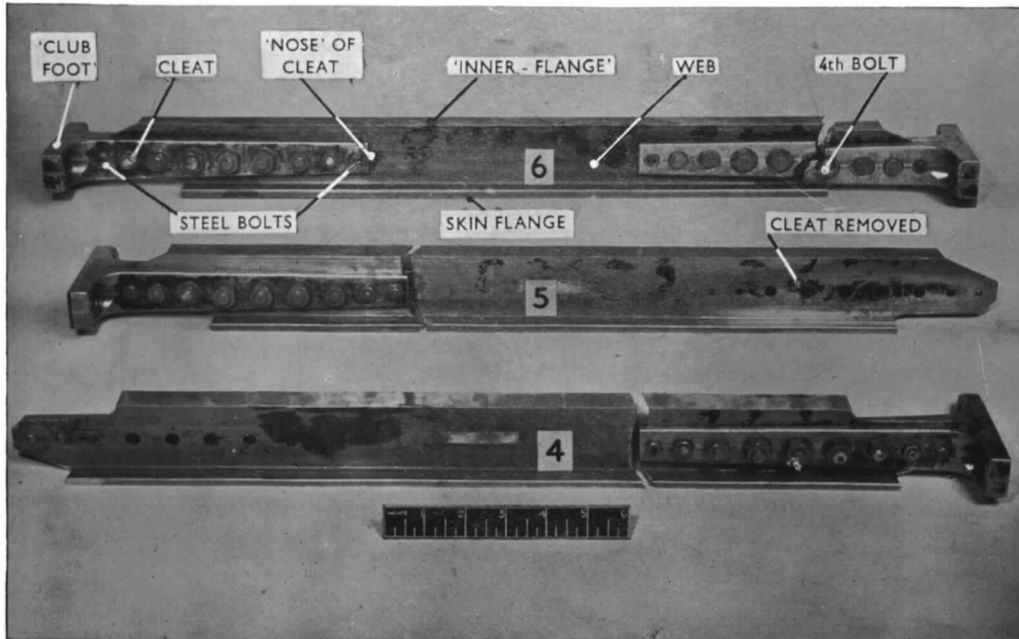
FIG. 1. Specimens after failure. Nos. 1–3.

2. *Tests on Z-stringer Specimens.*—Six stringer-joint specimens and their fractures are shown in Figs. 1 and 2. With the exception of specimen No. 6, in which a cleat failure occurred, the fatigue failure originated in the stringer web just inside of the end of the cleat.

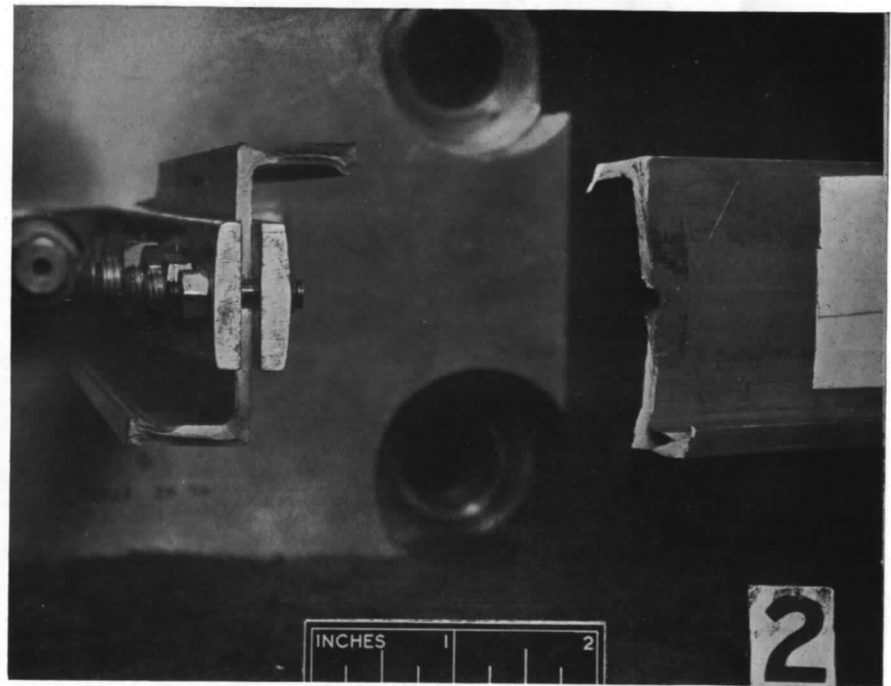
FIG. 4a. Nuts tight. Crack starts well clear of bolt hole.

2.1. *Test Results.*—*Specimen A* failed by rupture of the stringer from a transverse fatigue crack just inside the nose of the cleat (Fig. 4a).

Endurance 1·214 *million cycles.* See point A in Fig. 3.

2.2. *Discussion of Results.—Specimen A.* Evidently the change from light alloy bolts to steel ones had no noticeable effect on the endurance.
