THE EFFECT OF SURFACE FINISH ON THE
FATIGUE PERFORMANCE OF CERTAIN PROPELLER MATERIALS

By H. W. Russell, H. W. Gillett, L. R. Jackson,
and G. M. Foley
Battelle Memorial Institute

TECHNICAL NOTE NO. 917

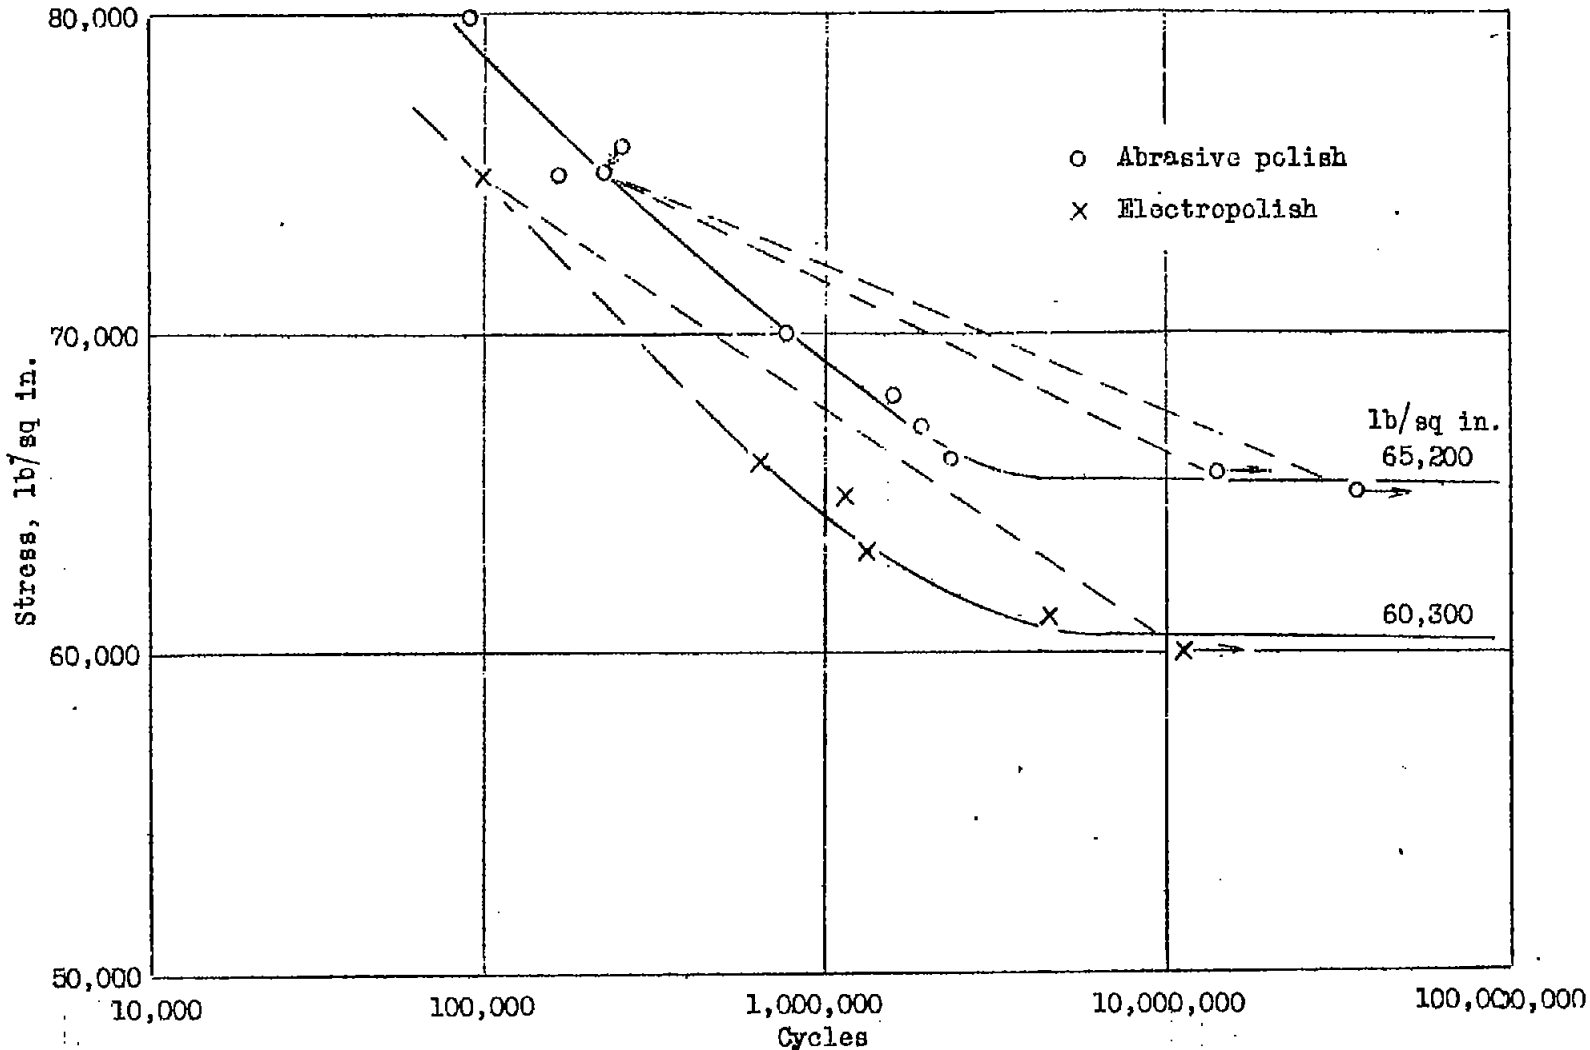
Figure 2.- Fatigue curves on normalized 4140 steel.

Fatigue tests on abrasive polished and electropolished specimens are reported in tables 2 to 4 and are plotted in figures 1 to 3.

The endurance of abrasive polished specimens is always better than that of electropolished specimens. The relative endurance limits are:

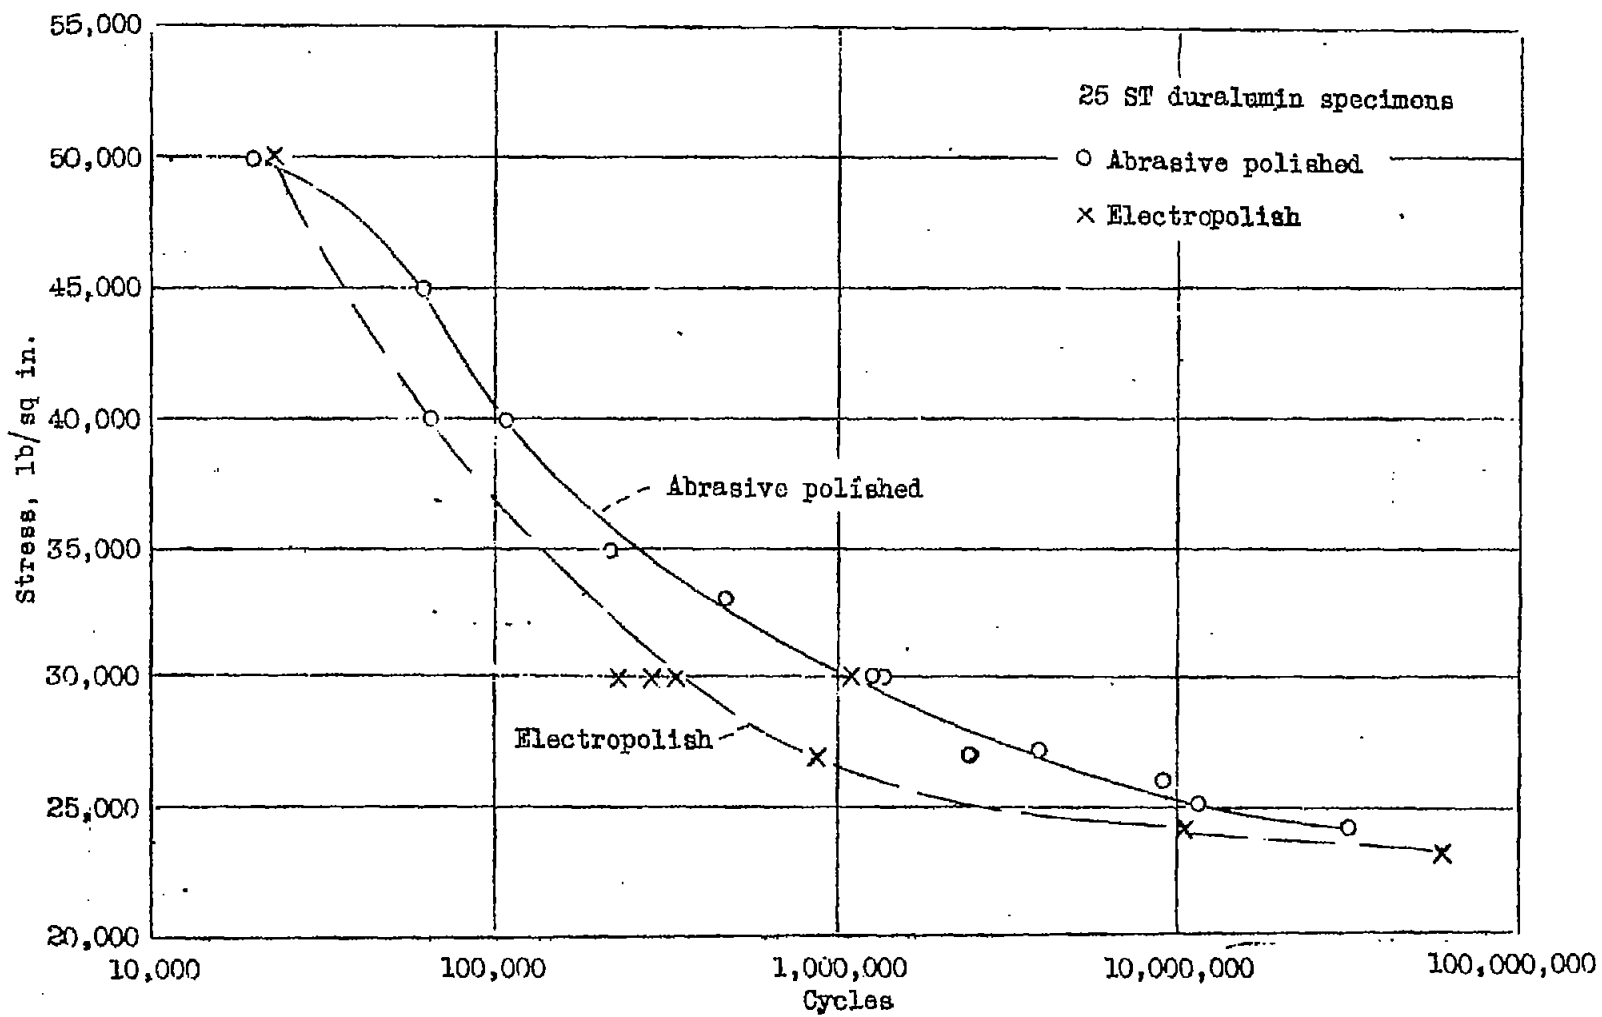
Figure 3.-- Fatigue curves on 25 ST aluminum alloy.
