NACA RM E56119

PRELIMINARY INVESTIGATION OF GUY ALLOY AS A TURBOJET-  
ENGINE BUCKET MATERIAL FOR USE AT 1650° F

By R. A. Signorelli, J. R. Johnston, and J. W. Weeton

Lewis Flight Propulsion Laboratory  
Cleveland, Ohio

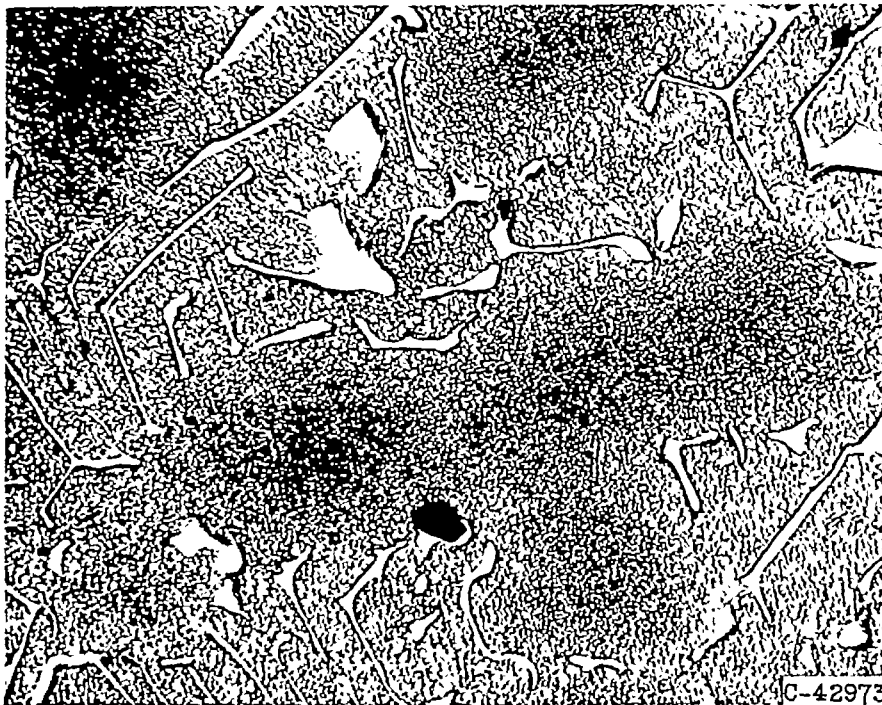
(a) Before engine testing.

Figure 5. - Typical microstructure of Guy alloy. Etchant: 45 percent water; 45 percent glycerol; 10 percent hydrofluoric acid.

Photomicrographs of the typical as-cast structure of Guy alloy buckets are shown in figure 5(a). The photomicrographs in figure 5(b) illustrate the structure after engine testing. Comparison of figure 5(a) with figure 5(b) shows that no visible change occurs as a result of engine testing. Photographs of as-cast macroetched buckets are shown in figure 6. The grain size is small and uniform within each bucket with a small difference in grain size between the two buckets.

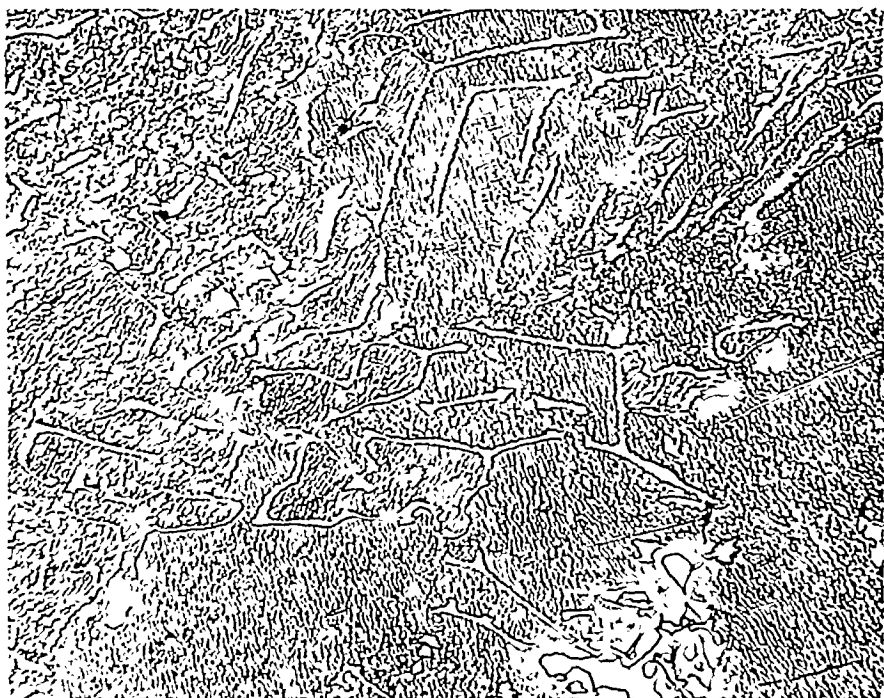
(b) After engine testing.

Figure 5. - Concluded. Typical microstructure of Guy alloy. Etchant: 45 percent water; 45 percent glycerol; 10 percent hydroflouric acid.
