NACA RM H57C22

FLIGHT-DETERMINED INDUCTION-SYSTEM AND SURGE
CHARACTERISTICS OF THE YF-102 AIRPLANE
WITH A TWO-SPOOL TURBOJET ENGINE

By Edwin J. Saltzman

High-Speed Flight Station
Edwards, Calif.

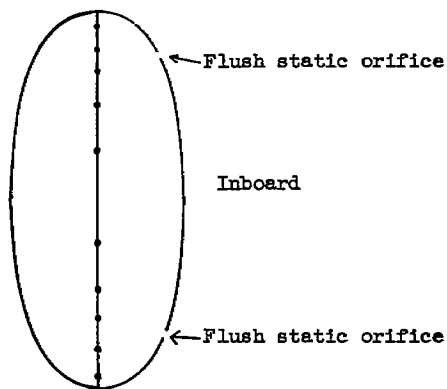
Survey station 1
 Area = 264 sq in.
 (All total-pressure probes manifold to single tube)

Survey station 2
 Area = 274 sq in.
 (All probes manifold to single tube)

Survey station 3
 Area = 721 sq in.
 (Probes individually recorded)

Note: Rake C located at 150°
 for part of program,
 then moved to 180°.

(b) Front view of survey station profiles.

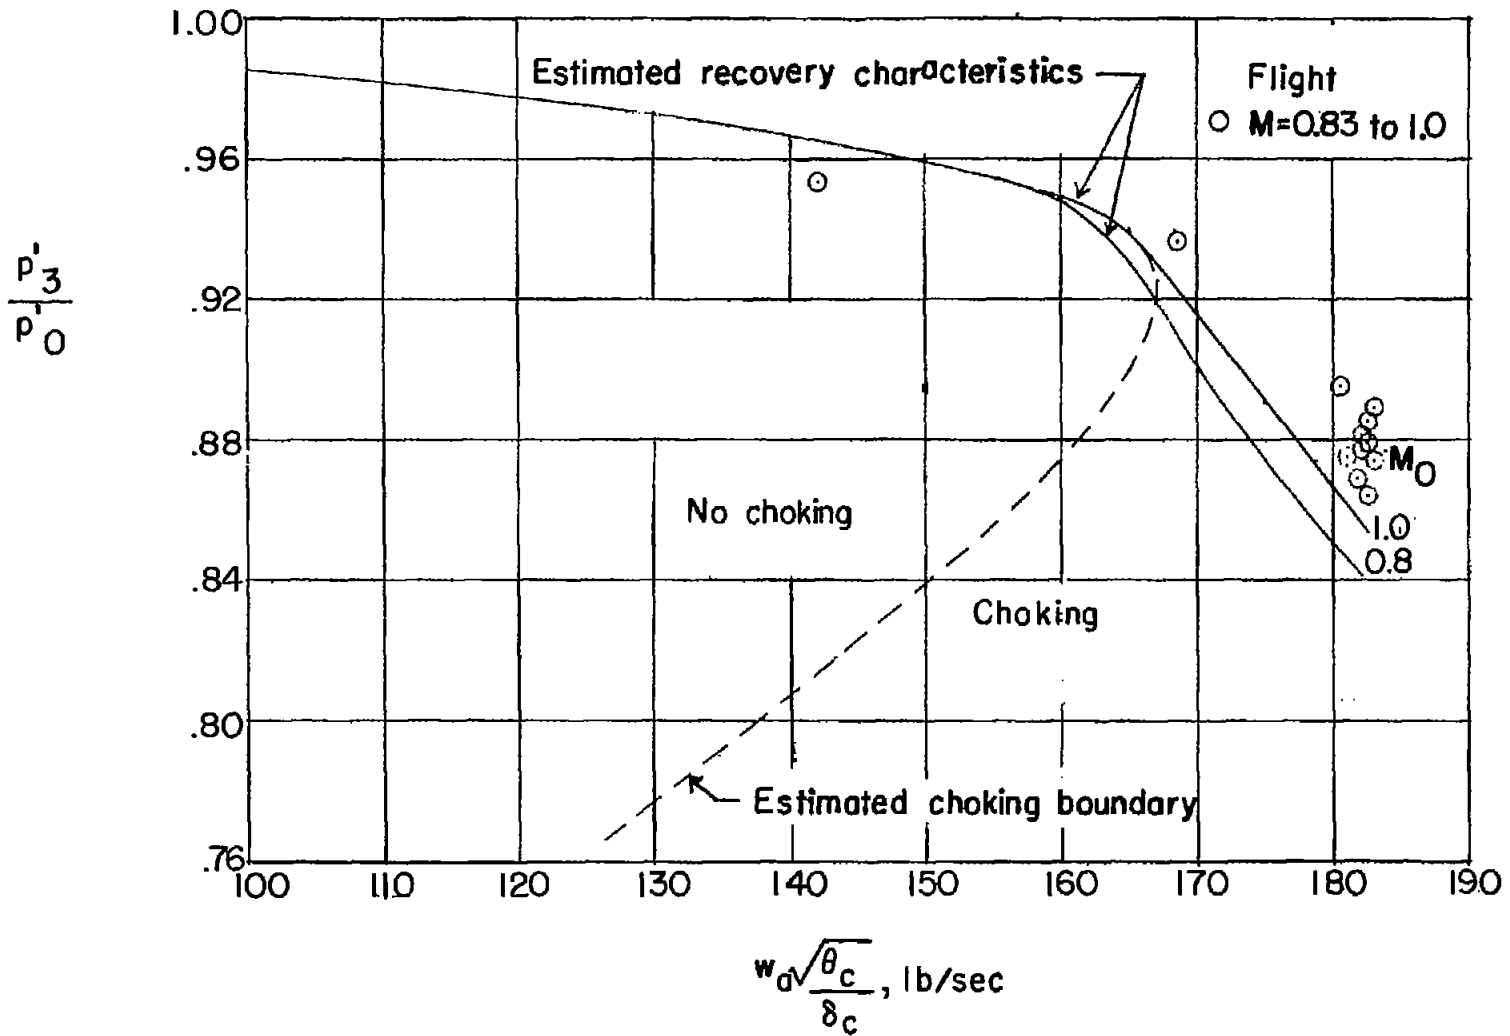
Figure 11.- Variation of compressor face pressure recovery with normalized air-flow rate.

This condition is illustrated in more detail in figure 11 where flight data are compared with recovery characteristics and the choking boundary, both of which are estimated in reference 2. Sensing devices were not available at the proper locations to indicate positively a choked condition in this duct. However, in view of the trend of flight pressure-recovery values and the position of the flight-recovery values relative to the estimated choking line, it is thought that a choked condition existed for most flight conditions. This is a rather serious case of mismatching.
